# Status Report

AX001-1/-2/02  
August 2002

Type of Occurrence: accident  
Date: 01. July 2002  
Location: near Überlingen /Lake Constance  
Aircraft: Transport category aeroplanes  
Manufacturer / Model: 1. Tupolev / TU154 M  
2. Boeing / B757-200  
Injuries to Persons: 71 persons fatally injured  
Damage: both aircraft destroyed  
Other Damage: damage to fields and forest

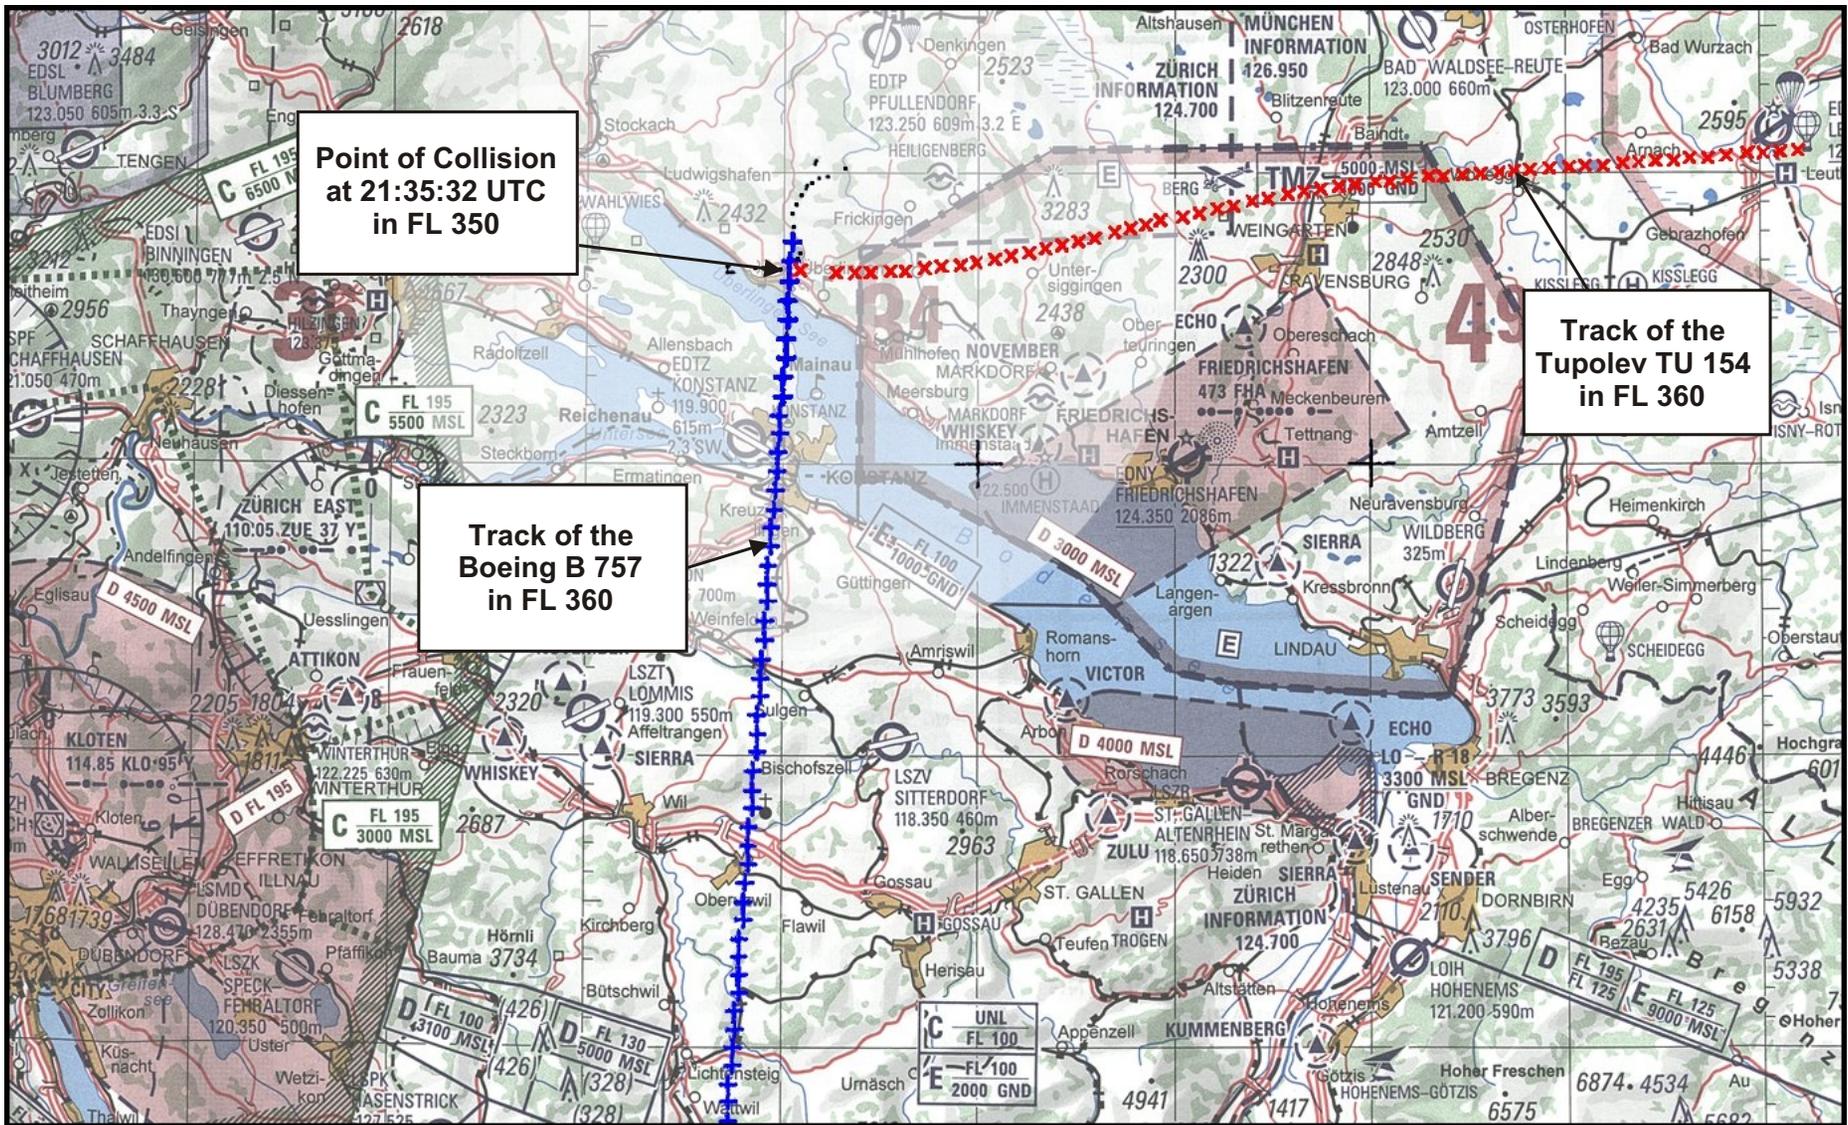
**Flightracks and Collision of Tupolev TU 154 M with Boeing B 757-200**

- The aircraft collided at a right angle. Whereas the Boeing B757 was on a northern heading (004°) the Tupolev TU154 M had a western heading (274°). The collision occurred at an altitude of app. FL 350 (see attachment 1).
- Both aircraft were equipped with identical collision warning devices (TCAS Honeywell 2000, Change 7). According to the knowledge gathered so far, no malfunction was found.
- Both operators had provided training programmes for TCAS and the crews had completed the corresponding training.
- Neither the history of the flight nor the evaluation of the flight data recorders indicated any technical defects on the aeroplanes.

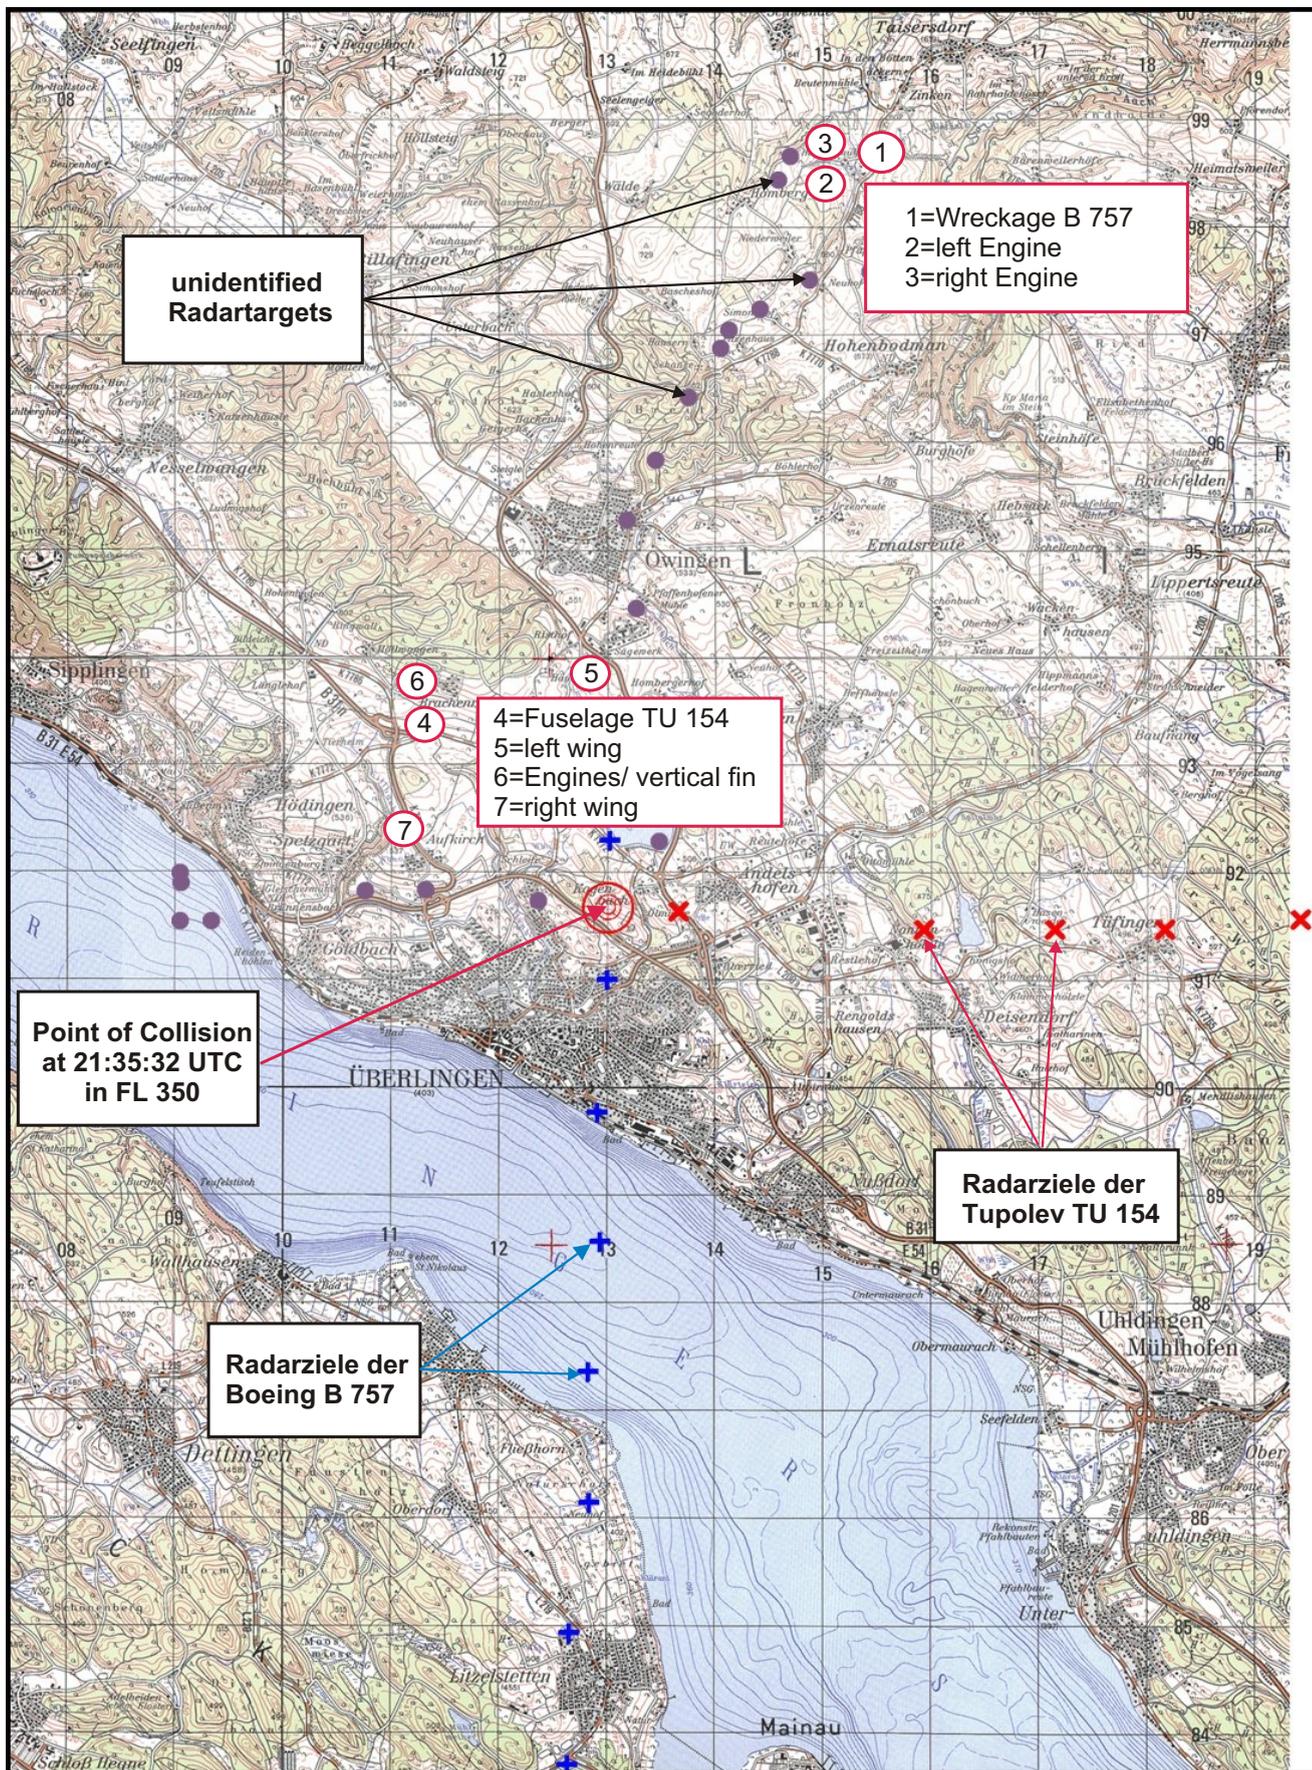
**Collision and wreckage distribution**

The TU154 M had broken in flight into four main portions (fuselage, right wing, left wing and tail unit including power plants). These parts had crashed on the ground southwest of the village of Owingen (see attachment 2).

The aircraft fuselage was found in the area of the village of Brachenreuthe in flat terrain. 300 m meters north of this site, the tail unit and the power plants had impacted the ground. The left wing had fallen into the garden of a residential building app. 2 km northeast of the fuselage. The right wing of the aeroplane was found app. 800 m south of the fuselage. All parts except the fuselage showed traces of a fire.

The B757 had crashed on the ground app. 8 km north of the TU154 M in the area of Taisersdorf. Shortly before the impact both power plants had separated from the aircraft. They were found at a distance of app. 500 m from the main wreckage (see attachment 2). Upon the impact, a fire broke out.

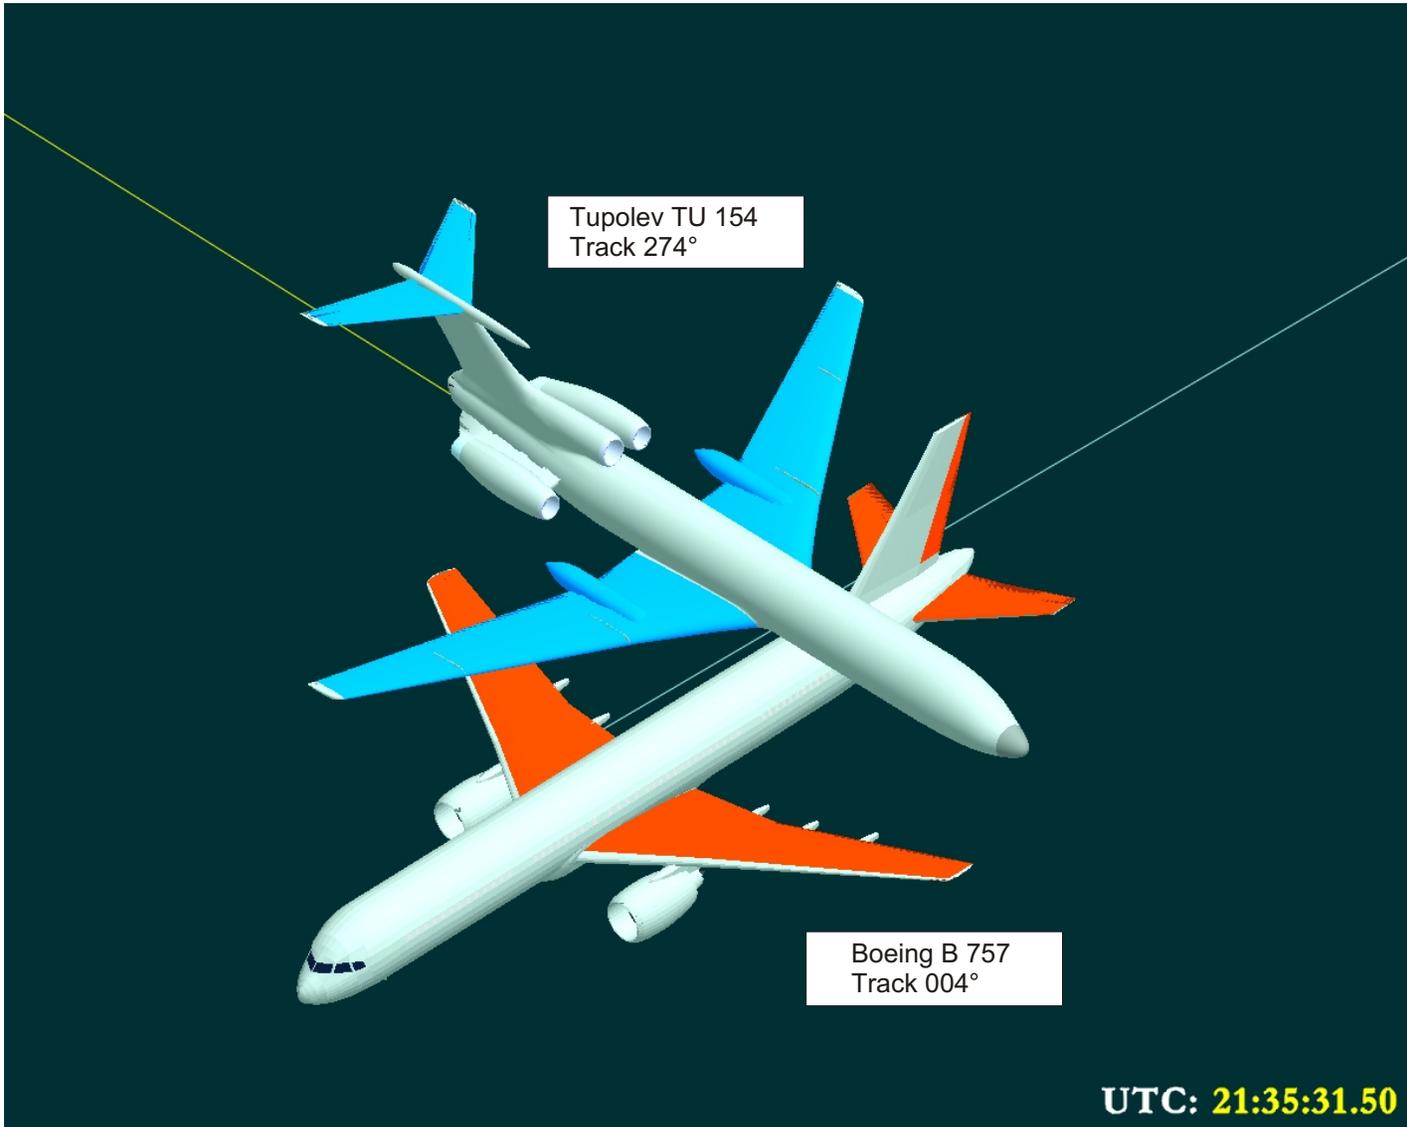
**Collision Tupolev TU 154 M with Boeing B 757-200**

The aircraft wreckage parts recovered were layed out in a hangar at Friedrichshafen airport and inspected for traces of the collision. During this inspection, traces in the form of scratch marks, paint scrape-offs and red paint traces were found on the left side of the TU154 M fuselage in the area of the two overwing emergency exits.

On the lower surface of the right wing of the TU154 M there were scratch marks over a length of app. 3.60 m and a width of app. 0.90 m running into the direction of the main landing gear fairing. The scratch marks were running at an angle of app. 45° into the direction of the longitudinal axis of the TU154 M. The fairing of the right main landing gear had been torn off over a length of app. 2.80 m. Besides red paint traces remainings of the honeycomb structure of the B757 rudder were found on this wreckage part.

The two aircraft collided first with the vertical tail surface of the of B757 and the left side of the TU154 M fuselage in the area of the two above mentioned emergency exits (see attachment 3).
