**AVIATION INVESTIGATION REPORT  
A06O0141**

**LOSS OF CONTROL AND COLLISION WITH TERRAIN**

**BEDE BD5-J C-GBDV  
OTTAWA / CARP AIRPORT, ONTARIO  
16 JUNE 2006**

Report Number A06O0141

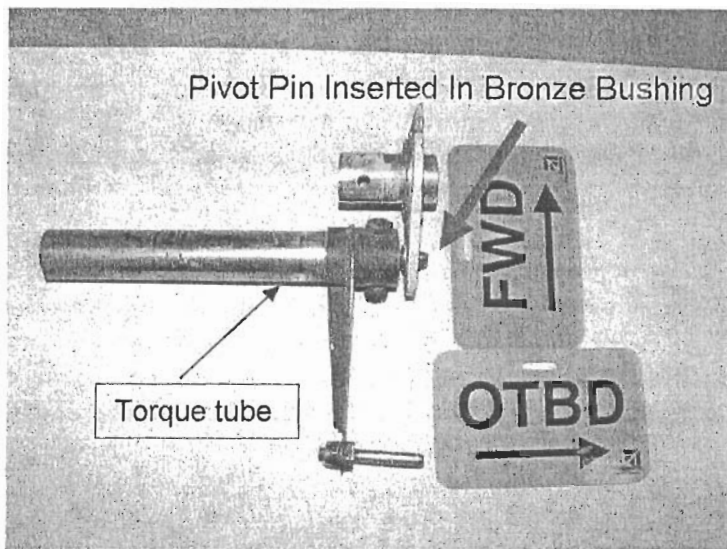
Figure 1. Properly assembled right flap mechanism

When the wings are installed, the pivot pin on the outboard end of the flap-drive torque tube must be guided into the bronze bushing on the flap arm (see Figure 1). The pin must be visually checked from underneath the aircraft to ascertain that the correct assembly has been accomplished. As a further check of the assembly, the flaps should be extended and retracted using cockpit controls.

If the pivot pin is not aligned with the bushing in the flap arm as the wing is ratcheted into position, the end of the torque tube will butt

tightly against the flap arm. The flaps may move when selected from the cockpit because of the friction between the torque tube and flap arm. On the ground where there is no air load, the flaps could work correctly and remain in the down position when selected down. However, in the air, if the pivot pin is not in the bushing, vibration and air loads could cause the flap to partially or fully retract, resulting in a flap asymmetry. According to the kit manufacturer, a flap asymmetry would cause the BD5-J to roll rapidly, and full aileron input would be insufficient to counter the roll.

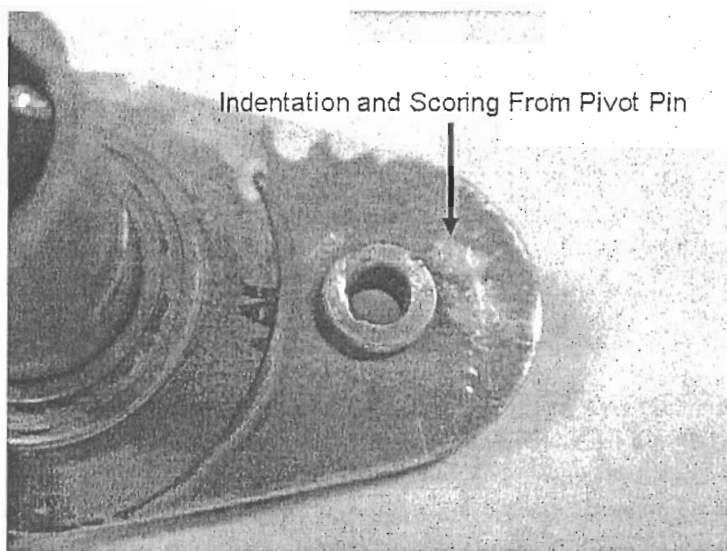
Figure 2. Right flap hinge arm

A detailed examination of the right flap hinge arm assembly revealed indentations and a crack in the bronze bushing. There were circular score marks and indications of smearing on the material adjacent to the bushing. These marks had the appearance of being made recently and were consistent with damage that would occur during movement of the flaps. The indentations corresponded in size and radius to the guide pin installed in the end of the flap drive torque tube. The radius of the circular score marks and rubbing corresponded with the radius of the flap drive torque tube. The smearing indicated that the torque tube had moved upward and aft around the bronze bushing (see Figure 2).

Reportedly, the pilot checked the flaps for correct installation and function before the accident flight. However, an examination of the aircraft indicated that the right flap was incorrectly installed, in that the torque tube pin was not secured in the flap arm bushing, which would allow the flap to retract in flight.

1. The right flap was incorrectly installed during the wing installation, which allowed the right flap to retract during the fly-past. This created a flap asymmetry that resulted in an uncommanded and uncontrollable right roll. The aircraft was at an altitude from which recovery was not possible before the aircraft struck the ground.

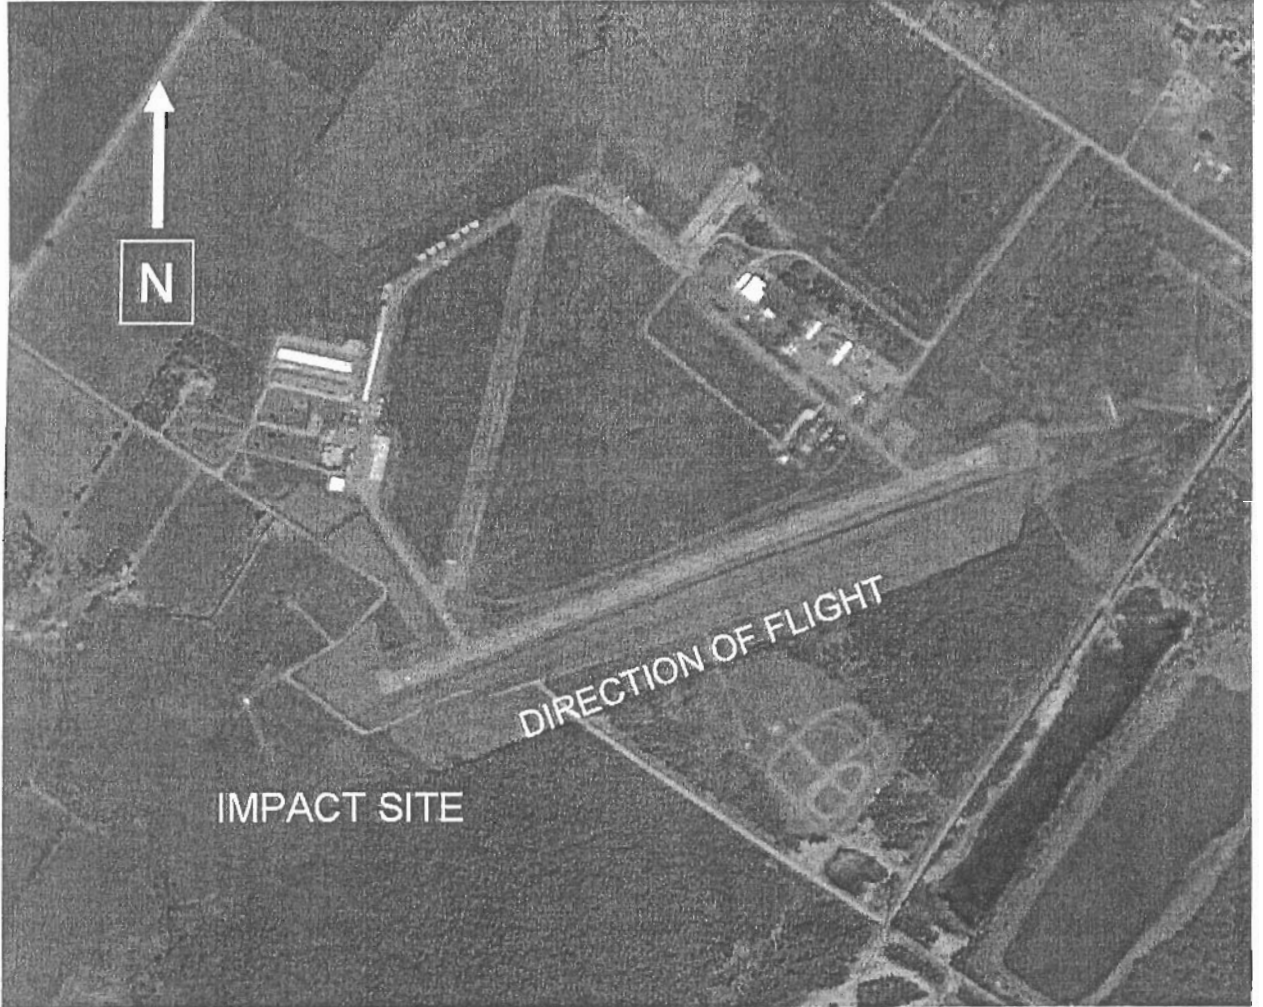
*Appendix A – Site Diagram*

The initial impact was 460 feet southwest of the button of Runway 10. The aircraft slid 23 feet and came to rest on a heading of approximately 200° magnetic (see Appendix A). The aircraft hit the ground in a slightly nose-low, left-wing-down attitude. The ground scars showed that the landing gear was down and that both wings separated from the aircraft at impact. When the aircraft was examined at the site, no discrepancies were found in the aileron, rudder, or elevator control systems.
