# Air Accident Investigation Unit Ireland

## Reports 1/2007

AAIU Synoptic Report No: 2006-026

Aircraft Type and Registration:	Bell 206B, EI-BYJ
No. and Type of Engines:	1 x Allison 250
Aircraft Serial Number:	1897
Year of Manufacture:	1976
Date and Time (UTC):	13 June 2004 @ 18.15 hrs (19.15 hrs Local)
Location:	Inniskeen, Co. Monaghan
Type of Flight:	Public Transport
Persons on Board:	Crew - 1      Passengers - 4
Injuries:	Crew - None    Passengers - None
Nature of Damage:	Tail boom damage following autorotation.
Commander's Licence:	Airline Transport Pilot's Licence (Aeroplanes) & Commercial Pilot's Licence (Helicopters)
Commander's Details:	Male, aged 45 years
Commander's Flying Experience:	8,830 hours, of which 263 were on type
Information Source:	Station Manager, ATC Dublin. AAIU Field Investigation

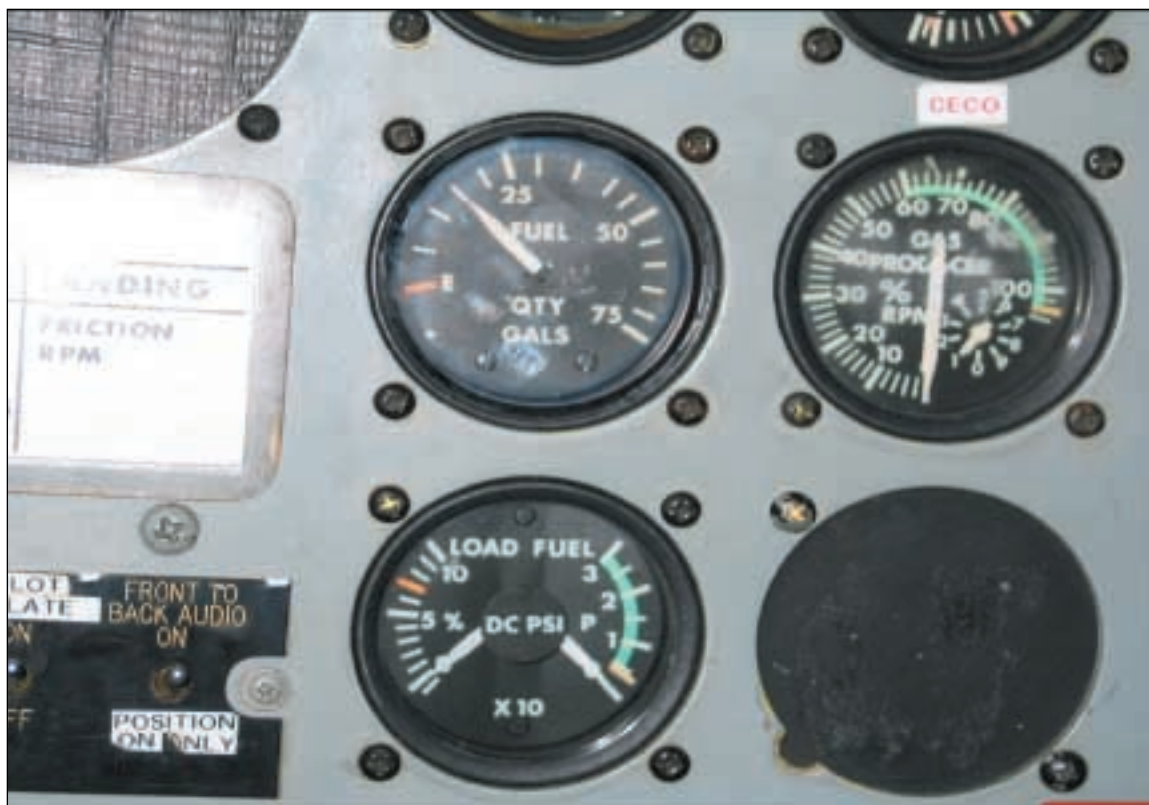
- 2.2** In his debrief to the Investigation the pilot said that he relied on his fuel gauge and time flown to estimate the flying time remaining. Hence, on the final trip, he noted that the fuel gauge was at or slightly above 10 US gallons, which he felt, was adequate to complete this trip. He was of the view that 10 US gallons would give him in excess of fifteen minutes flying time. However this belief made no allowance for the sloshing problem. It also indicated that the pilot was depending totally on his fuel gauge for information on his fuel situation. The fact that the pilot was not aware of the exact number of trips completed further indicates that he was not using time flown as a cross check on his fuel status. Total reliance on gauges for fuel contents information in small helicopters is generally recognised as inadvisable. Furthermore there is the possibility of misreading the gauge as discussed in para 2.12 below.

This photo shows a section on the instrument panel of EI-BYJ containing the fuel gauge, which is located at top centre. The photo is scaled at approximately full size. The gauge is located approximately 60 cm from the pilot's eye (an arm's length), below and to the left of his line of vision. The contents indication when this photo was taken was 15 US gallons. Empty is indicated by the orange line with the symbol E to the right of it. The graduation immediately above this zero mark is 5 US gallons and the next one up again is 10 US gallons.

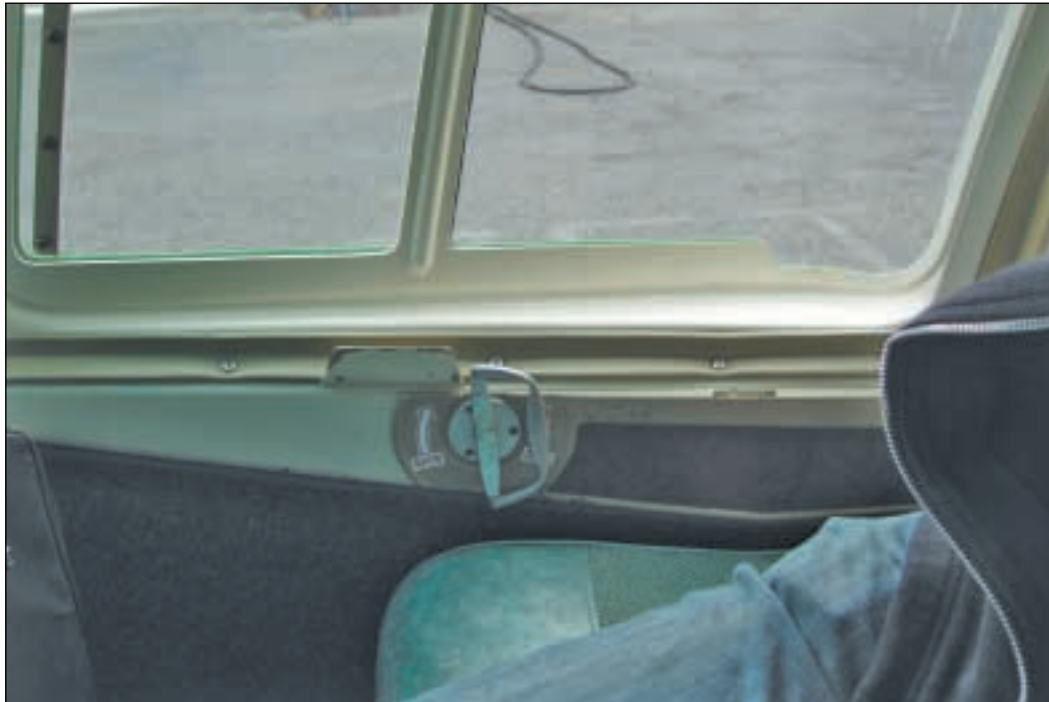
*Photo 1*

*This photo shows an unobstructed view of the operating handle of the RH door on EI-BYJ*

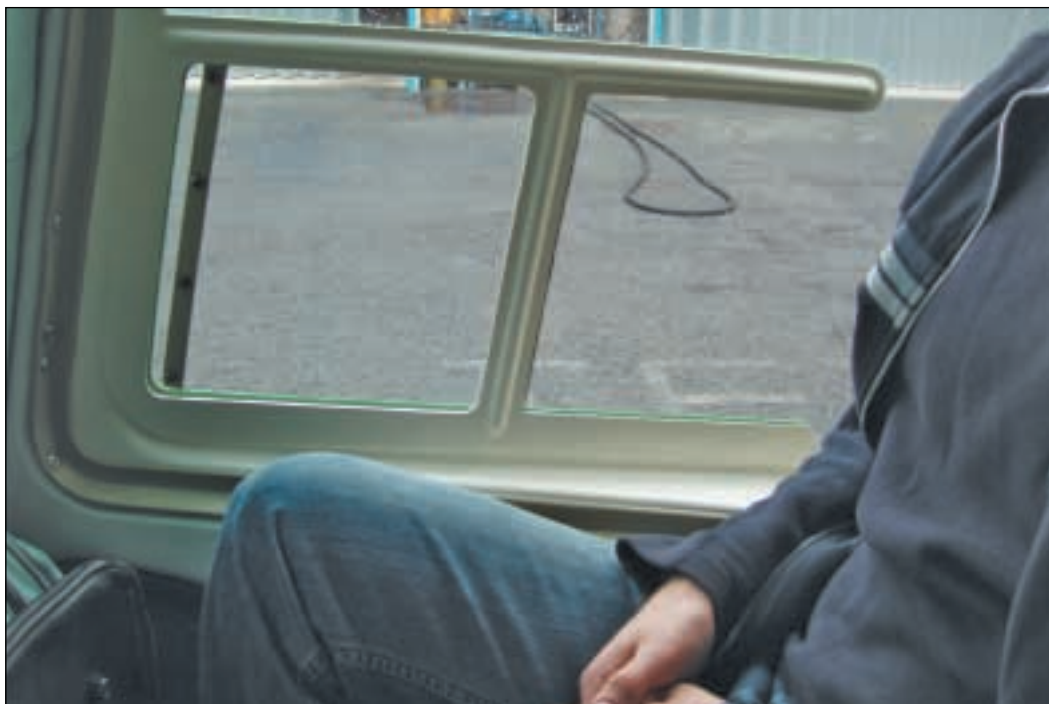
*Photo 2*

The Investigation noted that a person seated beside either rear door does not have a clear view of the door operating handle, as it is obscured by their own leg, as shown in **APPENDIX D, Photo 2**. Furthermore, their view of the operating handle on the opposite door would be obscured by the person sitting next to that door. The door can also be opened and locked from the outside by a corresponding rotating handle on the door's external surface.

- 2.17** In the case of this particular accident, the father was seated by the left rear door. Hence his view of the door-opening handle was obscured by his left leg and he was unable to locate it. His view of the operating handle on the right door was obscured by the two children. The Investigation noted that there were no instructions in the Safety Leaflet covering the location or operation of the handle, or on opening the door, particularly from inside the helicopter.

*This photo shows how the view of the operating handle of the RH door on EI-BYJ is obstructed when a person sits beside the door.*

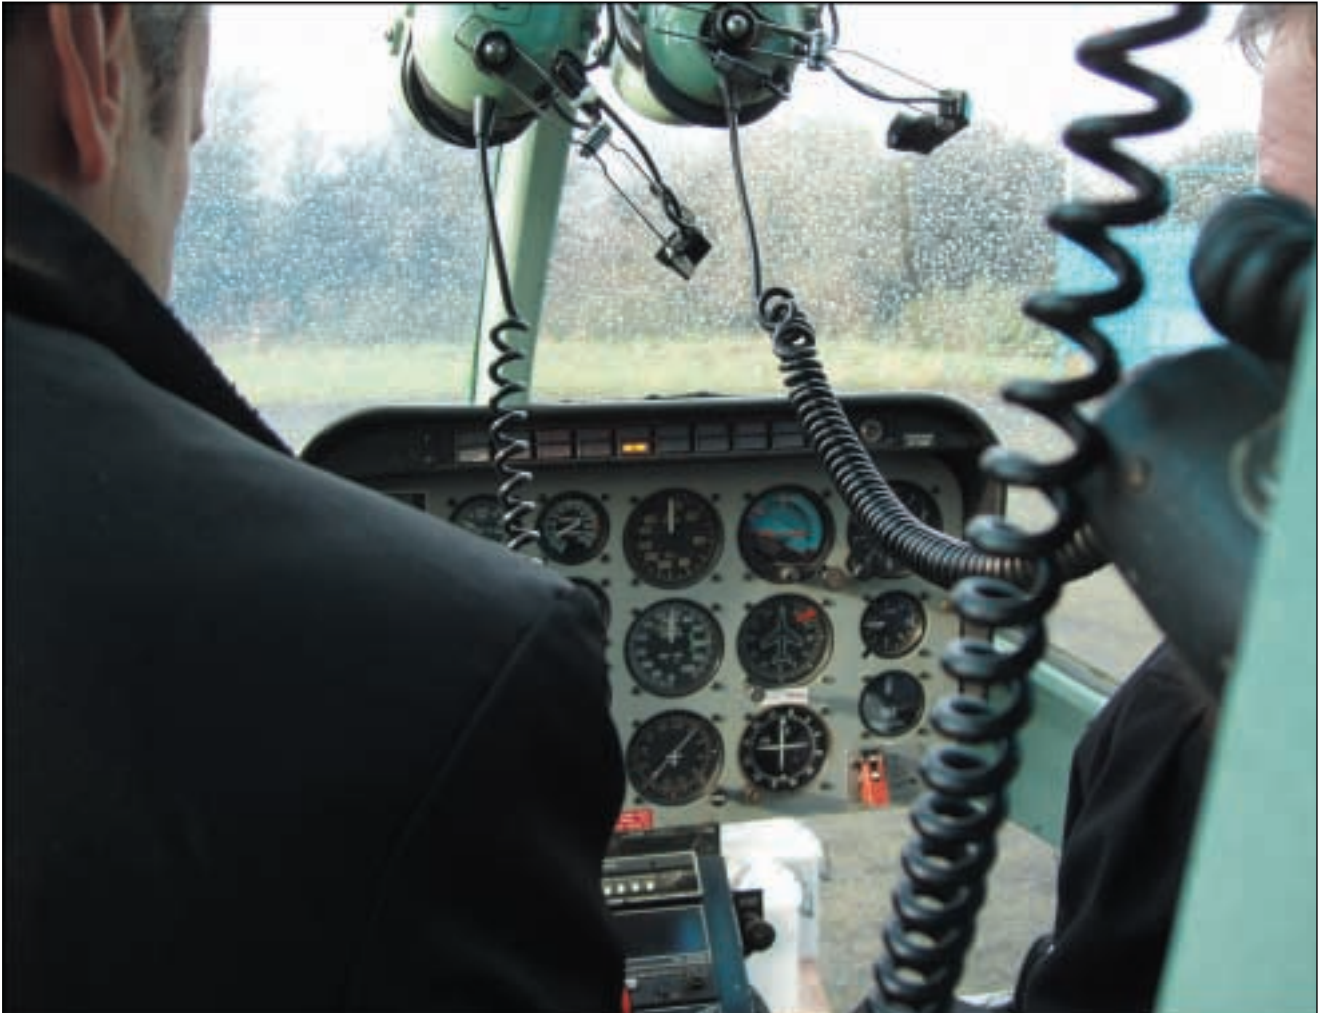
This photo shows the instrument panel as viewed from behind the head of a person seated in the front LH seat. This photograph was taken during the test runs noted in paragraph 1.12 of the main report. It represents what would have been seen by the pilot and front LH seat passenger when one booster pump was uncovered but before the second pump uncovered and the engine failed. The visible red light in the Warning Panel (upper centre) is the "FUEL PUMP" warning light. The main lighting of the warning light is red, while the logo "FUEL PUMP" is yellow. Because of the colour balance of the camera, the yellow is more visible in this digital photo, compared to the actual situation. In this test the low main rotor light was also on, as the rotor was running at idling speed. In this photograph, the warning light is hidden by the headphone cable to the right of centre. The fuel gauge is located on the left of the instrument panel. In this photograph it is hidden by the person seated in the LH seat.

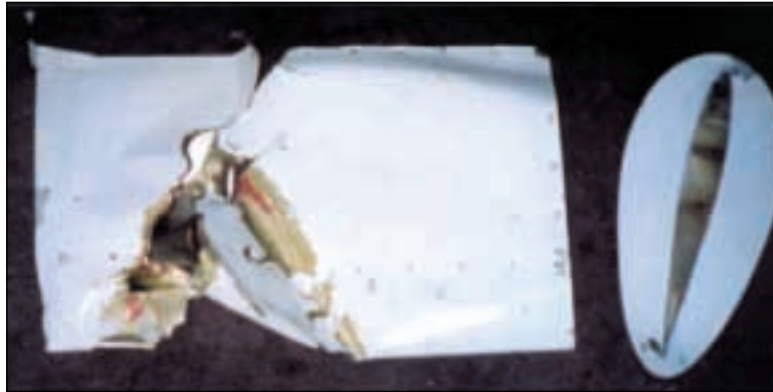
Witnesses on the ground heard the bang and saw pieces falling from the helicopter. Several parts of the tail section including three sections of the R.H. stabilizer (**APPENDIX A**) were subsequently found in a quarry 0.5 miles before the final landing area. Tail rotor blade strike marks were found on the underneath surface of the larger of the RH stabiliser sections and on the inner top surface of the smaller section. With the exception of the tail rotor drive shaft and the RH section of the stabilizer spar, which were, despite regular searches, never located, the rest of the tail section including airframe and dynamic parts were all located within 20 metres of the helicopter landing area. The cylindrical stinger tube with part of the tail boom attached was found 18 metres to the right of the helicopter. A large dent, 15 inches from the tube end was compatible with a strike from one of the main blades.

1. Failure of the spar (tube) has occurred through fatigue cracking.
2. The cracking appears to have initiated at the inner edges of the boltholes, where burrs were observed.
3. The extent of fatigue cracking, with only a small ligament in which final failure occurred, indicates high cycle fatigue.

*Three sections of the RH stabilizer found 0.5 miles from the landing site*

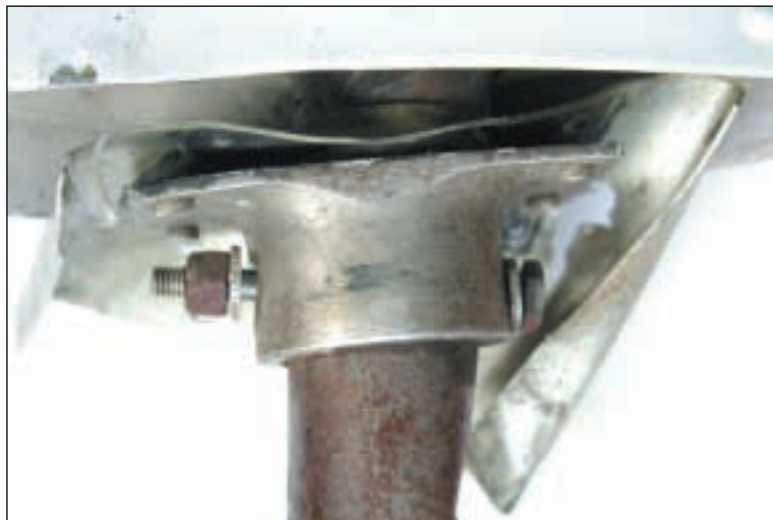
There was no indication of any inherent defect in the material of the tube. The spar was held in the fuselage fitting by means of a nut, bolt and washers at its LH side. It was observed that the nut was tightened to the end of the threaded portion of the bolt, and it appeared that the bolt was too long for the assembly (**APPENDIX A**). The fitting appears to have been machined to accommodate the washers so that the assembly could be tightened up with the bolt head, the washers and the nut parallel to one another and perpendicular to the longitudinal axis of the bolt. The fitting of the spar on the RH side was a plain fitting with no bolt. A grease mark on the spar indicates that there had been relative movement between the spar and its RH fuselage fitting. The wall thickness of the spar tube was 0.48 inch. Burrs were observed on the insides of both boltholes. Initiation points for fatigue fracture appear to have been at the inner edges of the boltholes.

*Spar /fuselage attachment bolt, nut and washer.  
Note long bolt and space between washer and housing.*

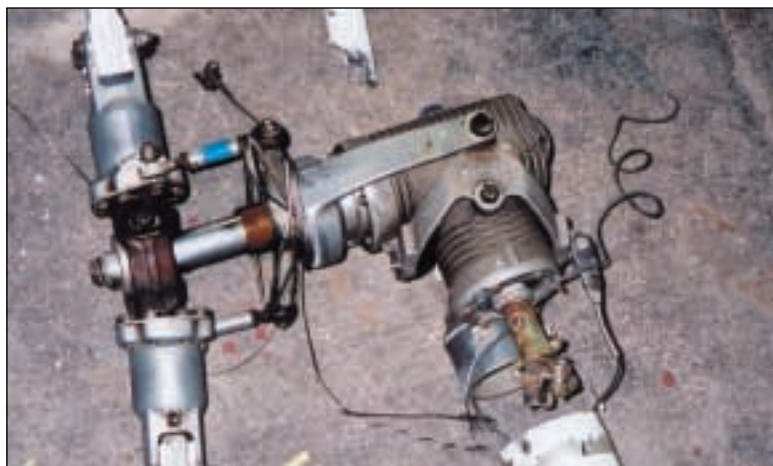
All of the RH tail rotor control cable was found wrapped around the TR gearbox output shaft. It was impossible to rotate the output shaft by hand. It unravelled in two separate lengths of 78 inches and 156 inches. Strands were either broken or damaged at regular intervals. Its anchor point to the pitch change mechanism had broken off. The other end had broken at the thimble Nicropress sleeve (18-2-G), adjoining the cable to the turnbuckle (MS21251-33S), in the lower engine bay. After unravelling, the gearbox shaft was free to rotate by hand. One of the two pitch link retainers had cracked at its root.

*Tail rotor gearbox pitch change mechanism and control cables  
as found separated from the tail boom at the helicopter landing site.*

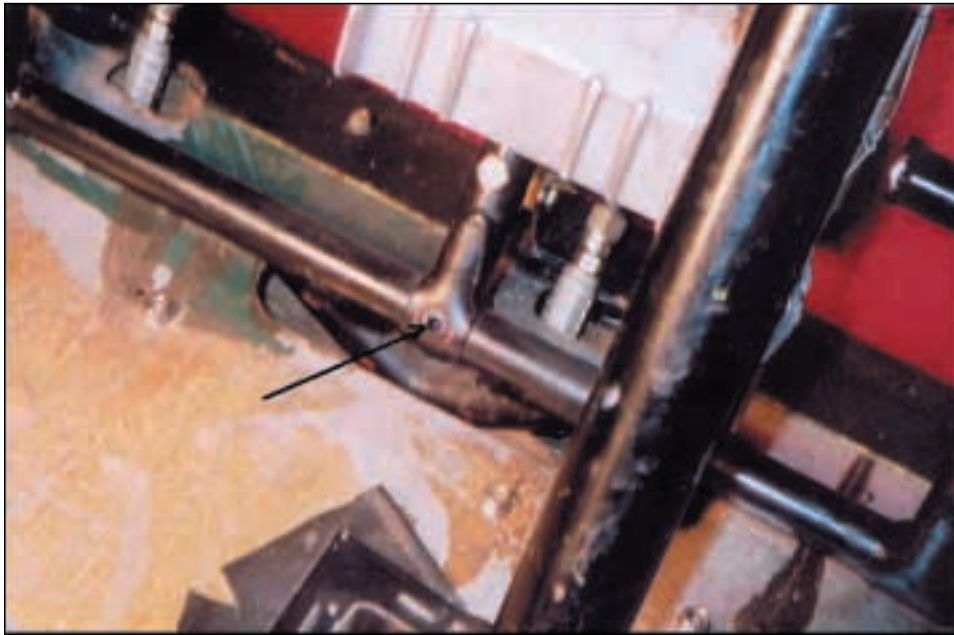
*A view of the pilot's RH pedal showing the elongated hole with the bolt removed*

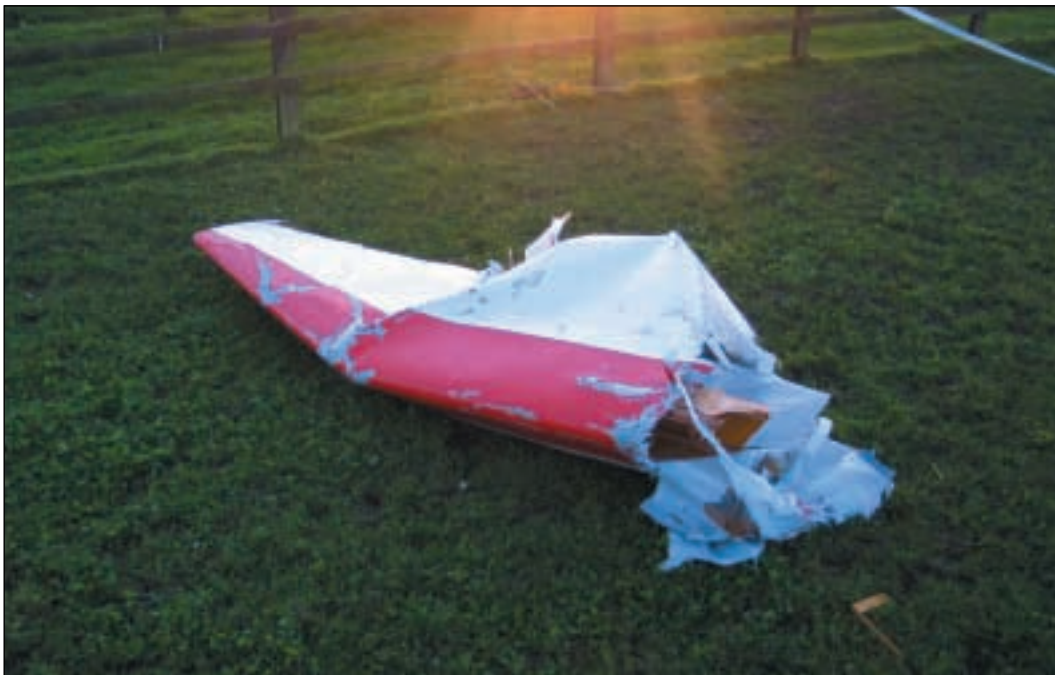
*Section of wing that separated from aircraft*

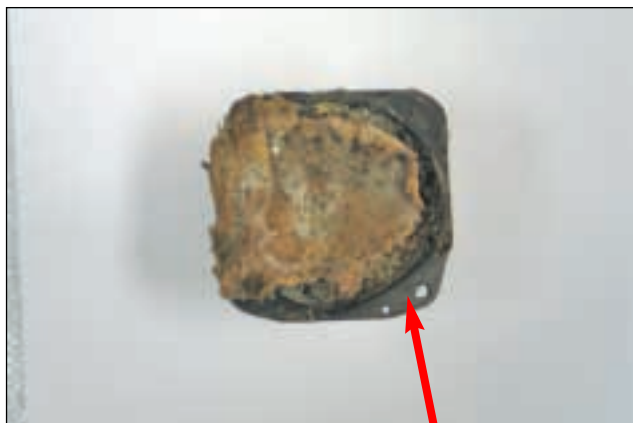
*Altimeter No. 1 with face covered*

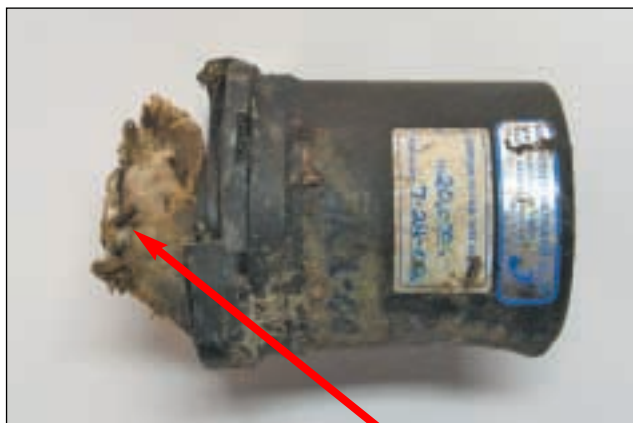
*Altimeter No. 1 with broken mounting screw*

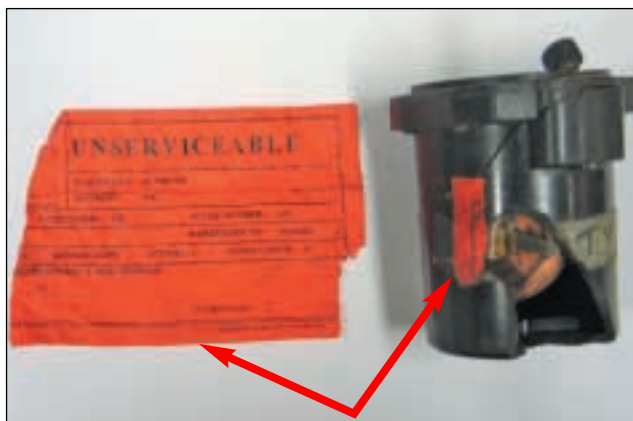
*Altimeter No. 2 with unserviceable label*

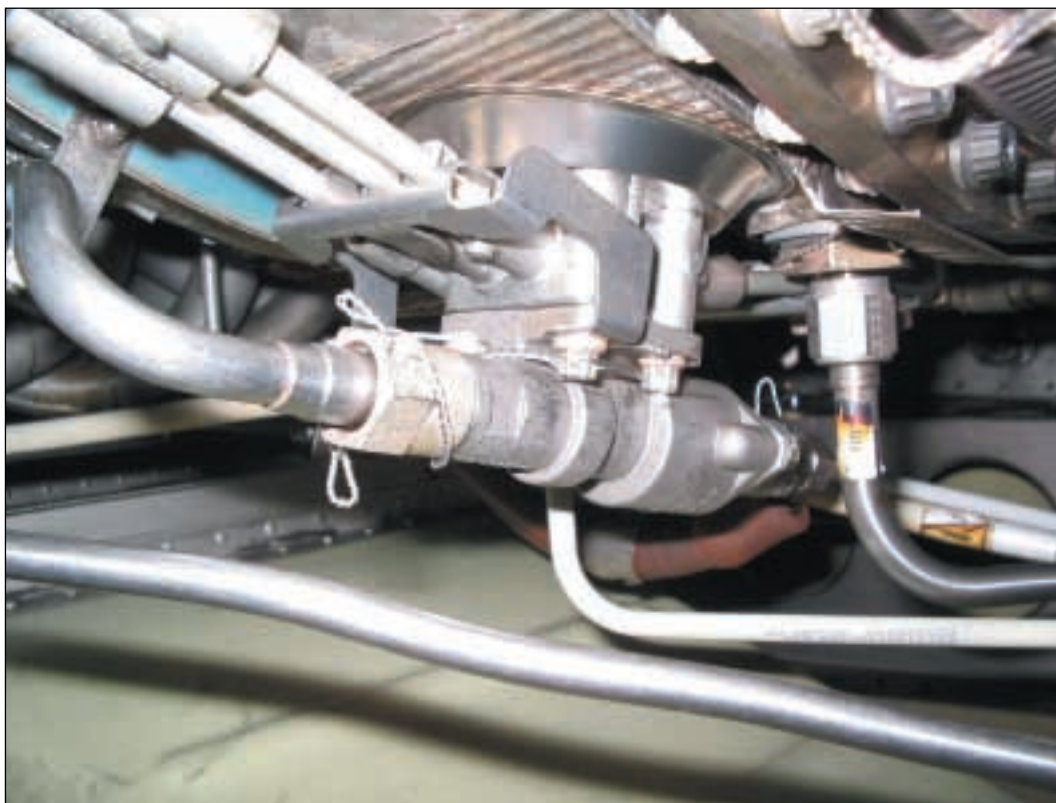
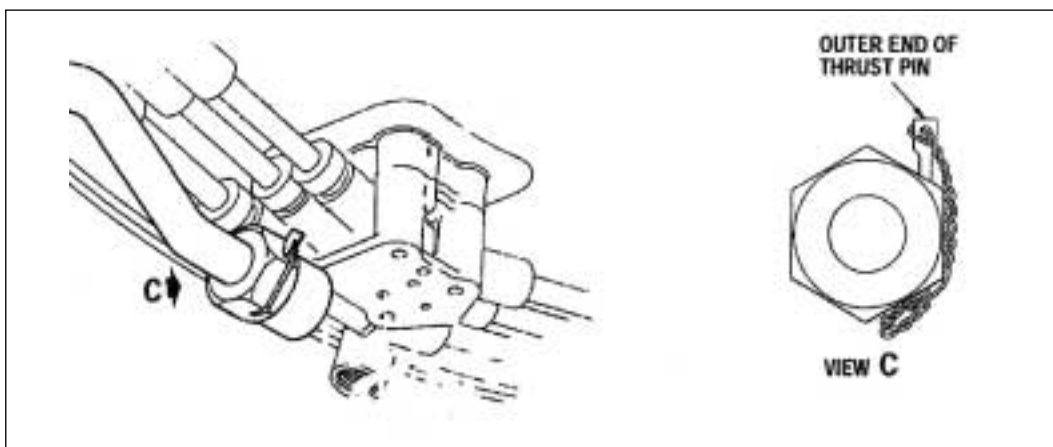
The tube coupling nut is wire locked to adjacent bolts on the dump valve in such a way that tension in the wire prevents the nut from backing off. The wire locking of the thrust pin to the coupling nut keeps the thrust pin in place.

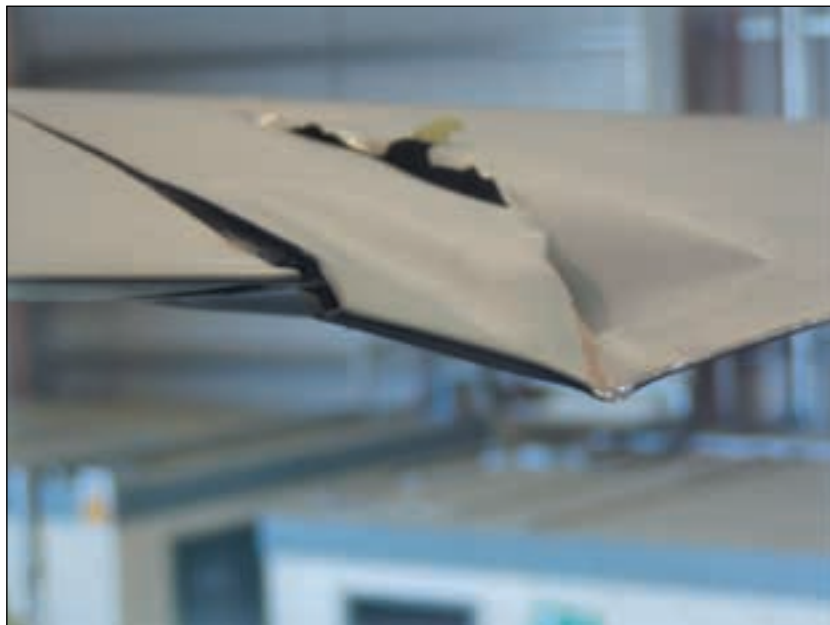
Photo No. 2 - Damage to White Blade

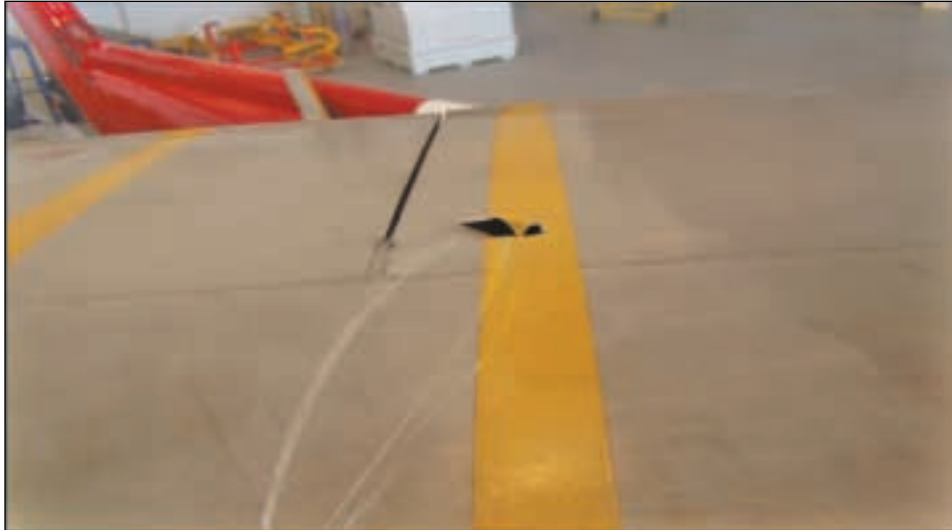
Photo No. 3 - Damage to Black Blade

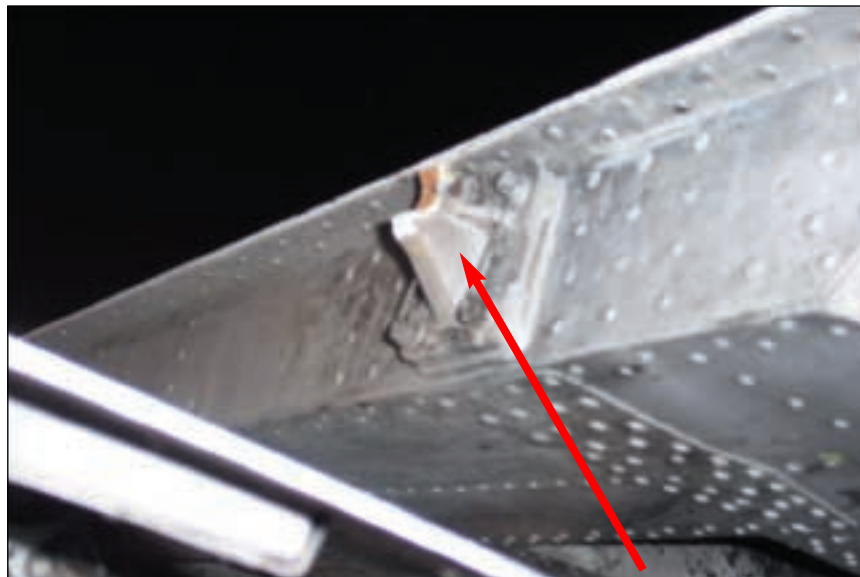
Photo No. 1: The broken half-hinge attached to the undercarriage door.

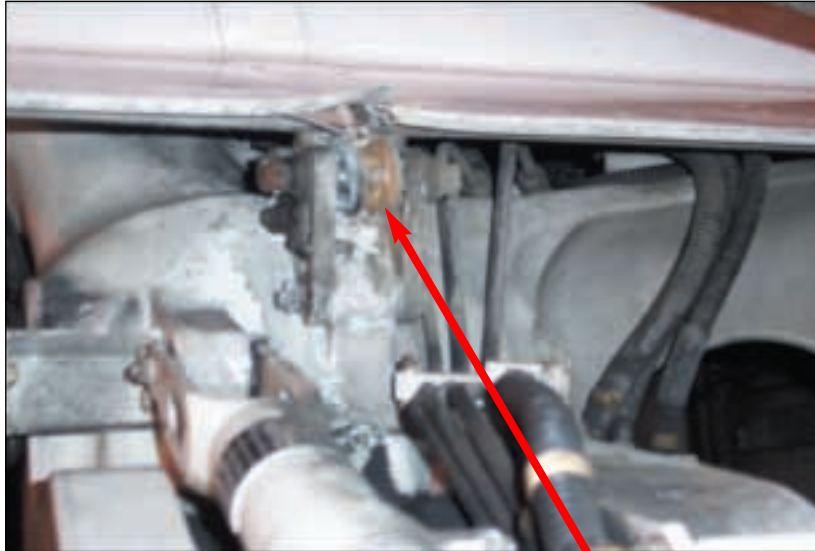
*Photo No. 2: The corresponding half fixed to the undercarriage strut showing the corrosion on the bearing housing.*
