08/31/88 Delta

Official Accident Report Index Page

Report Number	NTSB/AAR-89/04
Access Number	PB89-910406
Report Title	Delta Air Lines, Inc. Boeing 727-232, N473DA, Dallas-Fort Worth International Airport, Texas August 31, 1988
Report Date	September 26, 1989
Organization Name	National Transportation Safety Board Bureau of Accident Investigation Washington, D.C. 20594
WUN	4965A
Sponsor Name	NATIONAL TRANSPORTATION SAFETY BOARD Washington, D.C. 20594
Report Type	Highway Accident Report August 17, 1988
Distribution Status	This document is available to the public through the National Technical Information Service, Springfield, Virginia 22161
Report Class	UNCLASSIFIED
Pg Class	UNCLASSIFIED
Pages	135
Abstract	This report examines the crash of Delta flight 1141 while taking off at the Dallas-Forth Worth, Texas on August 31, 1988. The safety issues discussed in the report include flightcrew procedures; wake vortices; engine performance; airplane flaps and slats; takeoff warning system; cockpit discipline; aircraft rescue and firefighting; emergency evacuation; and survival factors. Recommendations addressing these issues were made to the Federal Aviation Administration, the American Asso

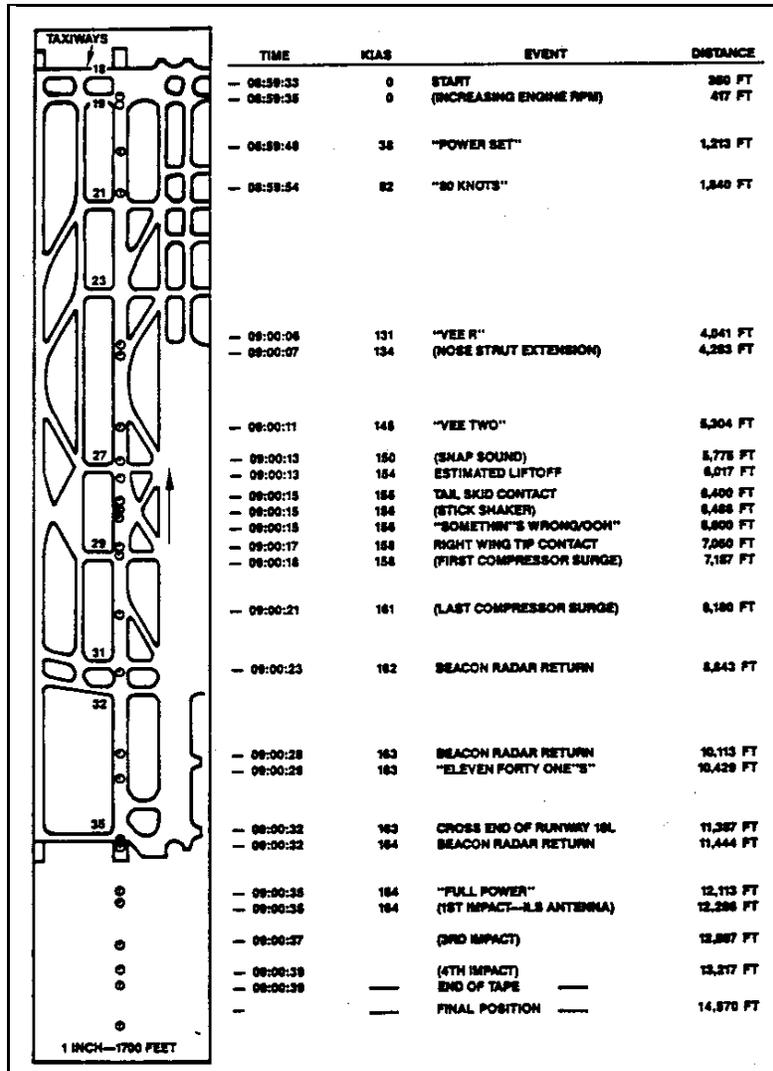
Figure 5.-- Flight 1141 takeoff events.

The first impact mark was made by the tail skid contacting the runway centerline and a runway centerline light between taxiways 27 and 29, at a distance of approximately 4,990 feet prior to the departure end of runway 18L (see **figure 5**). About 650 feet from this point, the right wing tip struck the right side of the runway near taxiway 29, approximately 4,340 feet prior to the departure end of runway 18L. The taxiway markers for taxiways 31 and 32 were found knocked over, but they did not exhibit any impact damage. Additionally, the grass was found to be

scorched between the end of the runway and the ILS antenna. Approximately 5,300 feet from the point of the right wing tip runway contact, and approximately 900 feet beyond the departure end of runway 18L, the airplane impacted and destroyed the ILS localizer antenna. From this point and beyond, airplane components such as the right wing tip and portions of the right inboard and outboard ailerons began separating from the airplane.

After first impacting the antenna installation, the airplane remained airborne for an additional 400 feet, then struck the ground with the main landing gear wheels which produced a 350-foot linear ground depression. The airplane then traversed a ground depression that was approximately 150 feet wide and 16 feet deep. As the airplane crossed the depression, it impacted the ground on the far side. The airplane track then began to gradually swerve to the right of the extended runway centerline. This portion of the wreckage track was approximately 800 feet long.

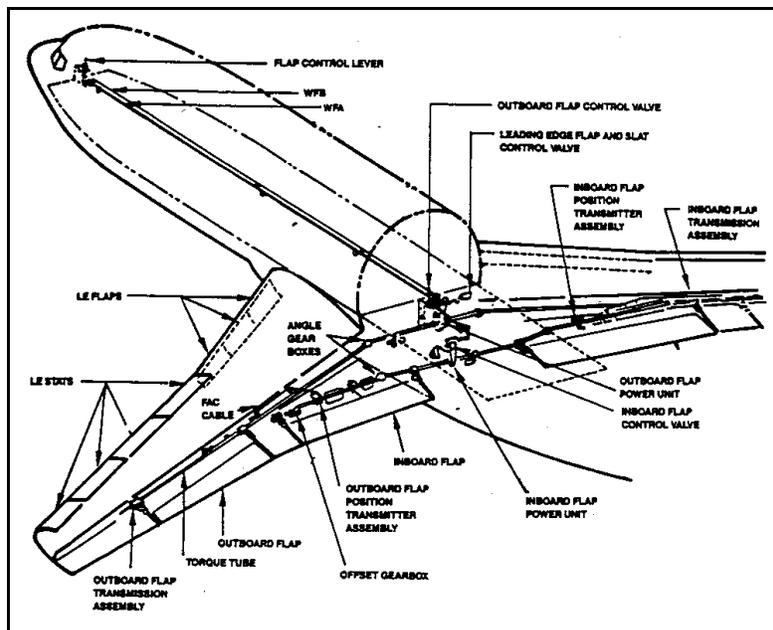
Figure 7.--Trailing edge flap system.

Trailing Edge Flap System.--The flap control mechanism in the cockpit area was found in the flap up position. (See **figure 7**.) The mechanism was intact and functional. The flap handle spring tension was normal. The flap control cables were attached, and continuity was established to the forward fuselage break. From the fuselage break, further continuity of the cables was established to the outboard flap control valve located at the forward wall of the right wheel well. Movement of the cables at the fuselage break produced a corresponding movement of the outboard flap control valve input linkage.

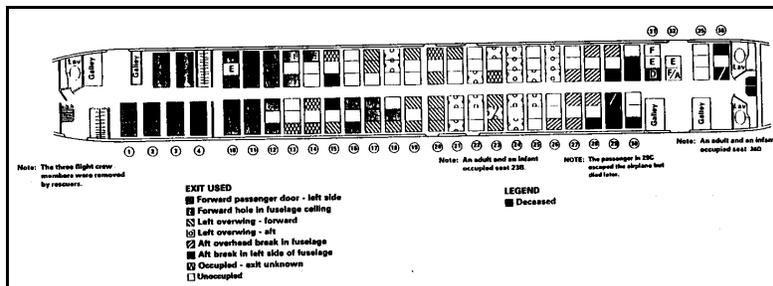
Figure 8.--Configuration of B727-232 and escape routes used.

The investigation found that although the fuselage had separated in several places, the occupiable volume of the cabin was not substantially compromised. Passengers generally stated that impact forces were not severe. Further,

the cause of deaths of the passengers in the aft section of the cabin were attributed to smoke inhalation and fire rather than impact injuries. Exit from the aft cabin was hampered by the fire that impinged on the right side of the airplane. Exit from the mid and forward cabin was through breaks in the fuselage and through the left side exits, except for the left aft service door which was not opened.

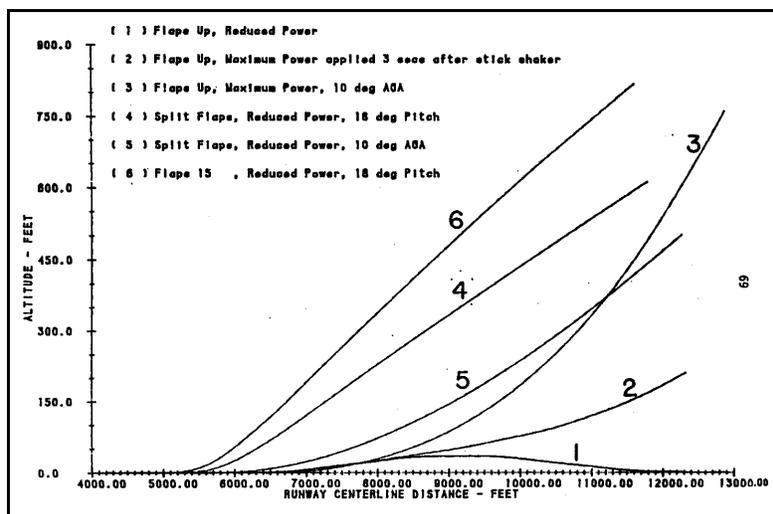
Figure 13.--Takeoff profiles.

The performance analysis, based upon the lift versus AOA data for the split flap configuration, indicates that had flight 1141 been so configured during the takeoff roll, the airplane's tail may have contacted the runway surface as the captain rotated to the takeoff attitude. However, the airplane, with its geometry-limited 10° pitch attitude would have lifted off at about 150 KCAS instead of the actual liftoff speed of 158 KCAS. A continued rotation at a rate greater than 1.5° per second would have resulted in stickshaker activation; but there would have been considerable margin to stall when the warning occurred and the airplane would have transitioned to a climbing flightpath with a vertical acceleration in excess of 1.2G. If the captain had ignored the stickshaker warning and continued to exert sufficient back force on the control column to raise the airplane's nose at a rate of 3° per second, the airplane would have achieved a 3° climbing flightpath at an AOA of about 15° within 2 seconds after liftoff. There would have been no airflow separation to explain the sudden roll of the airplane, and there would have been no engine inlet air turbulence to explain the compressor surges which were evident on the CVR. A more likely and proper flight crew reaction to the stickshaker activation would have been to relax the back force on the control column to silence the stickshaker, provided that that response would not result in a loss of critical altitude. Under such circumstances, the airplane would have continued to accelerate while developing sufficient lift force to transition to a climbing flightpath. These performance data indicate that about 10 seconds after liftoff, the airplane would have been about 100 feet above the ground and climbing at about 1,200 feet per minute. The stickshaker would have activated only momentarily.

The Safety Board concludes that the actual performance of flight 1141 is not explainable by the "split flap" theory. A possibility that one flightcrew member reacted to the delayed liftoff and stickshaker onset by intentionally or inadvertently retracting the flaps to 0° is also implausible, since the 20 seconds required for the trailing edge flaps
