**Accident Investigation Board of Finland
Annual Report 2004**

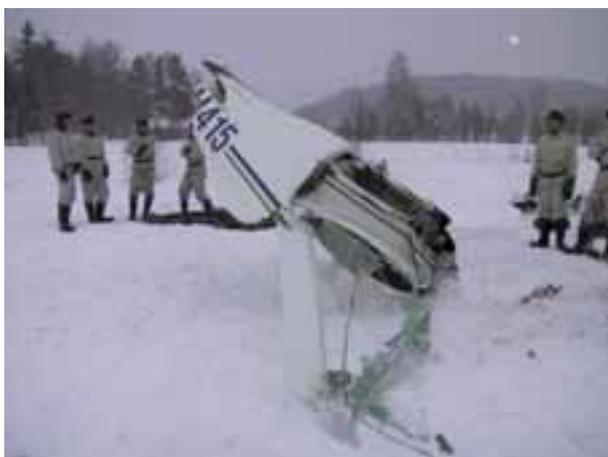
B 1/2004 L

Ultra-light aircraft accident in Hollola on 16 February, 2004

The probable cause of the accident was overweight and center of gravity that was well beyond the aft limit. As a result, the aircraft became unstable. When the horizontal stabilizer was suddenly pulled back, either by a gust or by the pilot unintentionally, the aircraft entered rapidly in a steep nose-up attitude and further inverted. The pilot had not fastened his seatbelts, or had unfastened them at some point, so he fell through the canopy. One reason for the pilot's unfastened seatbelts could be that they were deliberately unfastened in order to reach for the luggage compartment behind the seats. As a result of this kind of movement, the center of gravity would move even further backwards, making the aircraft more unstable. The horizontal movement of the aircraft had been so rapid, that the pilot had no chance to make corrective action. It is also possible, that as the airspeed decreased, the possible corrective action had no longer effect on the movement of the aircraft.

The Investigation Commission made three safety recommendations as a result of the investigation. The Finnish Aeronautical Association is recommended to emphasize the importance of the student's ability to fully understand the contents of their training and that the training is complemented with practical examples and learning is confirmed by examinations. This should be achieved by stressing the matter during teacher's basic and supplementary training. The Finnish Flight Safety Authority (FSA) is recommended to draw their attention to the performance and handling qualities of various ultra-light aircraft types and to define, if necessary, the requirements set for type training. Further, the FSA is recommended to consider bringing the ultra-light pilot's licence requirements up to date and in line with the current aircraft types' requirements and field of use.

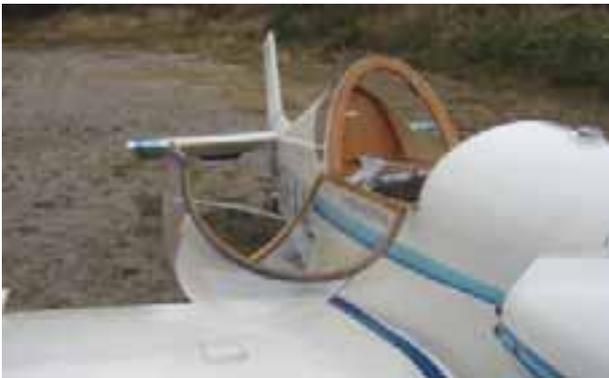
**B 3/2004 L****Aircraft accident in Mäntsälä on 24 August, 2004**

The aircraft had crashed on a vertical angle of 40°–50° and banked to the right. The crash trace heading was 044°. The accident site co-ordinates were 60°36,881 N 025°22,121 E (WGS 84). The investigation of the propeller revealed that the engine had been running the whole time. All the outer parts of the aircraft were found, so the aircraft had not broken into pieces in the air. The frame of the cabin hood was apart from the cabin frame, in which the hood lock lever was attached. The lock was open, the hinges were unbroken, but the limiter rope was broken. The spring belonging to the lock lever was missing. The acrylic hood had gone into pieces, but some pieces were still attached to the hood frame. There were lots of pieces of the hood along the crash trail. Some of the pieces were found also approximately 700 meters east-south-east from the accident site. A conclusion was made that the hood had opened in the air and hit the wing. The dispersion of the aircraft and the crash traces on ground proved that the collision speed was high. It was also possible to draw the conclusion that the aircraft had not been in a spin. The aircraft was not overweight. The centre of gravity was within the limits.

The probable cause of the accident is that the lock lever of the hood had during the flight accidentally opened. The side-hinged hood had immediately opened and hit the right wing of the aircraft, and the hood partially broke. On the basis of the finding place of the hood pieces, it is obvious that the hood had accidentally opened just before the crash dive. The aerodynamic drag of the large hood swung the nose of the aircraft to the right. Simultaneously the aircraft rolled rapidly to the right and the nose went into a steep dive. All happened so swiftly that the pilot lost the possibility to upright the aircraft because of low altitude.

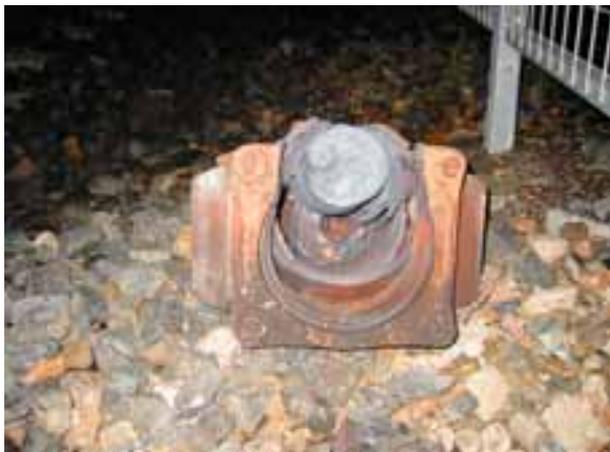
C 5/2003 R

Last car of freight train displaying bearing damage and derailling in Lahti on 28 May, 2003

In terms of hot-box detectors, the Accident Investigation Board notes a favourable development and progress and suggests that their generalization take place at an even faster pace than currently.

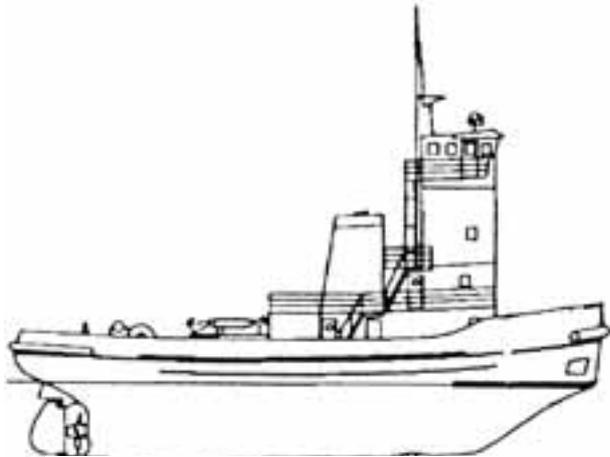
C 4/2001 M

The pusher-barge combination ALFA / PARA-UNO collision with the freighter SORMOVSKIY 118 within a separation zone in Northern Baltic on 15 May, 2001

The pusher barge combination ALFA / PARA-UNO collided with the freighter SORMOVSKIY 118 in the separation zone on the northern Baltic. The damages were minor. ALFA, owned by Paratug Ltd in Turku, Finland, had left Gotland for Inkoo in Finland. ALFA. The owner of SORMOVSKIY 118 is Onego Shipping from Petrozavodsk, Russia. She was bound for St. Petersburg.

The conditions were good and there were no technical problems. It was found that the Rule of the Road was not followed. Just before the accident the look-out was in ALFA's bridge but he did not know how to manoeuvre the vessel in the critical situation. Shortly before the OOW had to leave the bridge though the situation needed intensive observing and possible action. The investigators do not give any recommendations.

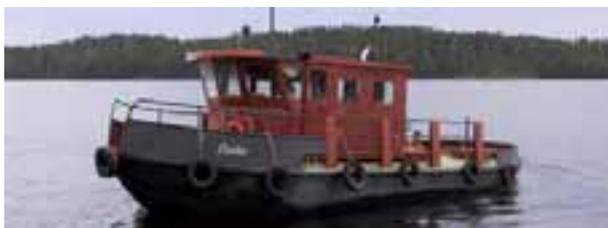
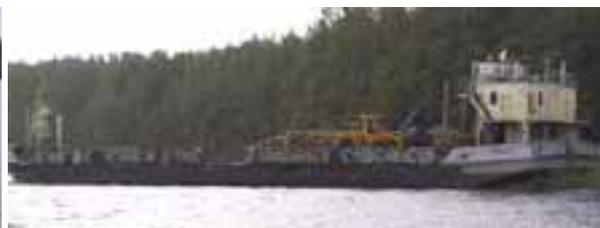
Push barge PUSKU and PÖLLI 7, grounding in Savonlinna on 11 July, 2002

Tug boat PUSKU was pushing a combination of two barges connected to each other side by side, through the fairway of Kyrönsalmi in Savonlinna on 11.7.2002. The bigger barge called PÖLLI 7 carried mainly birch logs and the smaller barge a timber - handling machine. At the castle Olavinlinna when manoeuvring through the strait of Linnasalmi, the bow of the barge PÖLLI 7 hit the guide fitted on the shore rock of the isle of Linnasaari. As a consequence, the combination turned to the right and drifted into the shallows of the isle of Tallisaari and grounded. The barge PÖLLI 7 got a leakage and a list. A half of logs rolled in the stream and the timber handling machine was

The accident resulted from the steering of the too wide tug-barge combination having poor manoeuvring capabilities through a difficult navigable strait. Moreover, the crew had manoeuvred this type of combination on a few occasions only and the routine to do it had not accumulated.
