Statens haverikommission
Swedish Accident Investigation Board

Report RL 2008:05e

**Accident to helicopter SE-HUN
at Broby säteri, Södermanland county,
on 22 March 2007**

Case L-03/07

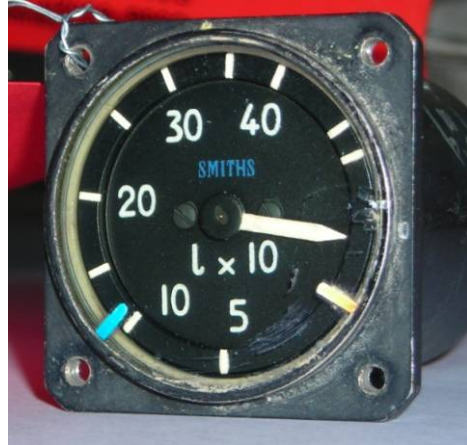
Photograph 1 Fuel gauge from helicopter SE-HUN

The recording also shows that the fuel quantity indicator shows definitely less than 50 litres, the reading at which the warning lamp for insufficient fuel should illuminate. A maximum of 15 minutes flight is then permitted according to the pilot manual. Whether or not the lamp illuminated is not shown by the recording as it was obscured by other equipment. According to the previous owner, the passenger, on the day after the accident, said that the pilot had asked him if he could see the text on an illuminated red warning lamp. He replied that he could not see because he was without his spectacles.

An analysis of the video recording made in connection with the flight shows that the indicator of the fuel gauge, at the time of the start, was at between “3 o’clock” and “6 o’clock”, this corresponding to approximately 25 litres of remaining fuel. (See photo below)

Fuel gauge

Picture of fuel gauge from video recording.

The reading of the fuel gauge cannot be seen exactly but it appears to have been clearly less than 50 litres. If it is assumed that the calibration of the fuel gauge is on the conservative side, the flight time, fuel consumption and fuel quantity at start correspond well.

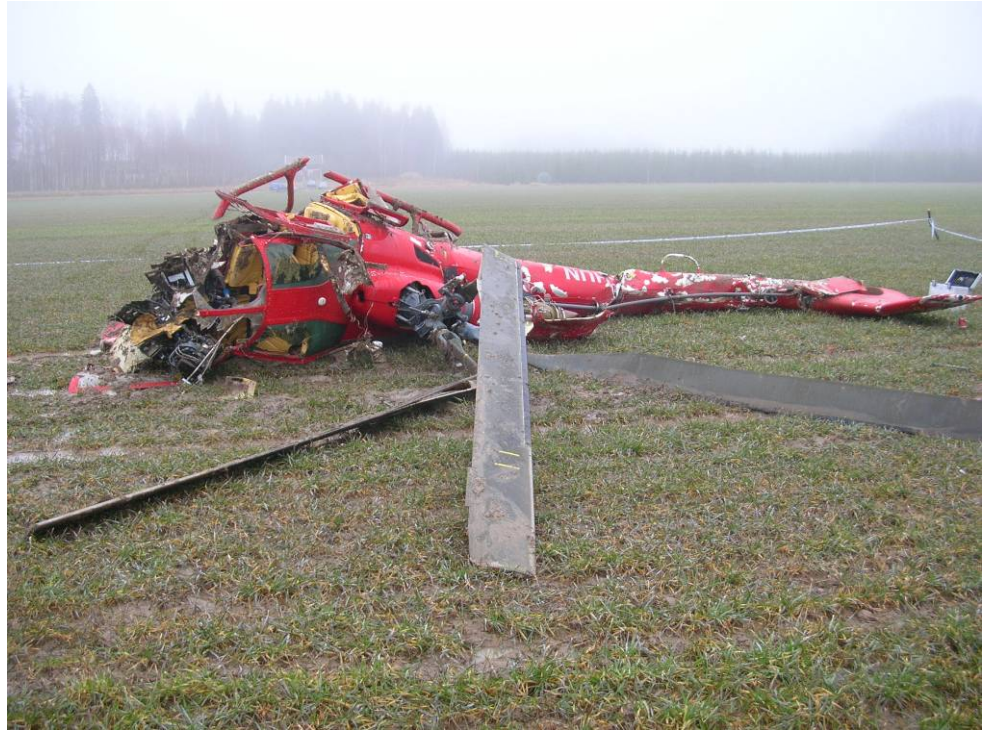
Photograph 2 Site of the accident with helicopter wreck

Tracks in the ground show that on impact, the helicopter was in its normal attitude with speed forward on an approximately 100 degree heading. The tail skid contacted the ground first, then probably the landing runners after which the helicopter tipped over on to its starboard side, the rotor blades impacting the ground. The helicopter pitched forward and over, coming to rest on its port side with its nose in the direction of the landing.

The helicopter had been badly damaged. The nose section was crushed and both runners broken. The tail boom was buckled at several places and all rotor blades bent near the rotor hub. The damage to the leading edges of the rotor blades extended inward toward the hub which indicated that the rotor speed was relatively low and that the rotor blades had also impacted against the helicopter structure. See the following photograph.

From the damage to the helicopter, and tracks in the ground surface, it can be deduced that after the tail skid contacted the surface, the helicopter, banked at 45 degrees to starboard, and with relatively high forward speed, estimated to be 50-60 knots, struck the ground. Sliding on its starboard side, the helicopter then tipped over on its nose and came to rest lying on its port side.

The tracks scored in the ground by the main rotor blades indicate that the rotor speed was very low, probably under the speed required to maintain lift.
