Accident
on 24 December 2000
at Tahiti Faaa Airport
to the DC10-10
registered N132AA
operated by Hawaiian Airlines

REPORT
n-aa001224a

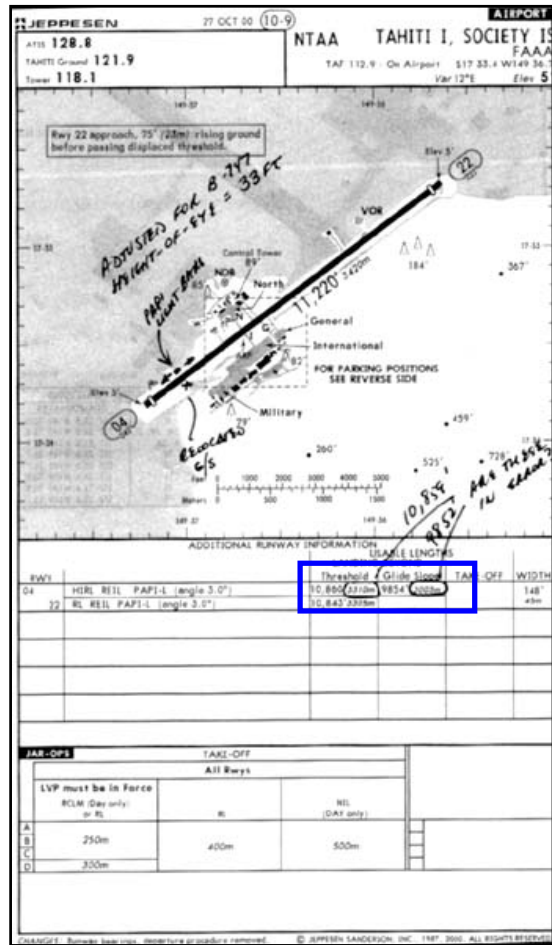
The crew was using Jeppesen charts that did not take into account the various amendments published in September and November in the AIP/PAC.

Most operators use Jeppesen documentation and crews are used to doing so. However, although Jeppesen receives NOTAM's, the chart of the Tahiti airfield had not been updated. Such a failure could lead to dangerous situations for more restricted airfields, since it could lead to erroneous performance calculations during flight preparation.

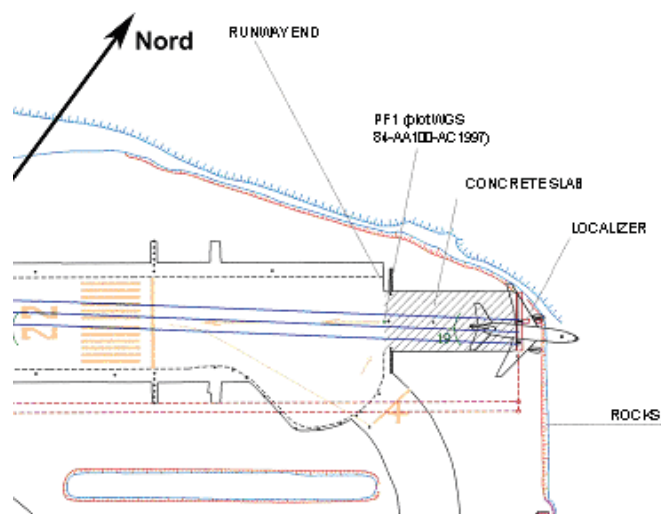
Source: Tahiti Faaa Air Transport Gendarmerie Brigade

The left and right engines were resting on a sea wall made of rocks, eighty meters from the end of the runway. The airplane's nose was in the waters of the lagoon though the nose gear was not touching the bottom. The forward part of the fuselage and the electronics bay were in the water.

- Impact marks between the nose and nose gear.
- The nose gear was marked by the impact with the localizer aerials, one of which was jammed inside. The anti-shimmy was destroyed. No serious structural damage was visible.
- The air intake on the right engine was punctured by a rock and that of the left engine showed signs of scraping along the ground. Some fan blades on the left engine were slightly damaged. The pylons of both on-wing engines were twisted.
- The left main landing gear had struck the localizer installations. Numerous contact marks with the antennae were visible.
- The left inner flap was damaged on its lower part. The right inner slat was deformed by contact with the pylon of engine three.

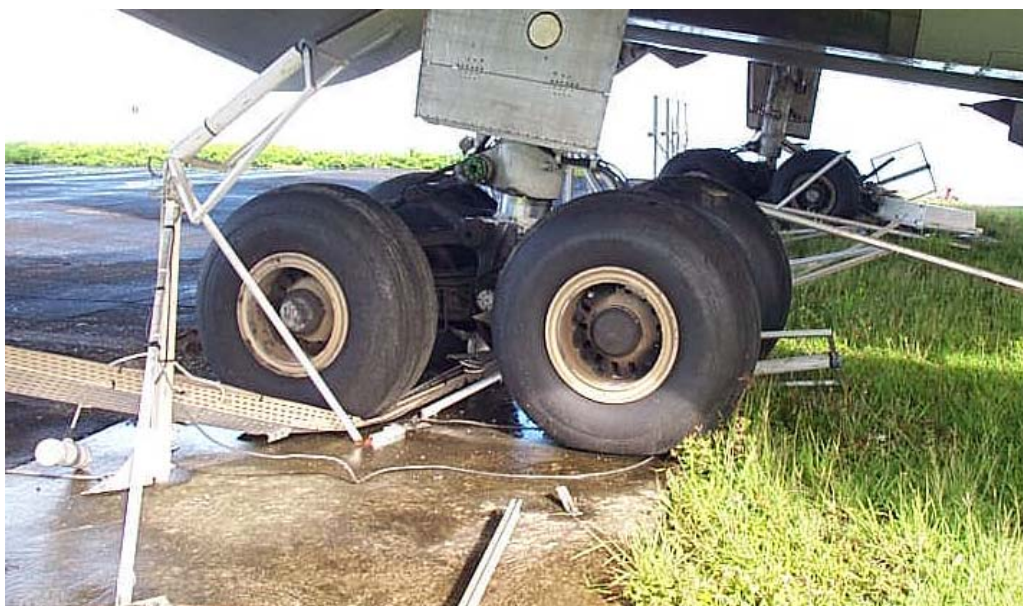
Note: the localizer antennae, located seventy-two meters from the end of the runway, were destroyed.

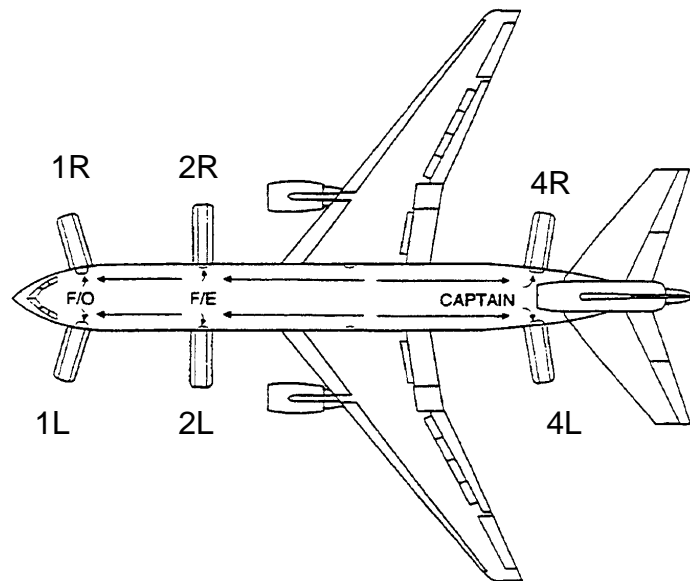
Given the sloping position of the airplane, the evacuation was carried out via the right center door emergency slide (2R) which was the only one considered to be usable. The slide at the left center door (2L) was also deployed but it seemed that the depth of the water was about fifteen meters. The lighting conditions made it difficult to evaluate the situation and advice was taken from the firefighters not to evacuate the passengers via that door. The end of the right slide was tied up to the sea wall located

at the end of the runway so as to give the passengers the shortest walk possible through the water, which was shallow on that side. The passengers were greeted by the firefighters, who had taken care to remove the barbed wire coils that were protecting the aerodrome against intruders from that side.

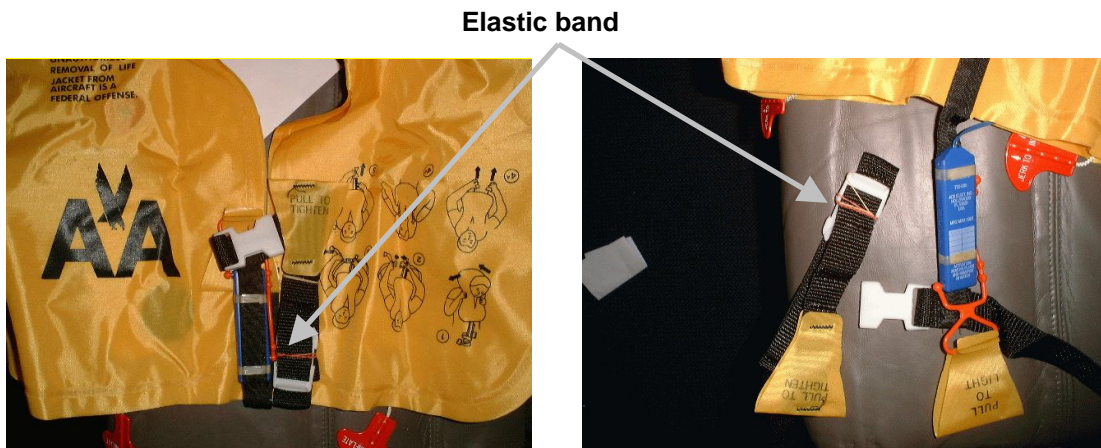
On some of the life jackets, when the passenger put it on and pulled the “Pull to tighten” tag, the elastic band installed during packing to maintain the adjustment slack was placed in the male part of the attachment mechanism, thus preventing it from locking into the female part.

If the wearer managed to attach the male and female parts by forcing them, he could not pull the excess strap through the locking buckle and thus adjust the life jacket.

The poor conditioning of some life jackets had no effect on safety since there were more life jackets than passengers and the evacuation of the airplane took place calmly and with no rush. It is probable that under other, less favorable, conditions, the discovery by the passengers of the unavailability of some life jackets could have been a factor leading to panic.
