# Emergency Services Commissioner

*A report of the response to an emergency at Melbourne Airport  
on 21 February 2005*

24 March 2005

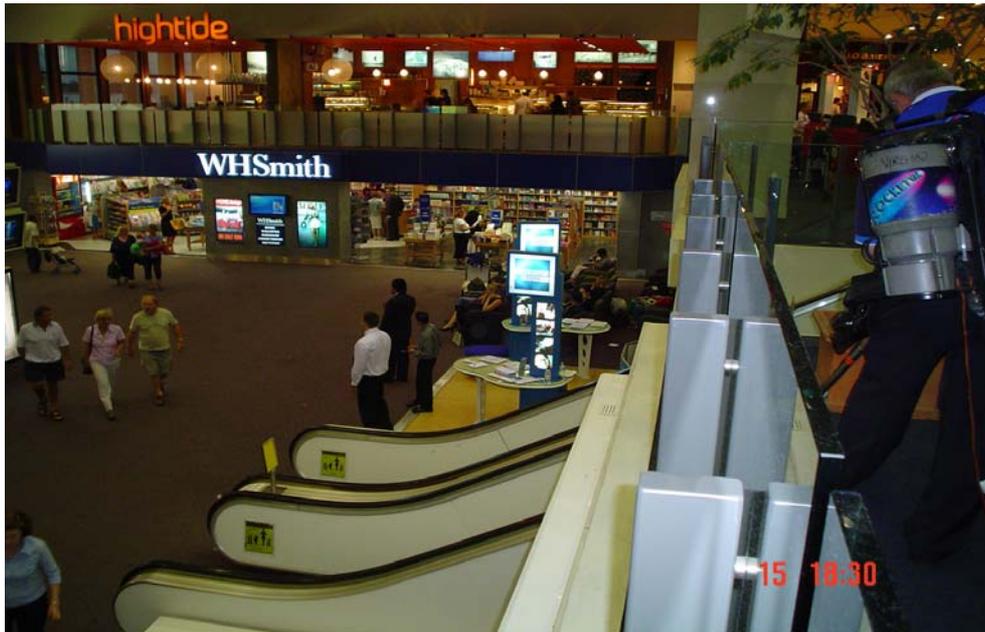
First newsagency employee collapsed near the bottom of escalators 7.12am.

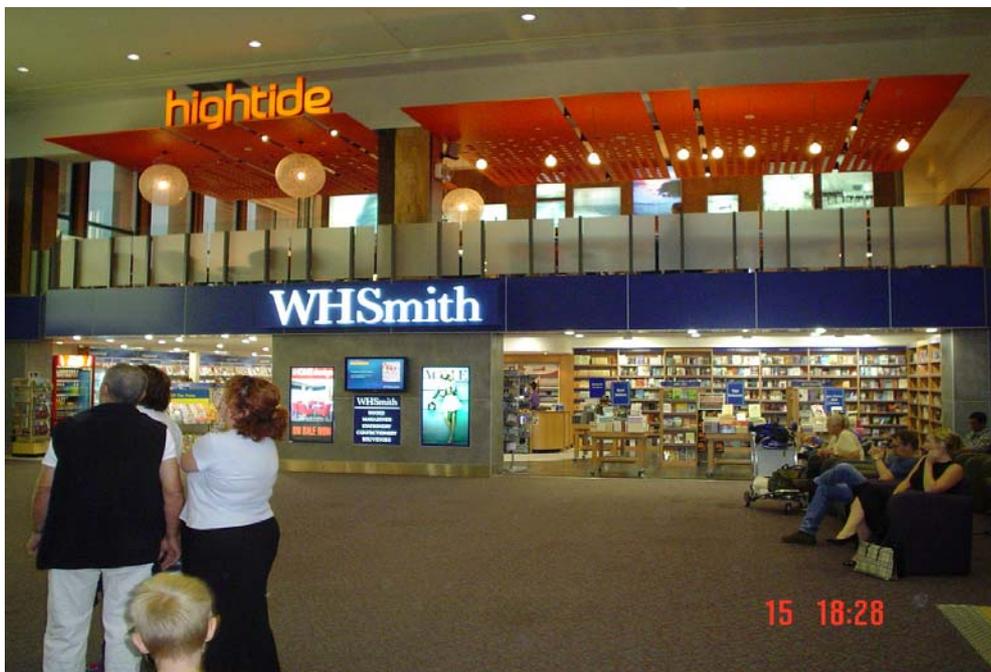
The newsagent where the second employee collapsed at 8.48am

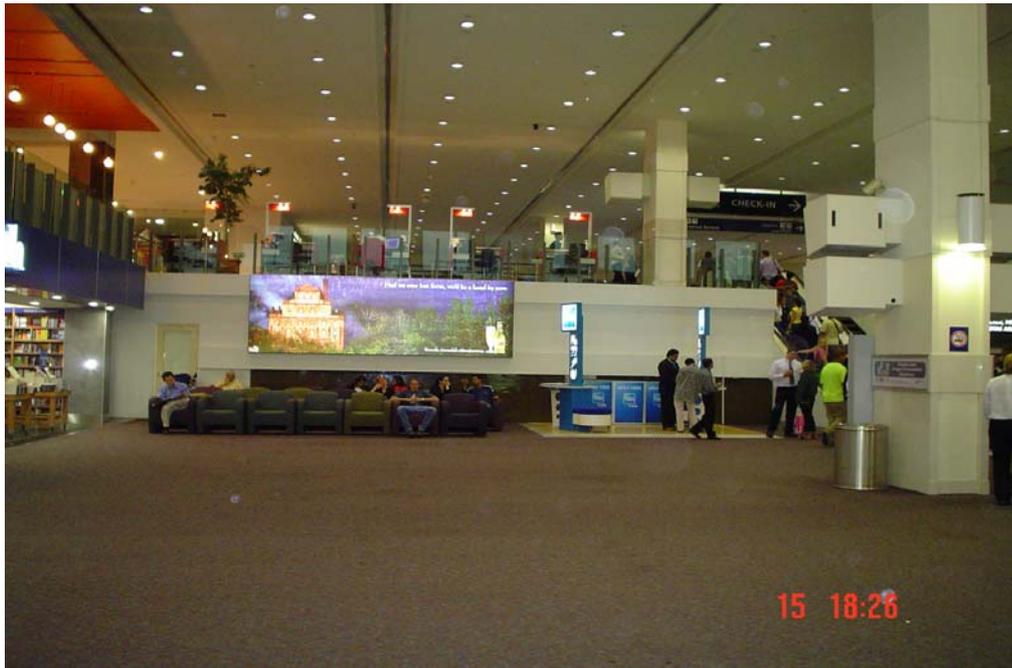
An American Express employee collapsed near the American Express stand at 9.02 am

Two Virgin Blue Airlines employees from the counter above this area reported ill at 9.55am
