National Transportation Safety Board

Robert L. Swaim

Fire Issues

October 23, 2001

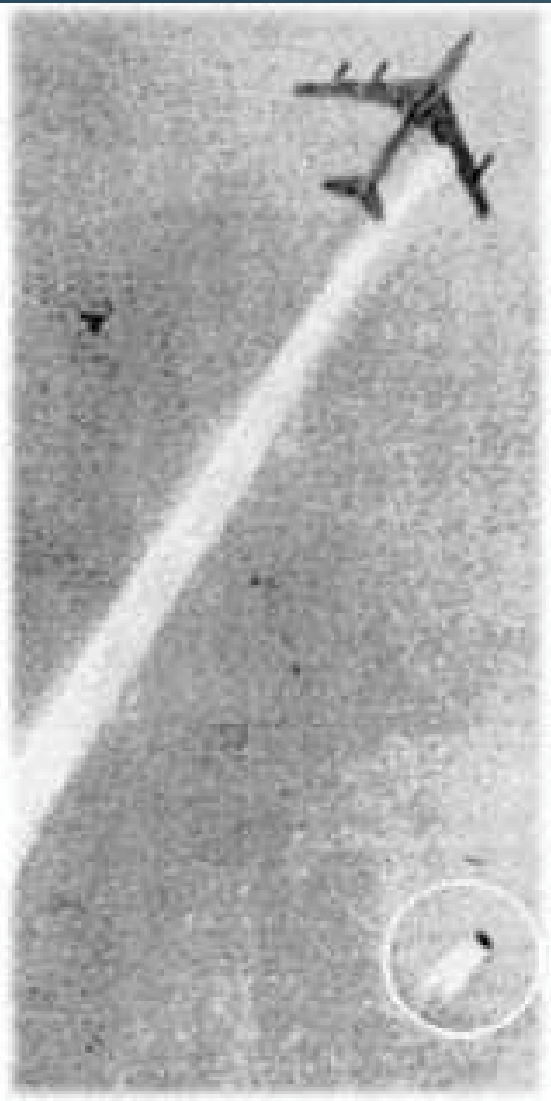
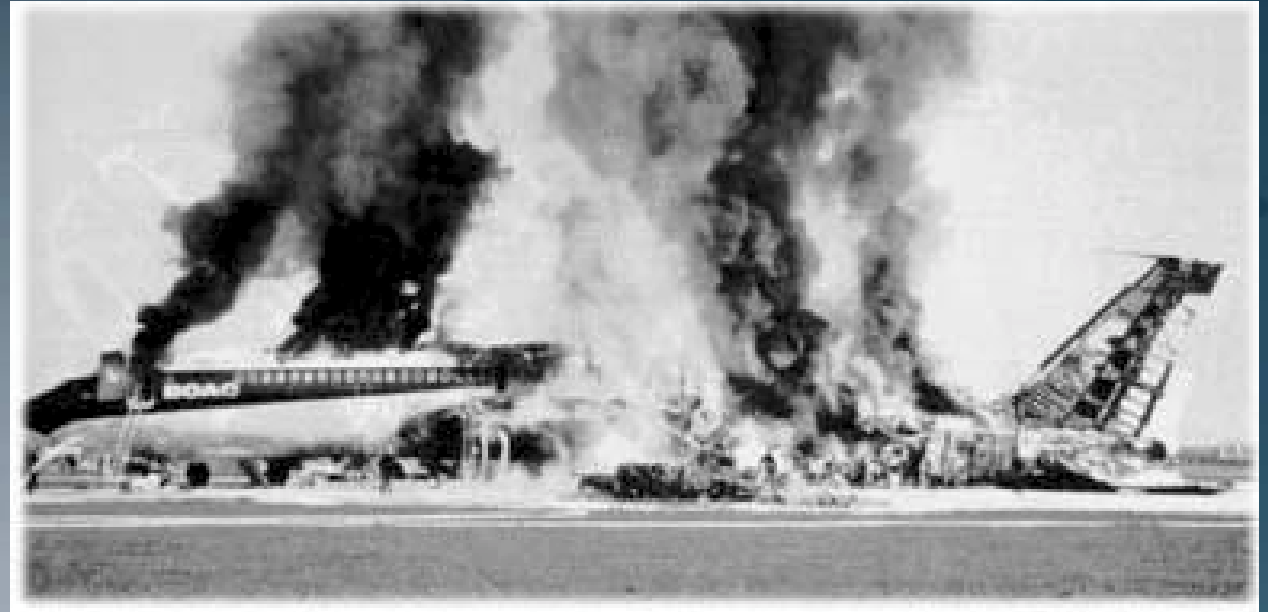
BOAC 707 uncontained engine failure results in in-flight fire, engine separation, then fuel ignition during emergency landing. Five fatalities. April 8, 1968

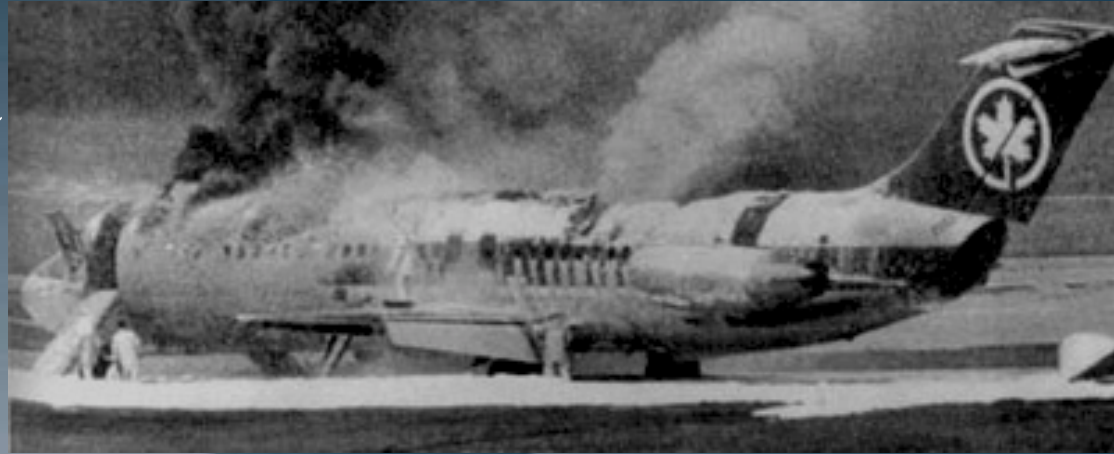
June 2, 1983, Air Canada DC-9 in-flight fire led to recommended changes.

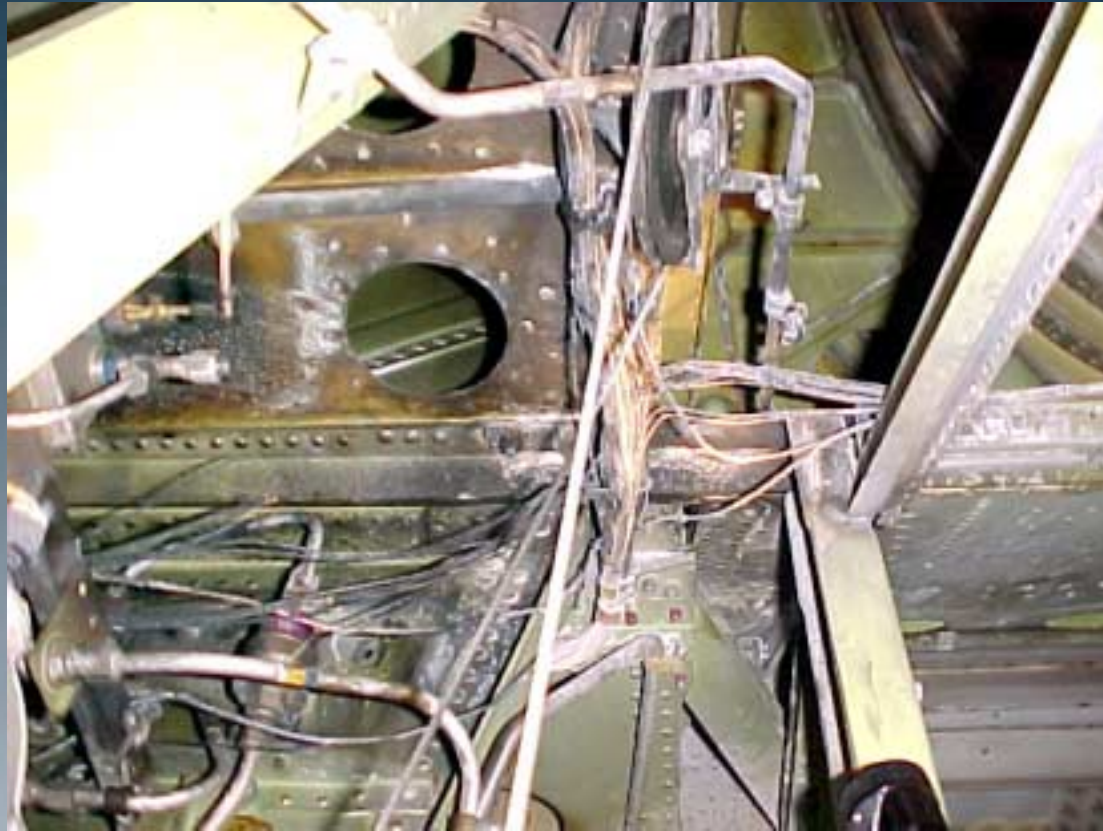
May 2001 Fire in 727 Air-stair Area Resulted in All-Base Operators Message & Fleet Inspections

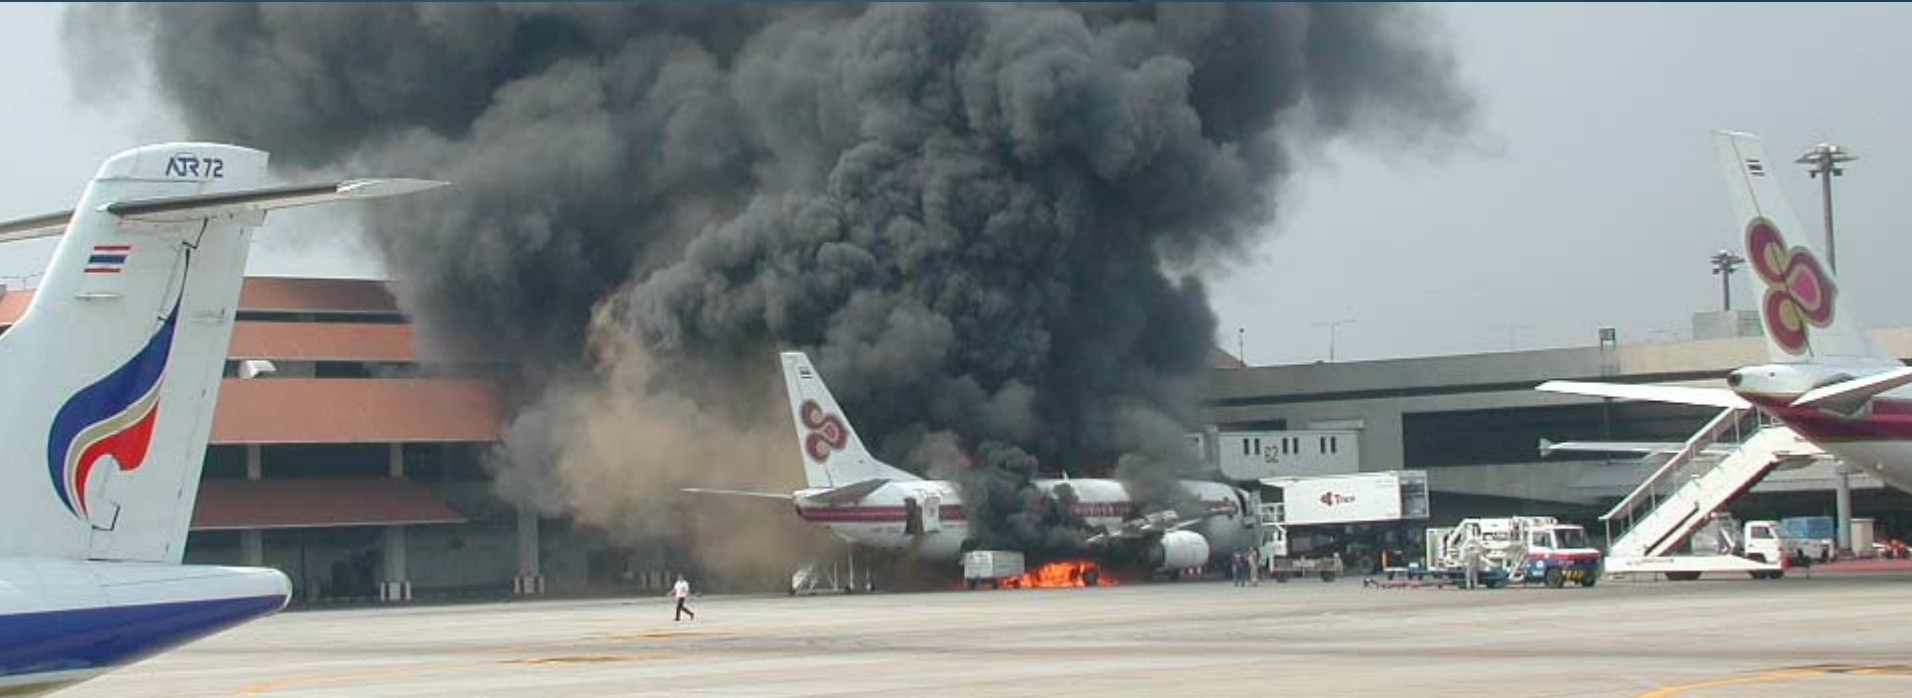
Thai 737 Fuel Tank Explosion of March 3, 2001

No evidence of bomb.

Fuel pump testing about to begin.

Electrical and fuel quantity systems still under investigation

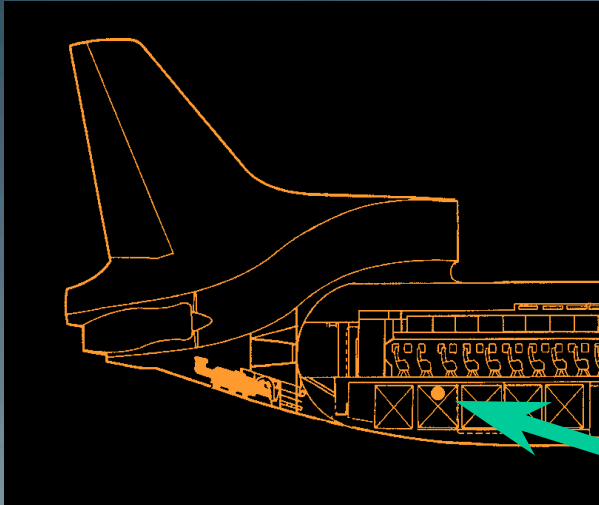
L-1011 In-Flight Fire of March 17, 1991

2 INCHES OF LINT
ON CABLES

HYDRAULIC
"B-NUT"

PLASTIC
WRAPPER

NUTPLATE

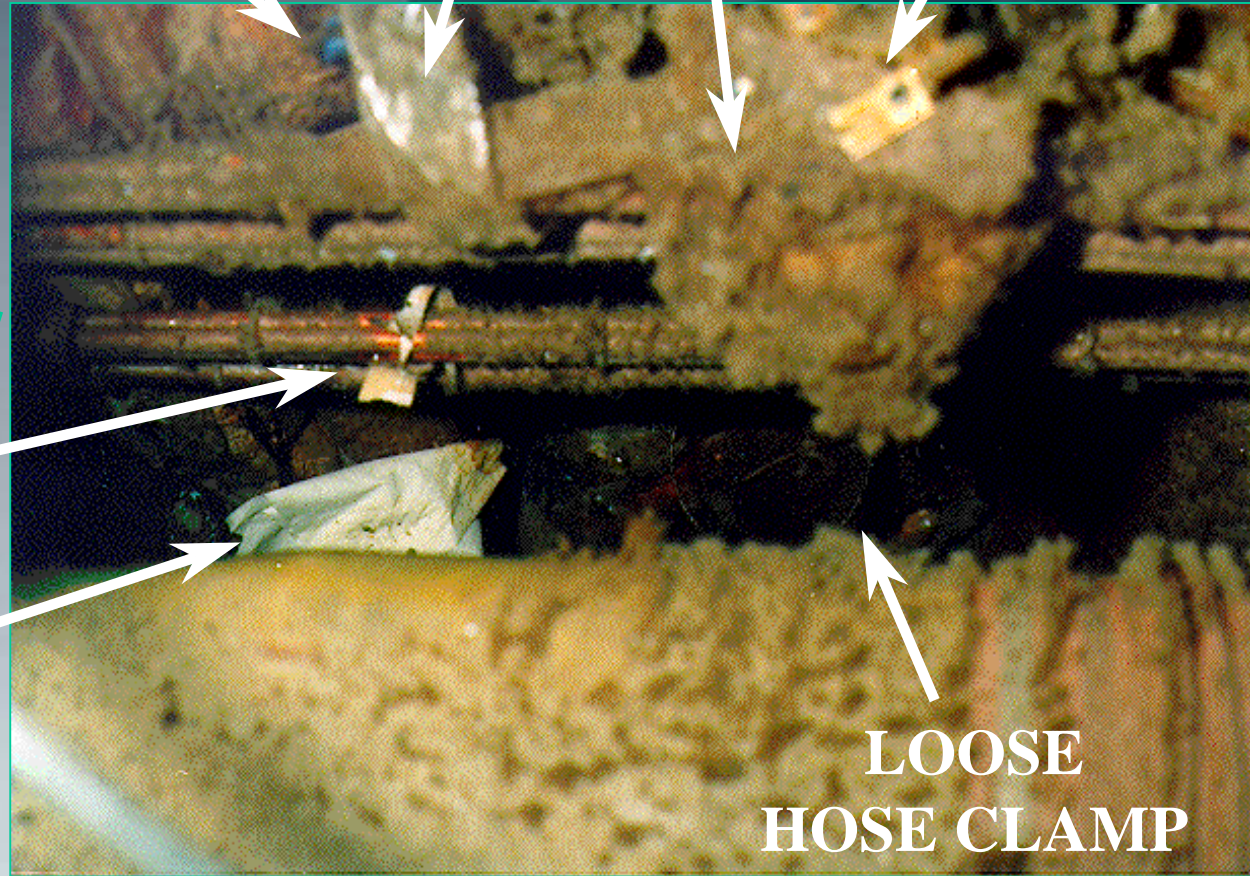
FOIL WRAPPER
IN GEN. CABLES

PAPER

LOOSE
HOSE CLAMP

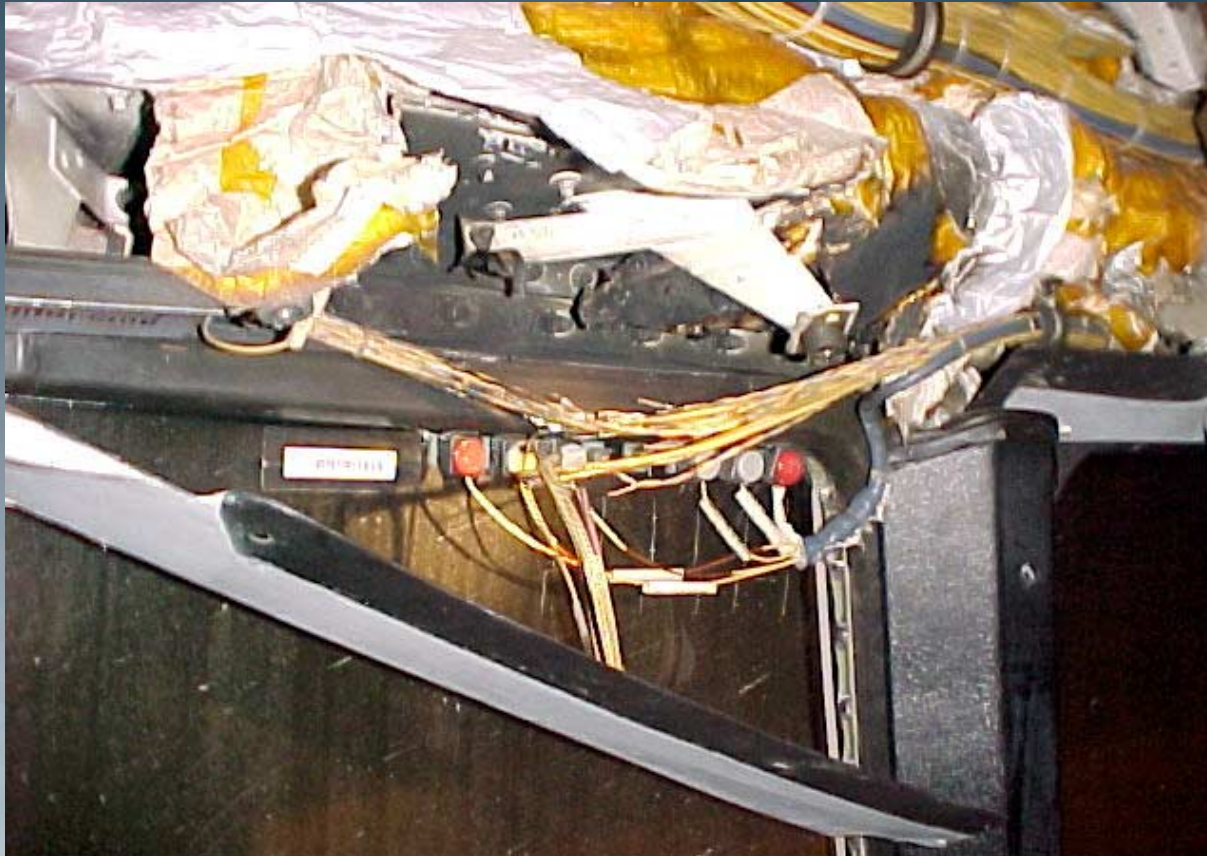
December 2000, LOCKHEED L-1011-385. Wire fire above
First Officer Window.

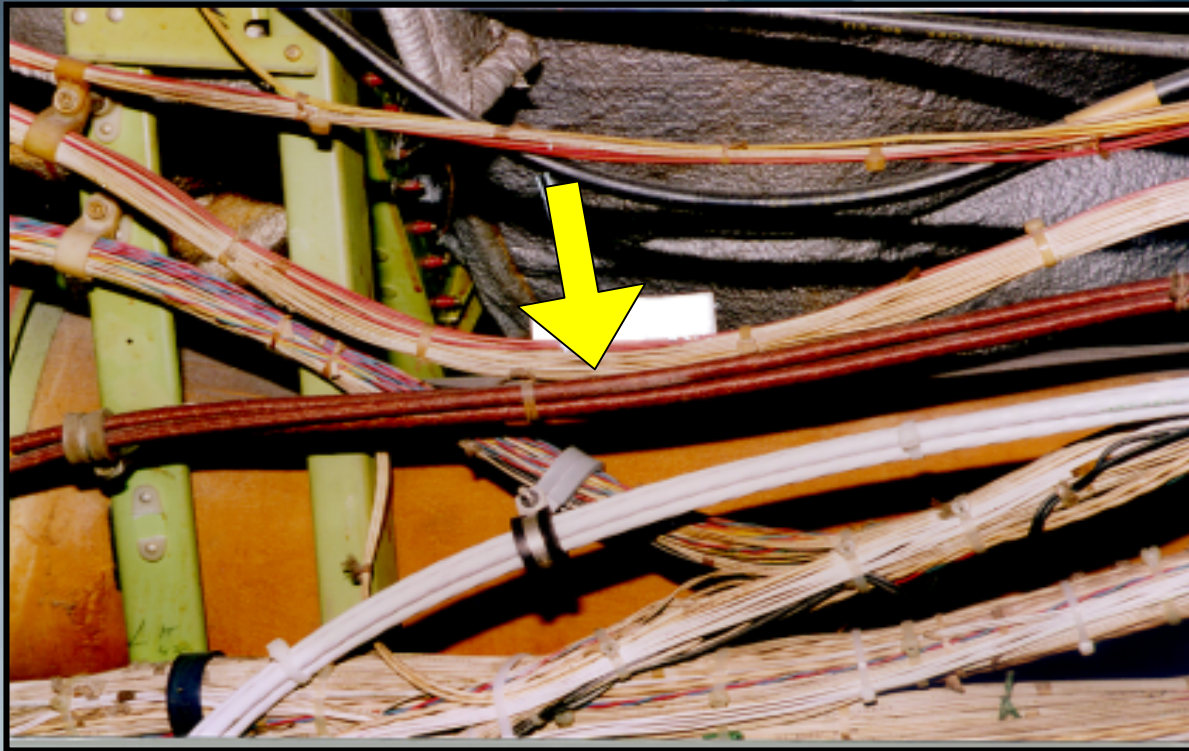
Chafe of Fuel & Galley Power Wires (747)

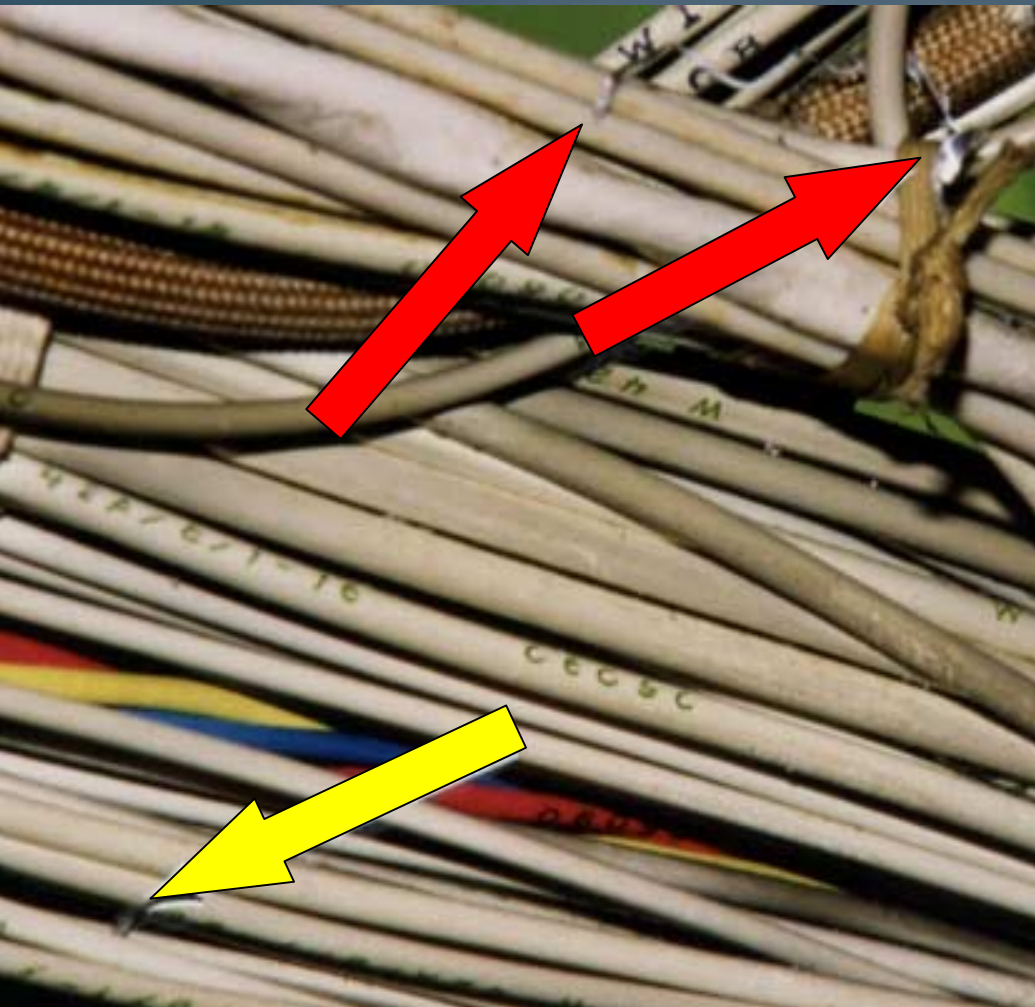
Shavings On Top
Of Wires And Coming
Through Bundle (747)

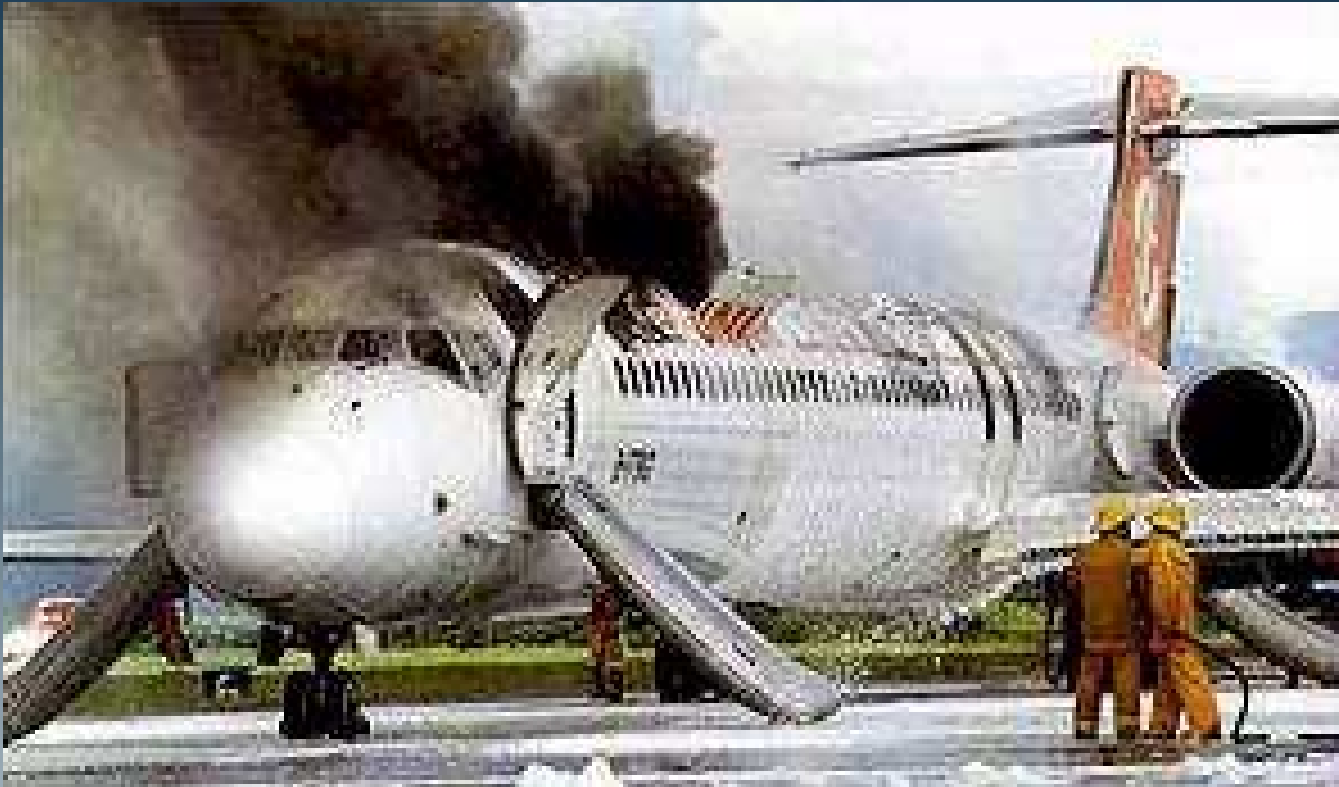
Gasoline carried in overhead luggage.
Uni Air MD-90 cabin fire at Hualian, Taiwan,
on August 24, 1999.

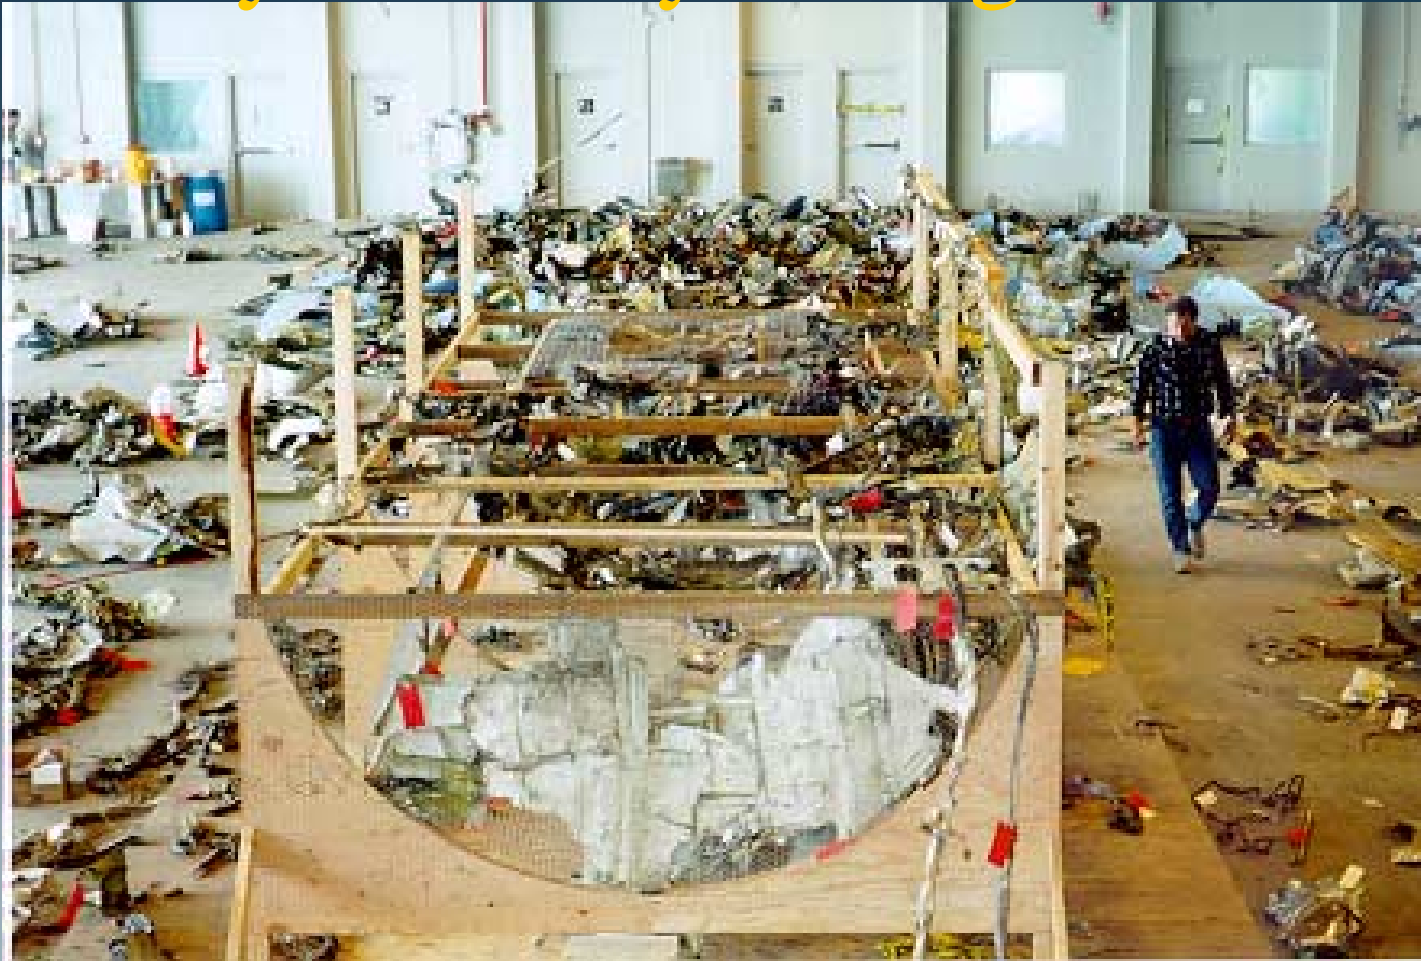
DCA96MA054, VALUJET AIRLINES DC-9, May 11, 1996,
Everglades, Florida, about 10 minutes after take off.
