Aircraft Wiring Service History

Brett Portwood

FAA Technical Specialist for Safety and
Integration

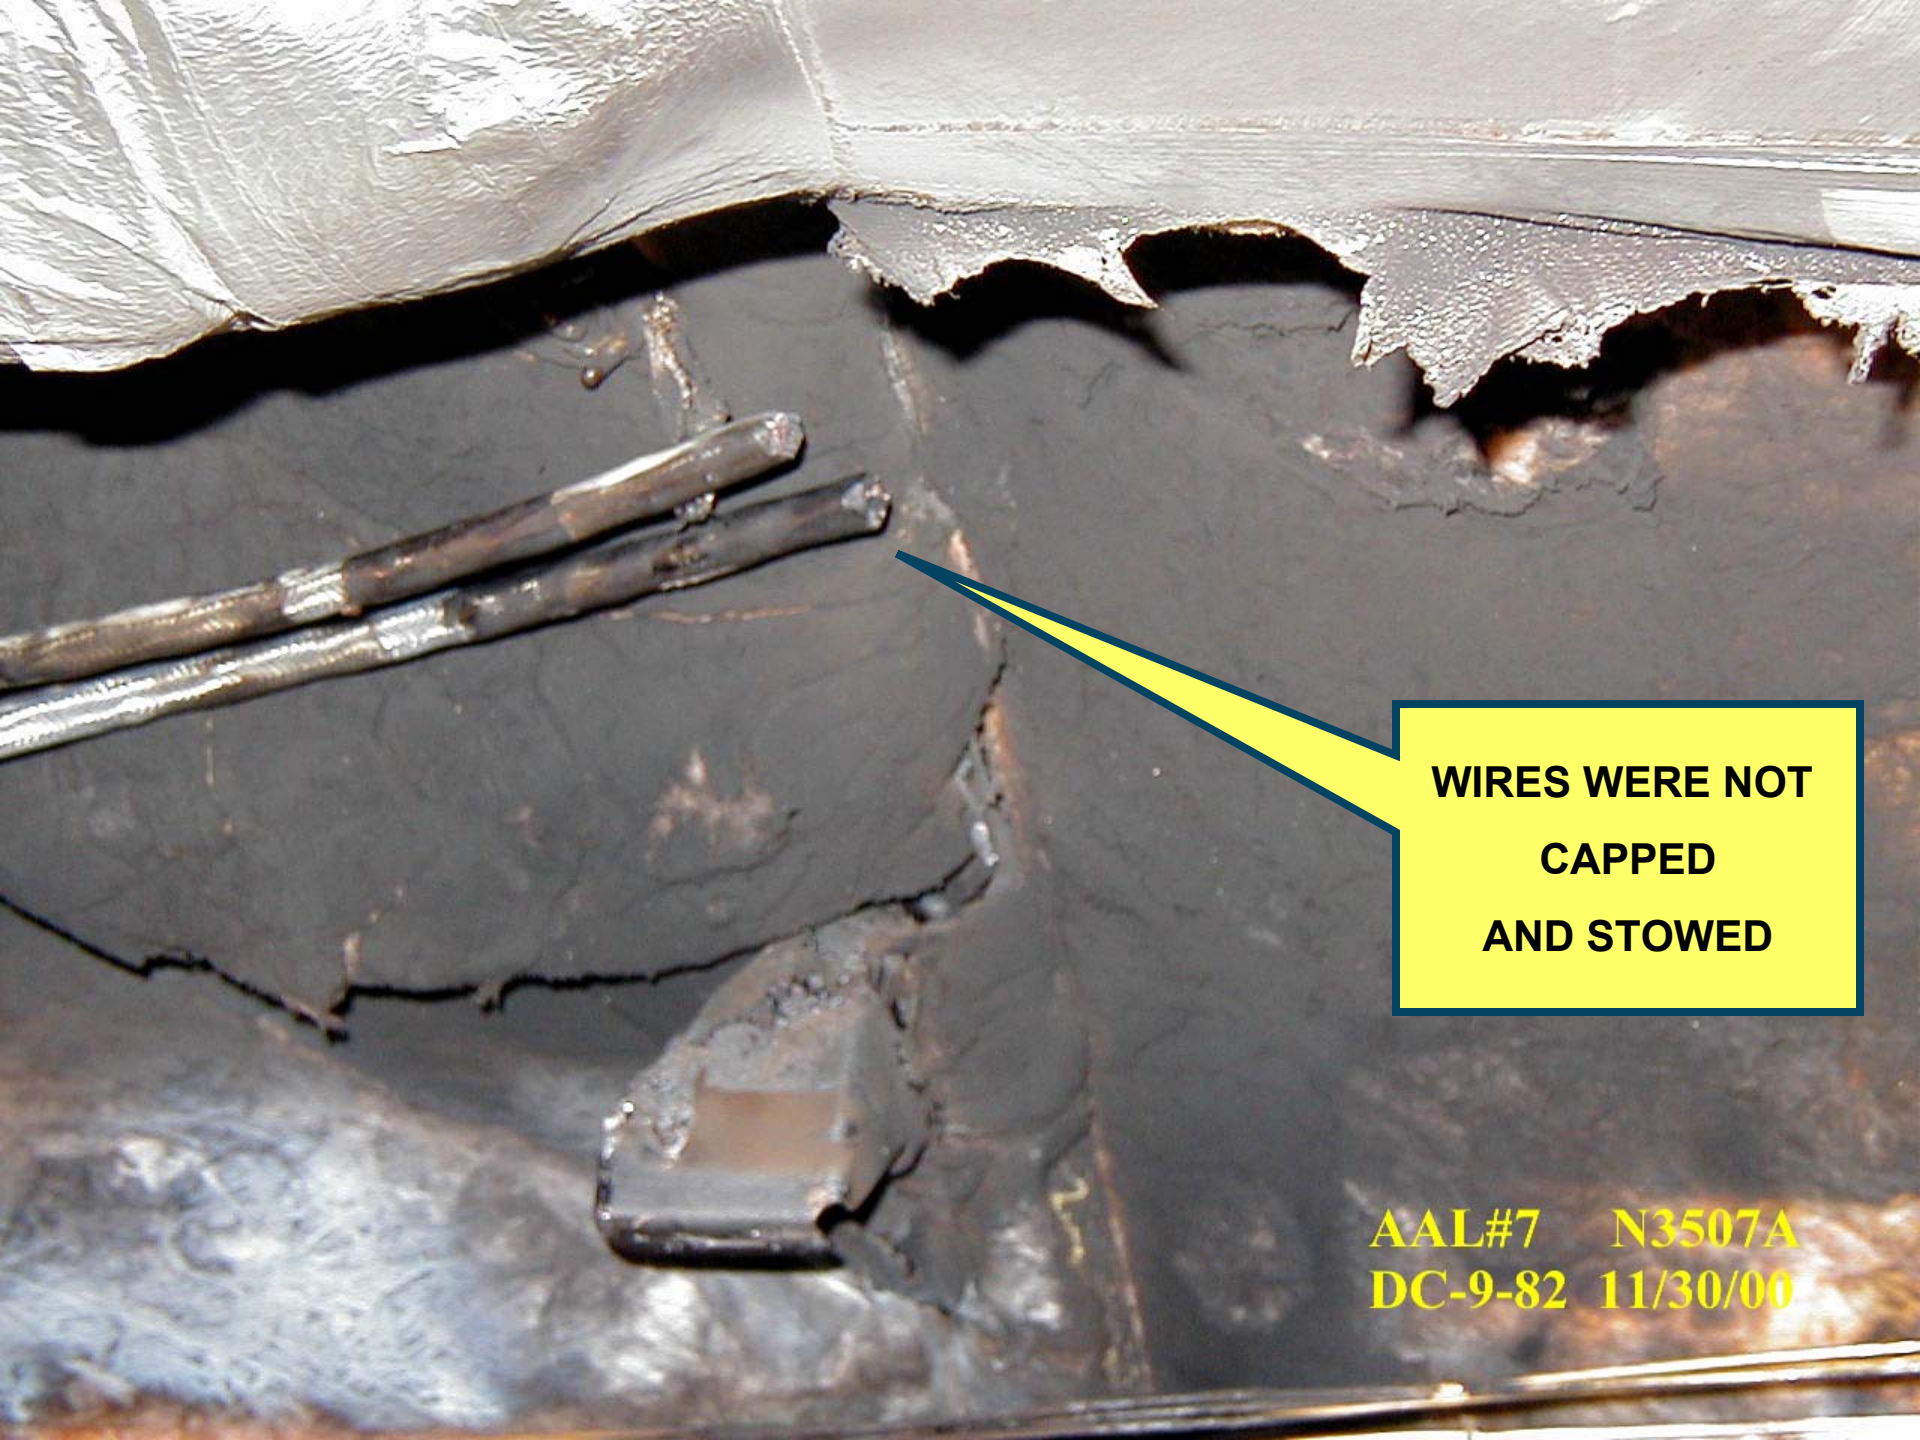
**AAL#7 N3507A
DC-9-82 11/30/00**

**WIRES WERE NOT
CAPPED
AND STOWED**

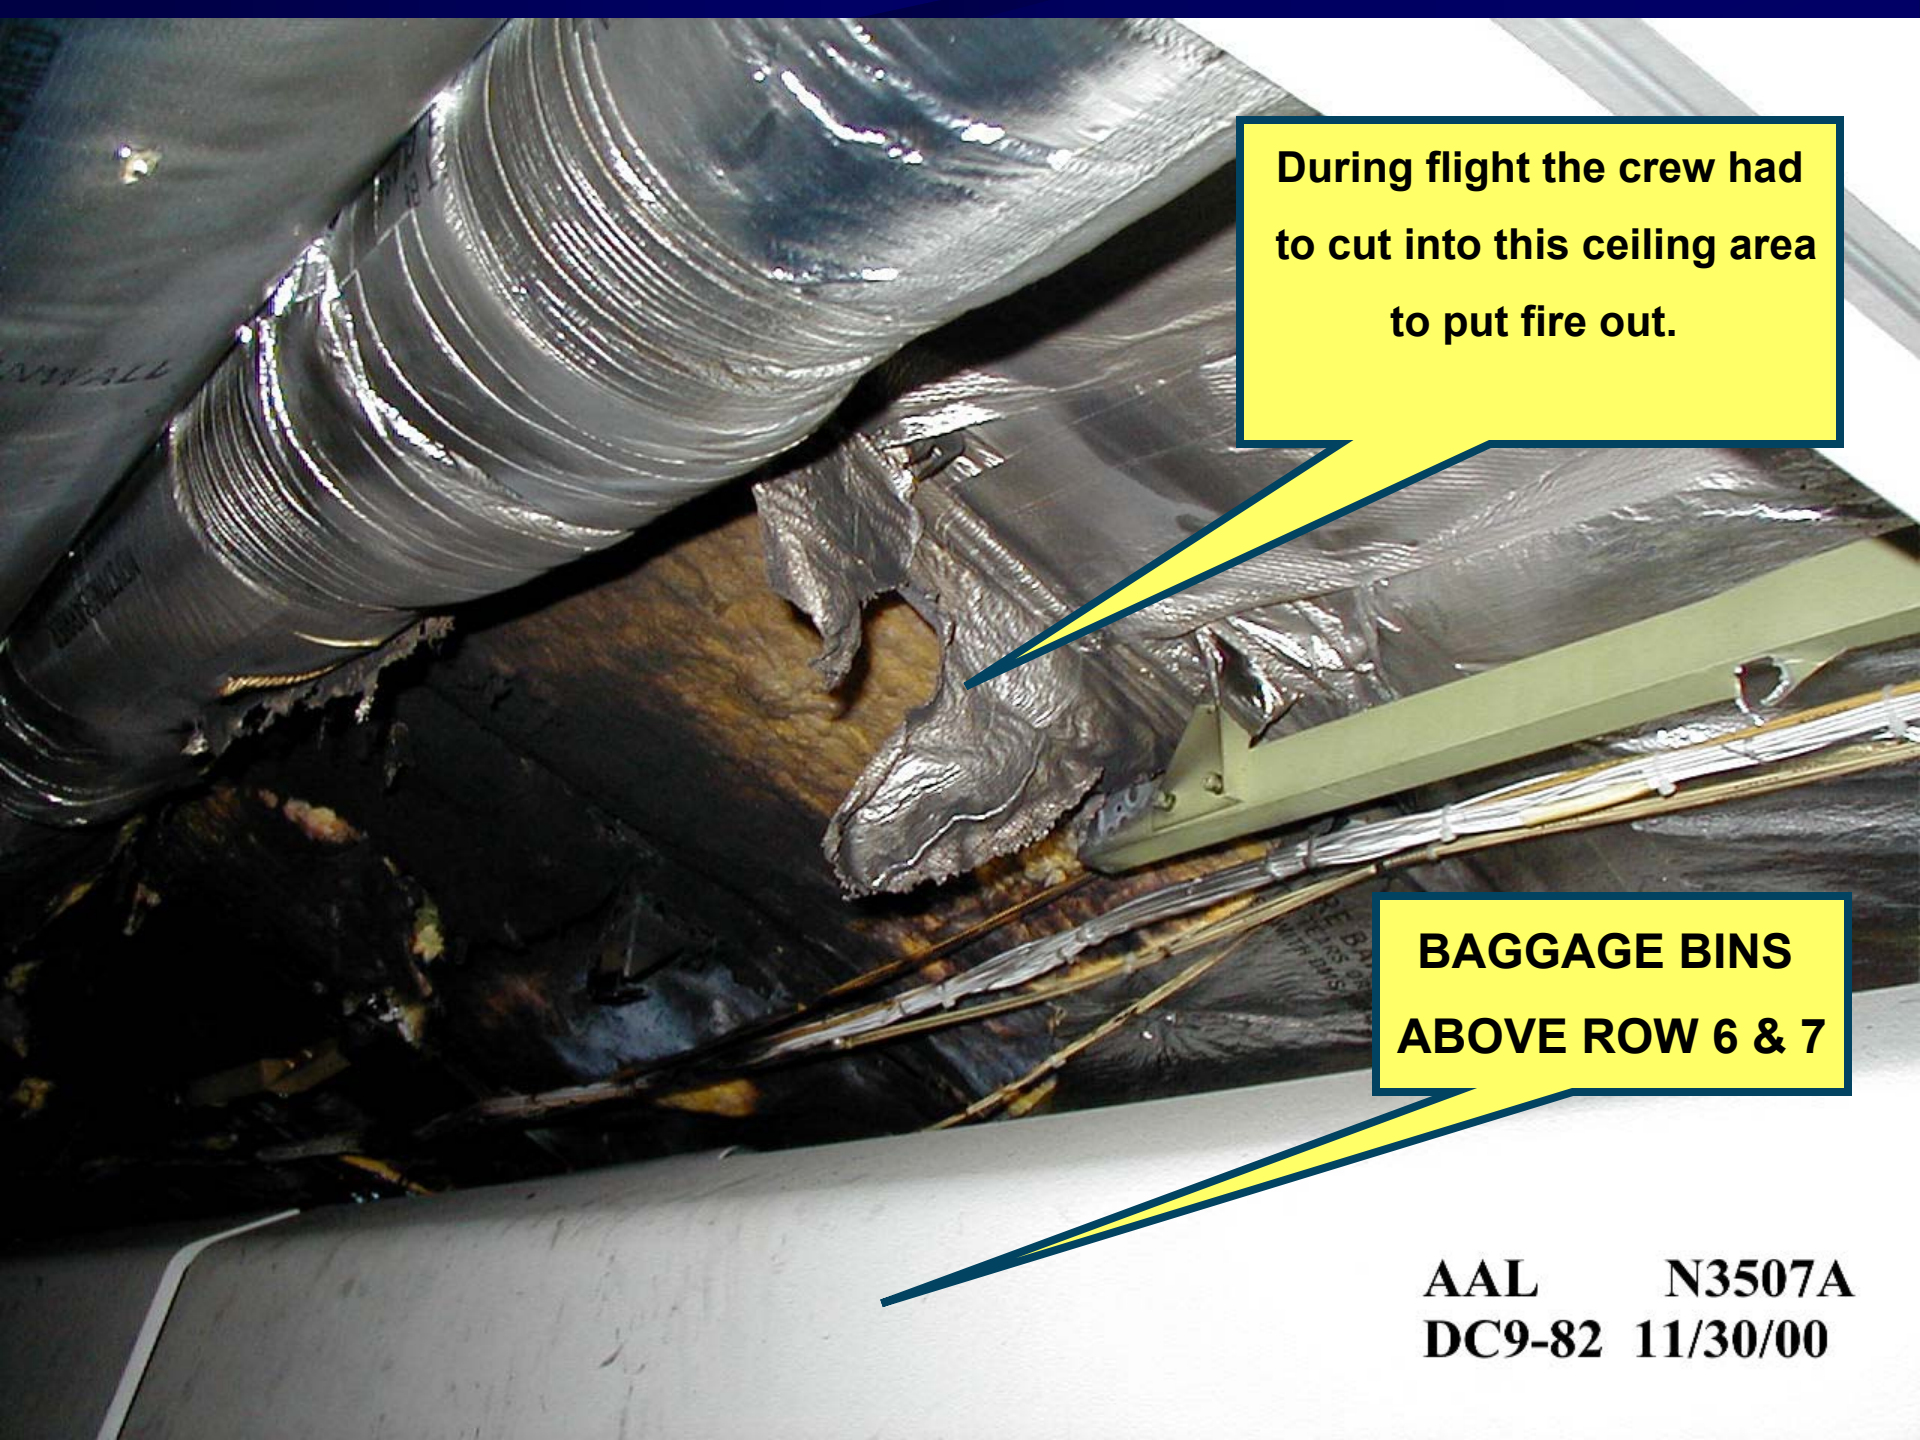
**AAL N3507A
DC9-82 11/30/00**

**During flight the crew had
to cut into this ceiling area
to put fire out.**

**BAGGAGE BINS
ABOVE ROW 6 & 7**

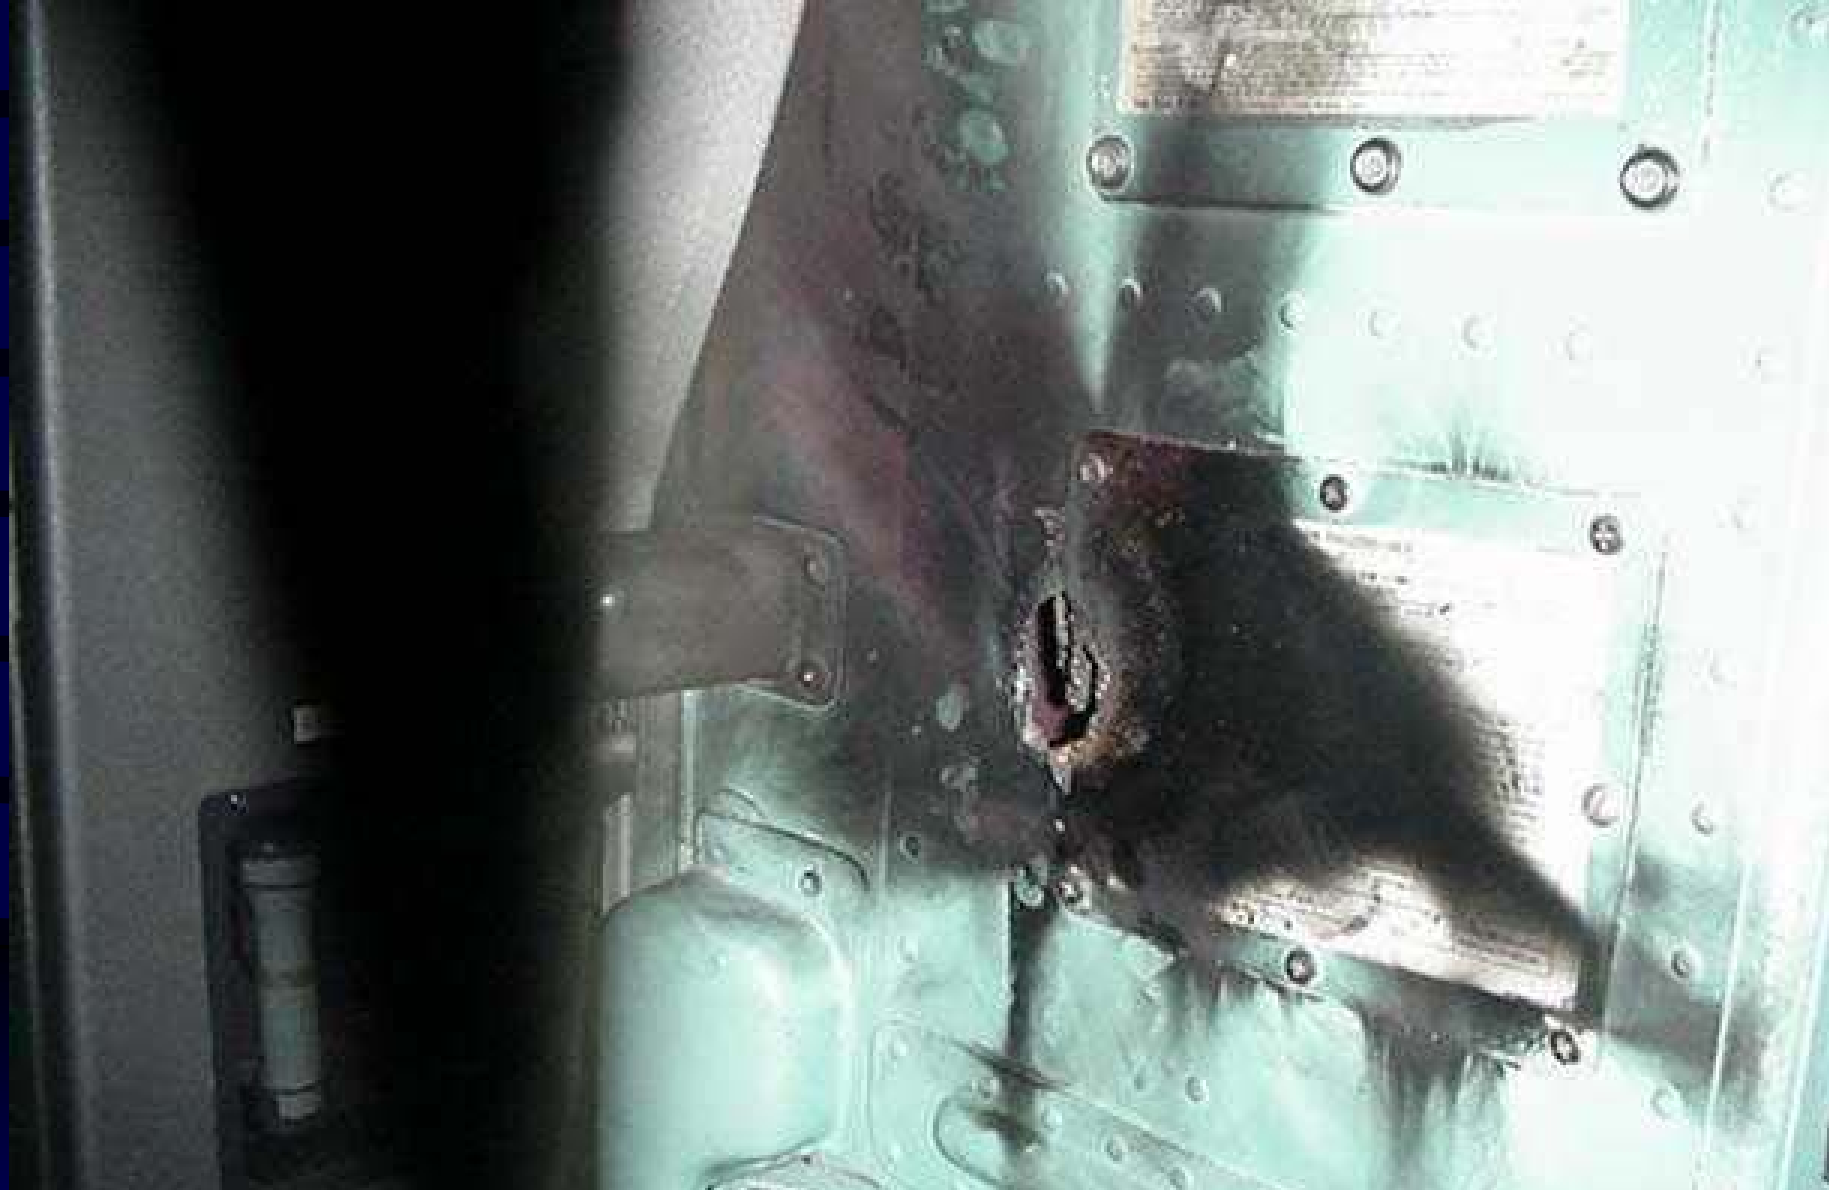
- Arcing originated in Electrical Power Center
- Burned through to the cockpit and burned inspector riding in the jumpseat
- Caused by a screw that penetrated into wire bundle in Electrical Power Center

The arcing event, which originated from inside the electrical power center, burned a hole through the left side of the hallway (looking forward) between the cockpit and cabin.
