## ***Report RL 2009:01e***

Accident to aircraft SE-IIX at the lake Norasjön,  
Örebro county, on 10 June 2008

Case L-12/08

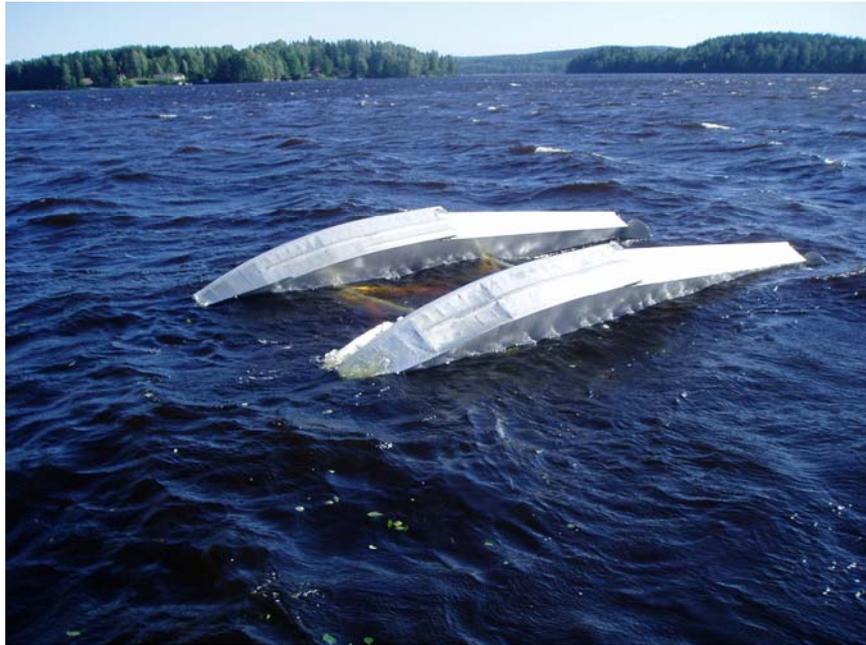
When the aircraft turned over it first ended up on its back with the tail section above water level, but quickly sank down so that finally only part of the floats were above water. There was a faint smell of fuel. Those who had been on board climbed up on to the underside of the fuselage, and standing between the floats they waved to attract attention and signal that they were unhurt.

Fig 2: The aircraft about one hour after the accident

The rescue services checked that there was no leakage from the aircraft. Because of rough sea and strong wind they could not save the aircraft. It could not be secured at any point, so it was marked by a buoy. It was retrieved later by the owners and suffered no damage other than from ingress of water. According to the owners there was no environmental impact from pollution during the retrieval.
