Investigation Report of the Aircraft Accident Investigation Bureau

concerning the accident

to the aircraft Cessna CE 560 Citation V, HB-VLV

at Zurich-Kloten Airport

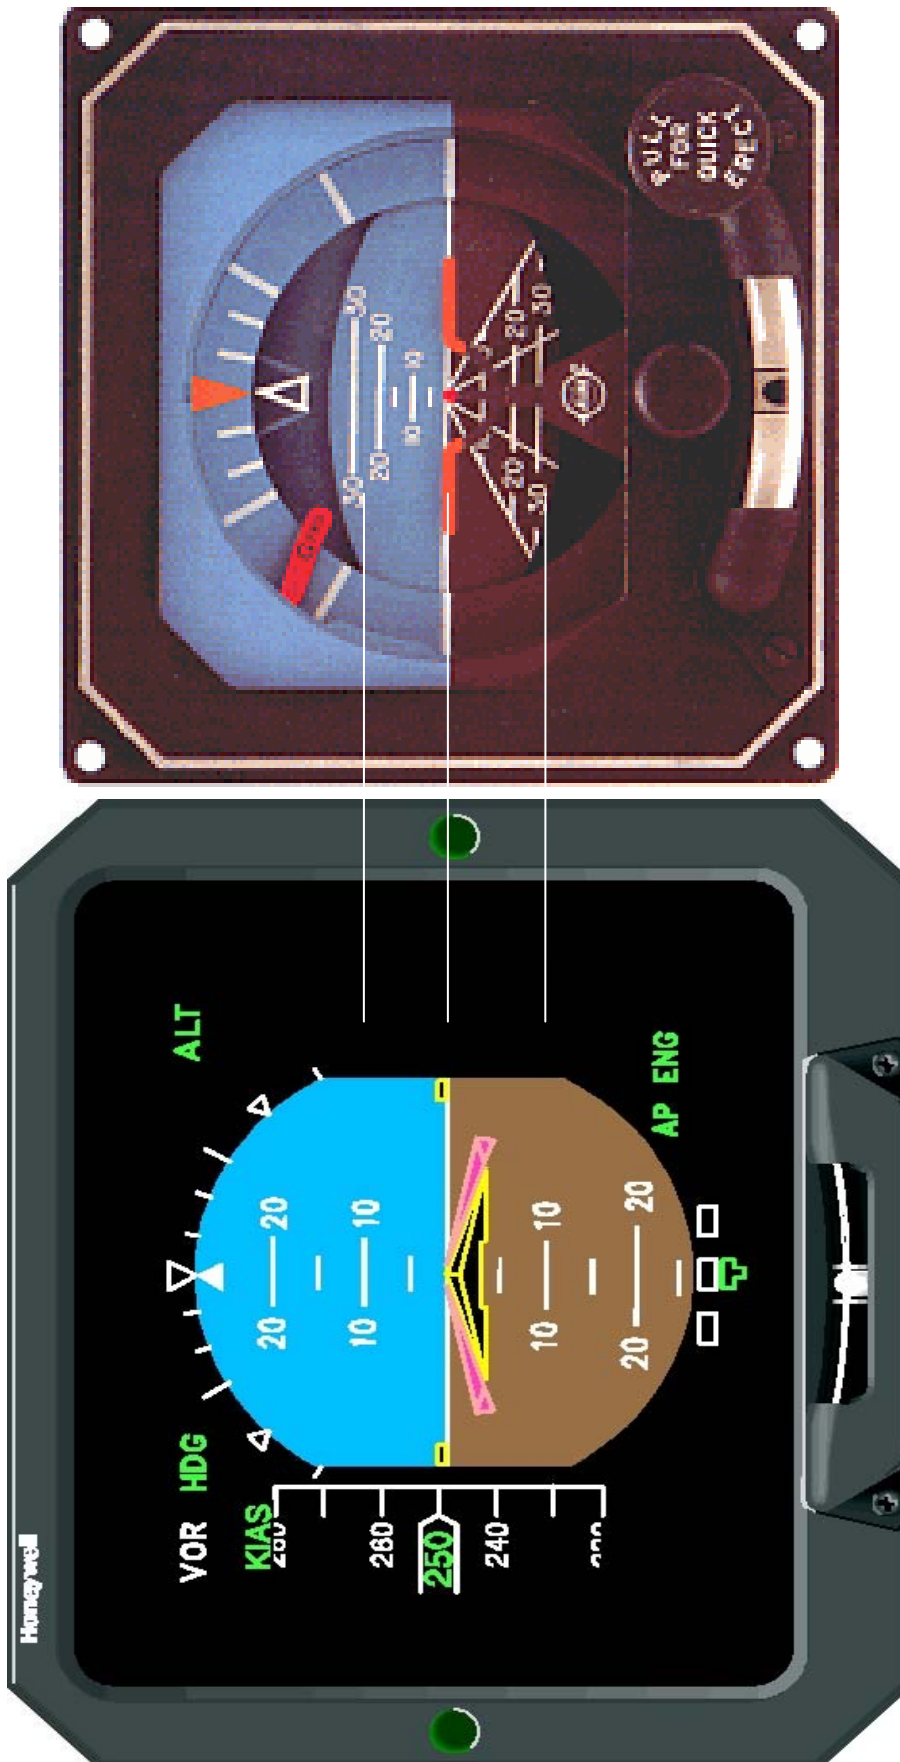
5.1 Comparison EADI and AI, scale 1:1

AI – AIM Horizon

EADI – Honeywell ED600
