FINAL REPORT

AAIU Synoptic Report No: 2006-001

Aircraft Type and Registration: Savannah MXP-740, EI-DGI

Location: Runway (RWY) 15/33, Granard Airfield, Ferriskill, Granard, Co Longford.
(N53 45 490 W007 31 982)

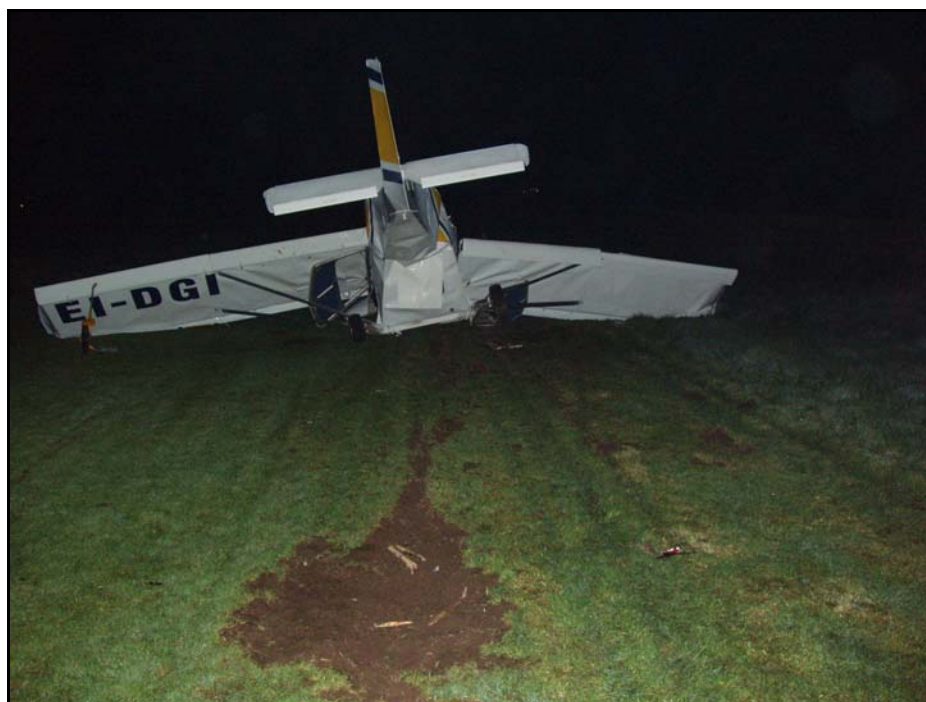
Photo 1.

The ultralight impacted the ground heavily at low forward speed and at a considerable nose down attitude. This is evidenced by the short ground run of 9.2 metres to its final resting position (**Photo 1**). The initial impact also showed evidence of a high vertical speed, as evidenced by the damage to the ultralight. The rearward collapse of the nose wheel and the main undercarriage further supports this analysis. Analysis of the impact marks indicate that the ultralight was in a nose down attitude of approximately 30° at the point of impact and that it was descending at an angle of approximately 25°.

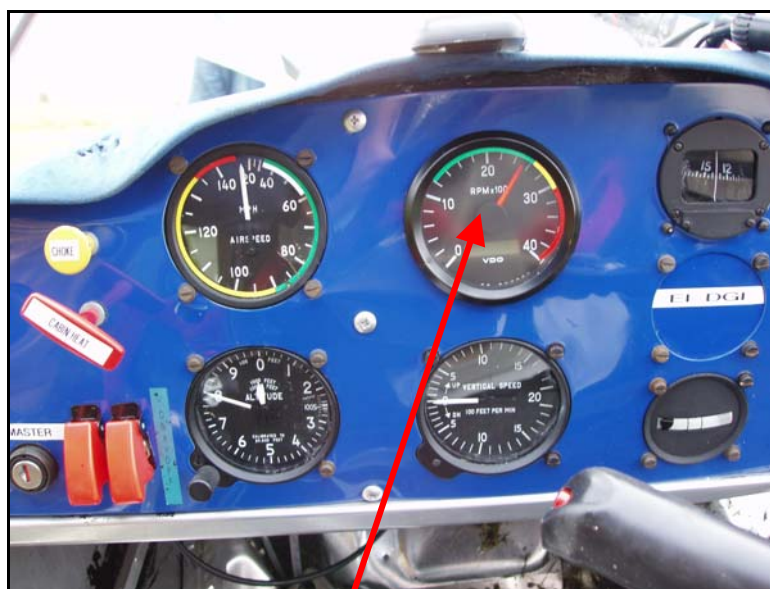
The propeller was made of wood. Both blades shattered close to the hub. There were slash marks in the ground, containing propeller fragments, in the initial impact area. Portions of propeller fragments were scattered over a wide area, both left and forward of the direction of flight. Some fragments were approximately 40 metres to the left of the impact point, while others were 30 metres forward of this point in the 11 o'clock position. This indicates that the fixed pitch propeller was turning at high RPM, and operating at high power, at impact. This conclusion is reinforced by the fact that the engine tachometer froze at approximately 2,550 RPM (**Photo 2**). The likelihood is that following the closure of throttle in error, the throttle was re-applied just prior to or during the impact sequence.

Photo 2. Tachometer frozen at approximately 2,550 RPM following impact

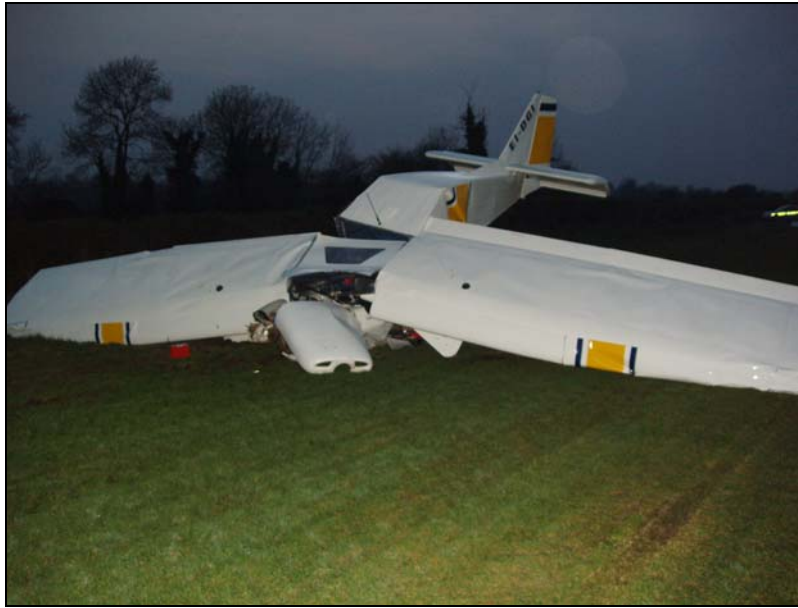
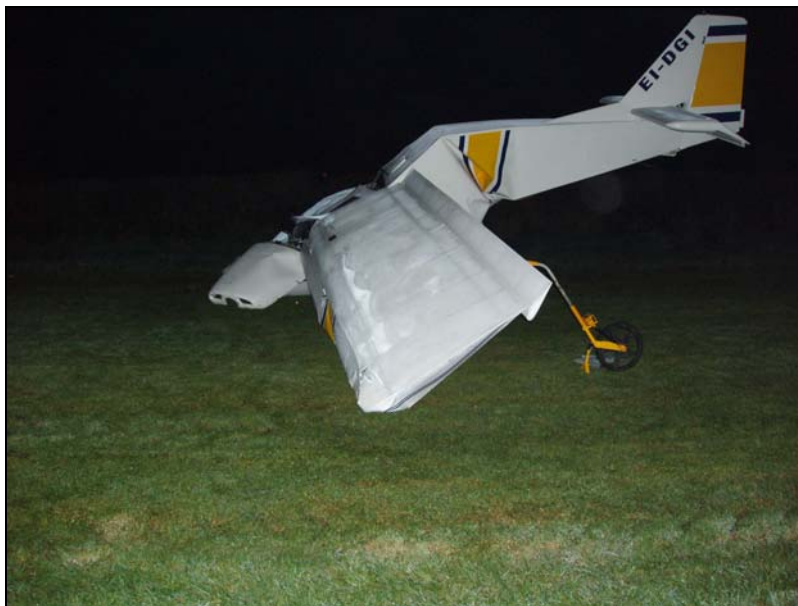
The cockpit space was compacted in the impact. The forward floor moved upwards and the rudder pedals upwards and rearwards. The instrument panel and firewall moved rearwards. This compaction of the cockpit was a significant factor in the injuries suffered by the persons on board. However, the use of a four-point shoulder harness by both occupants contributed greatly to their survivability. The Investigation has seen similar accidents (low speed approach at high rate of descent with a nose down attitude) with similar or greater impact in certified light aircraft (Cessna 150, PA 28 etc), where the cockpit space was not compromised, and no/minor crew injuries resulted. The comparative loss of cockpit integrity suffered by this ultralight in this accident was striking (**Photo 3 & 4**).

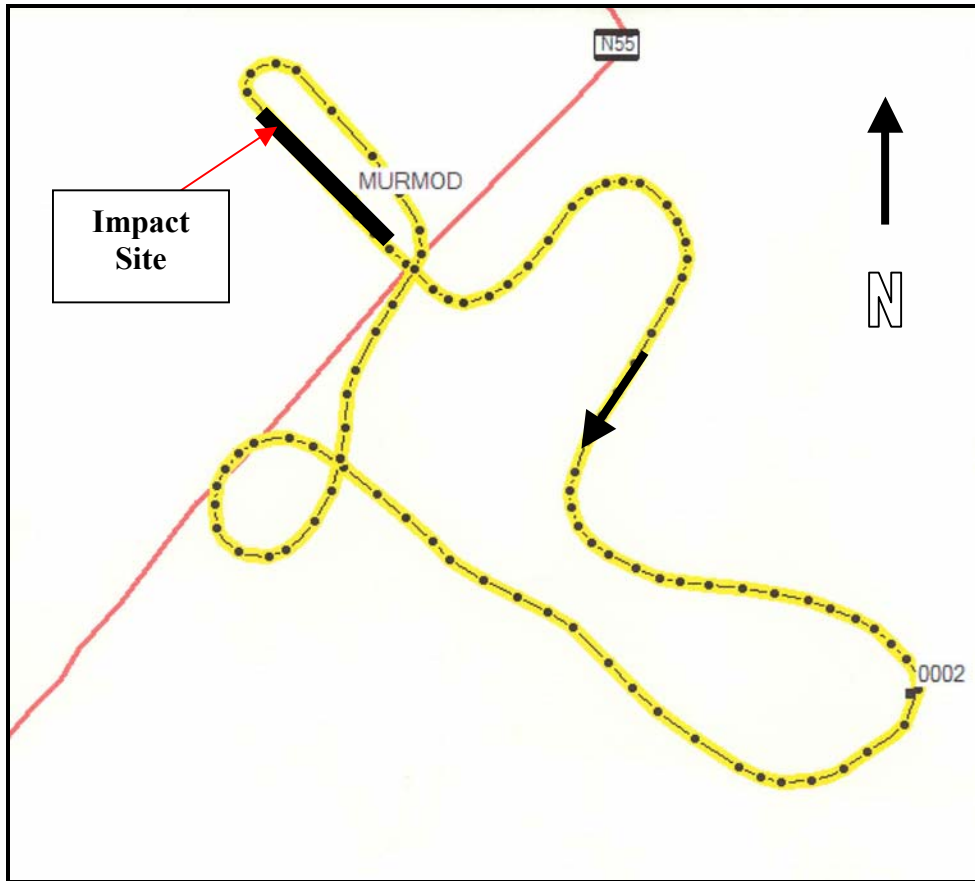
Appendix A GPS derived track of EI-DGI

A Garmin GPSMAP 296 was recovered intact from EI-DGI. A download facility on the unit provided the Investigation with a “track flown” map (See **Appendix A**) and a number of additional parameters, including, date, time, height (AGL) distance travelled, speed (MPH), heading (True) and Longitude/Latitude.
