Runway overrun Onur Air

Runway overrun after rejected take-off of the Onur Air MD-88, registration TC-ONP, at Groningen Airport Eelde on 17 June 2003

The Hague, 6 April 2006 (investigation number 2003071)

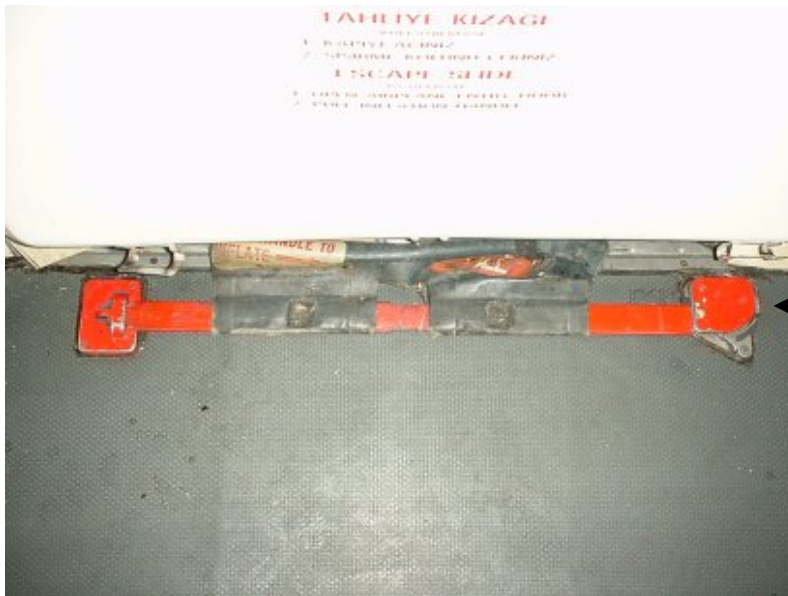
Slide bar right forward door

During the investigation it was noted that two different systems that hold the slide bar were used for the left and right forward aircraft doors. (See pictures below)

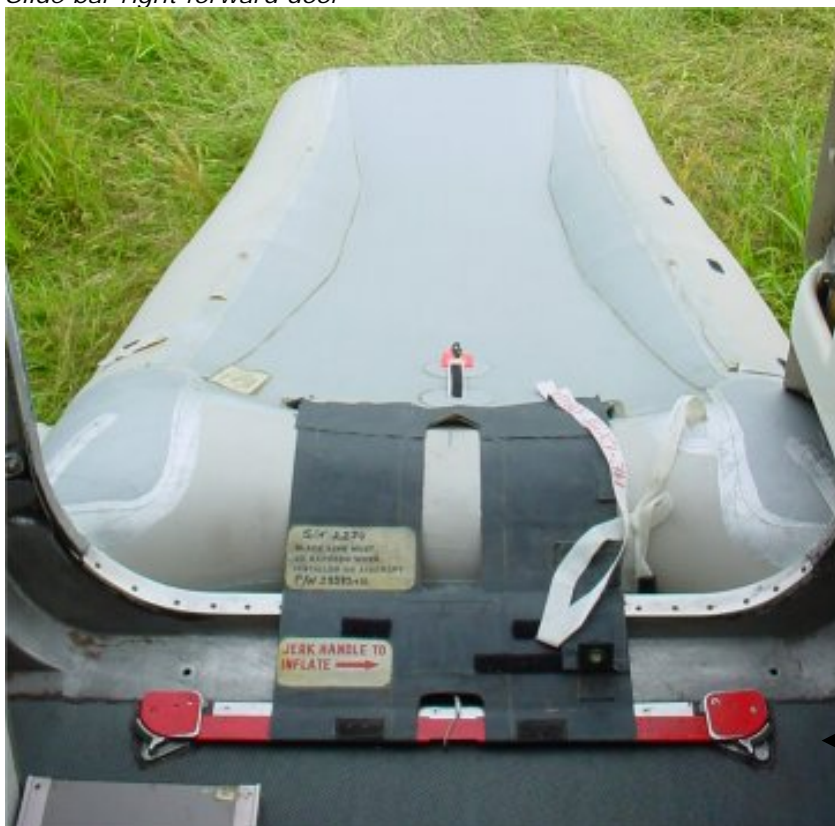
Slide bar left forward door

The left forward aircraft door was used during the evacuation. This door was fitted with an escape slide. The purser stated that she opened the door and activated the slide by pulling the inflation cord. The right forward aircraft door was not used during the evacuation. When a cabin crew member opened this door the slide fell out off its container and the package dropped on the ground next to the aircraft.

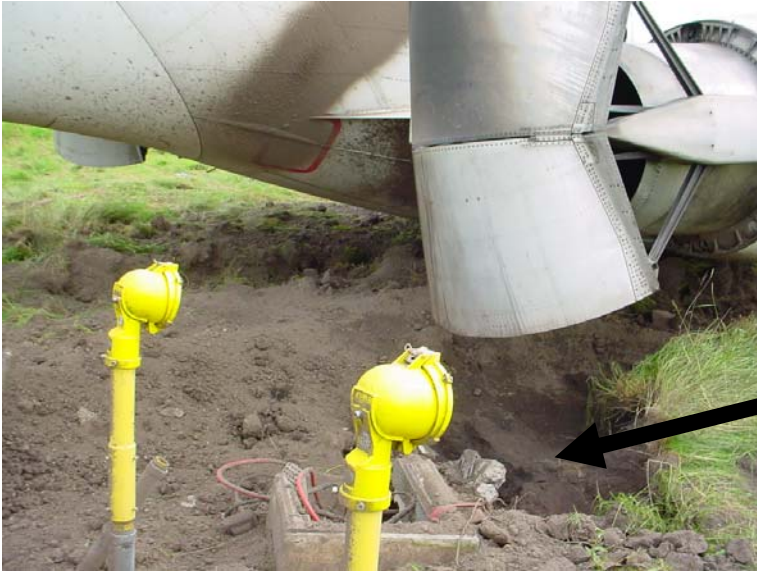
Investigation revealed that at the Groningen airport, in the area after the end of the runway, the so-called 'overrun area', there are underground concrete structures (transformation wells) in soft soil. The Dutch Safety Board holds the view that such a combination (underground structures and soft soil) entails a great fire hazard for the occupants in the event of a collision (the aircraft fuel, the risk of ignition of sparks and the engines which are hot). As Onur Air's MD-88 is a type of aircraft of which the engines are not located under the wing, but are mounted on the rear side of the fuselage, reducing the risk of contact with the ground.

At the day of the accident the soil in the overrun area was not strong enough to support the aircraft. During the overrun the main landing gear sank in the soft soil and damaged several of the approach light system embedded concrete structures and their contents. The centre and wing fuel tanks and engines did not encounter the concrete construction.

- It is recommended to the Minister of Transport, Public Works and Water Management to investigate to which extent the requirements concerning the underground infrastructure in the direct vicinity of start and landing runways has to be stepped up to prevent serious damage to aircraft that overrun the runway.

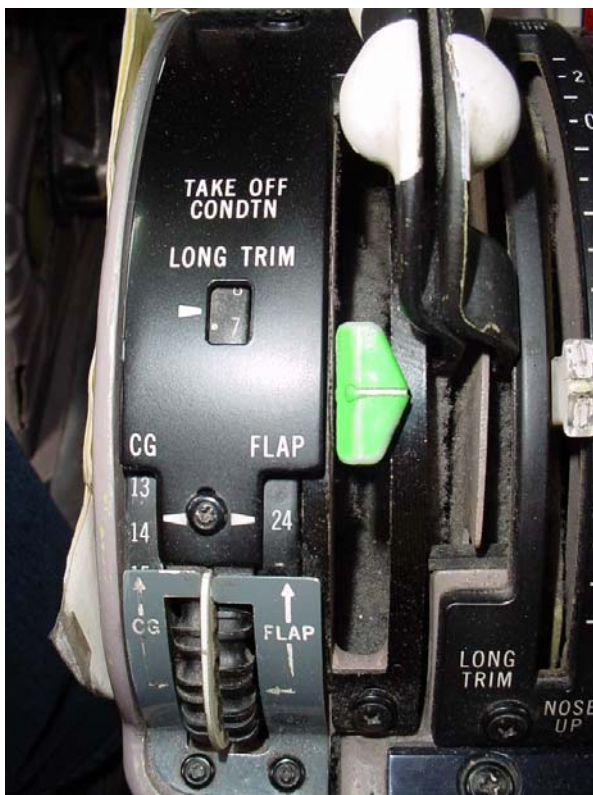
Figure 2: pedestal take-off condition computer.

The captain stated and the CVR recording confirmed that during the take-off a stabilizer warning sounded. After the accident DTSB investigators found the TO-CG input on the take-off condition computer set at approximately 13.5 % MAC (and flap input 24 degrees) , which positioned the green band opposite to the stabilizer trim position indicator.

The stabilizer take-off setting is determined by entering the calculated CG value from the load and trim sheet and the required flap setting in the pedestal mounted take-off condition (mechanical) computer. The stabilizer calculated numeric outcome will appear in the take-off condition long trim window. The crew have to set the horizontal stabilizer by running the stabilizer till the take-off position indicator matches the long trim window numeric outcome, see also the picture left.
