Transportation
Safety Board
of Canada

SR 111

Investigation

Report

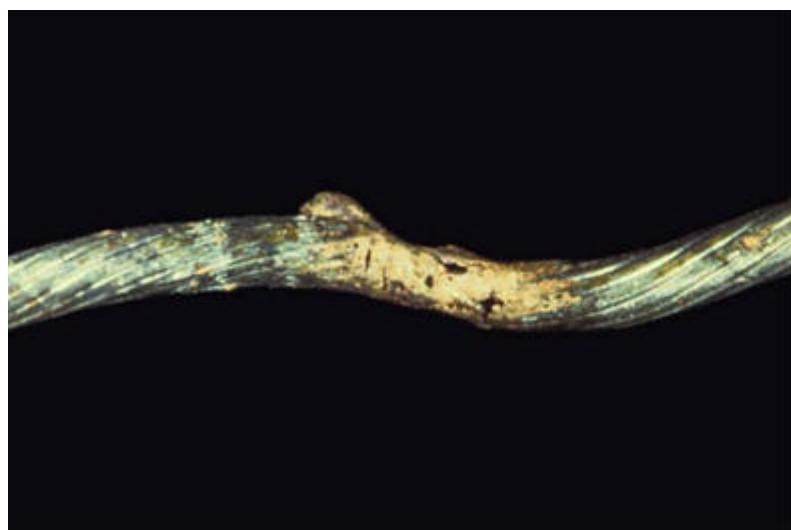
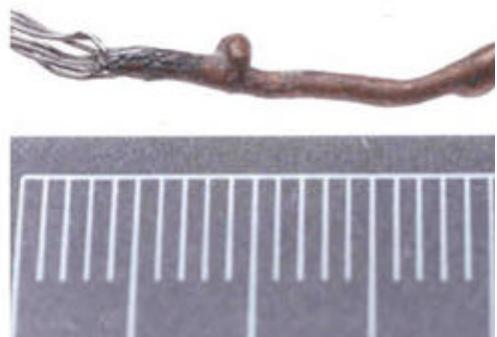
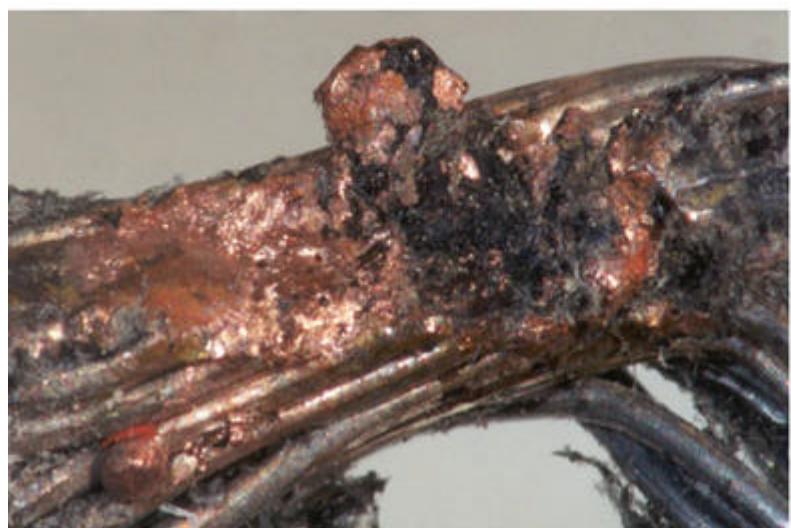
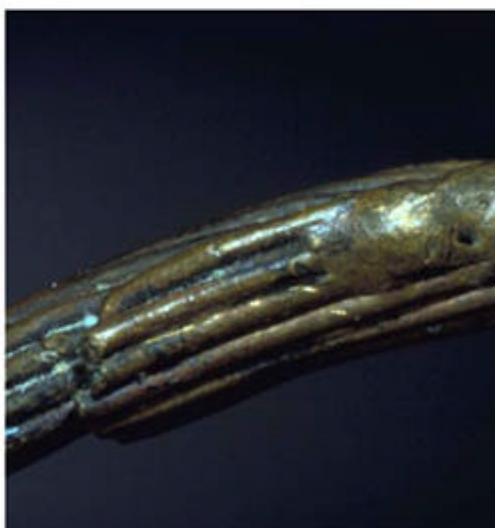
FIGURE 20 Wire segments with melted copper

Exhibit 1-12809, 24 AWG Wire
(magnification X19)

Exhibit 1-3796, 16 A
(scale in millime

Exhibit 1-14723, from 12 AWG IFEN Power Cable
(magnification X22)

Exhibit 1-3029, from 10 AWG Left Eme
(magnification X10)

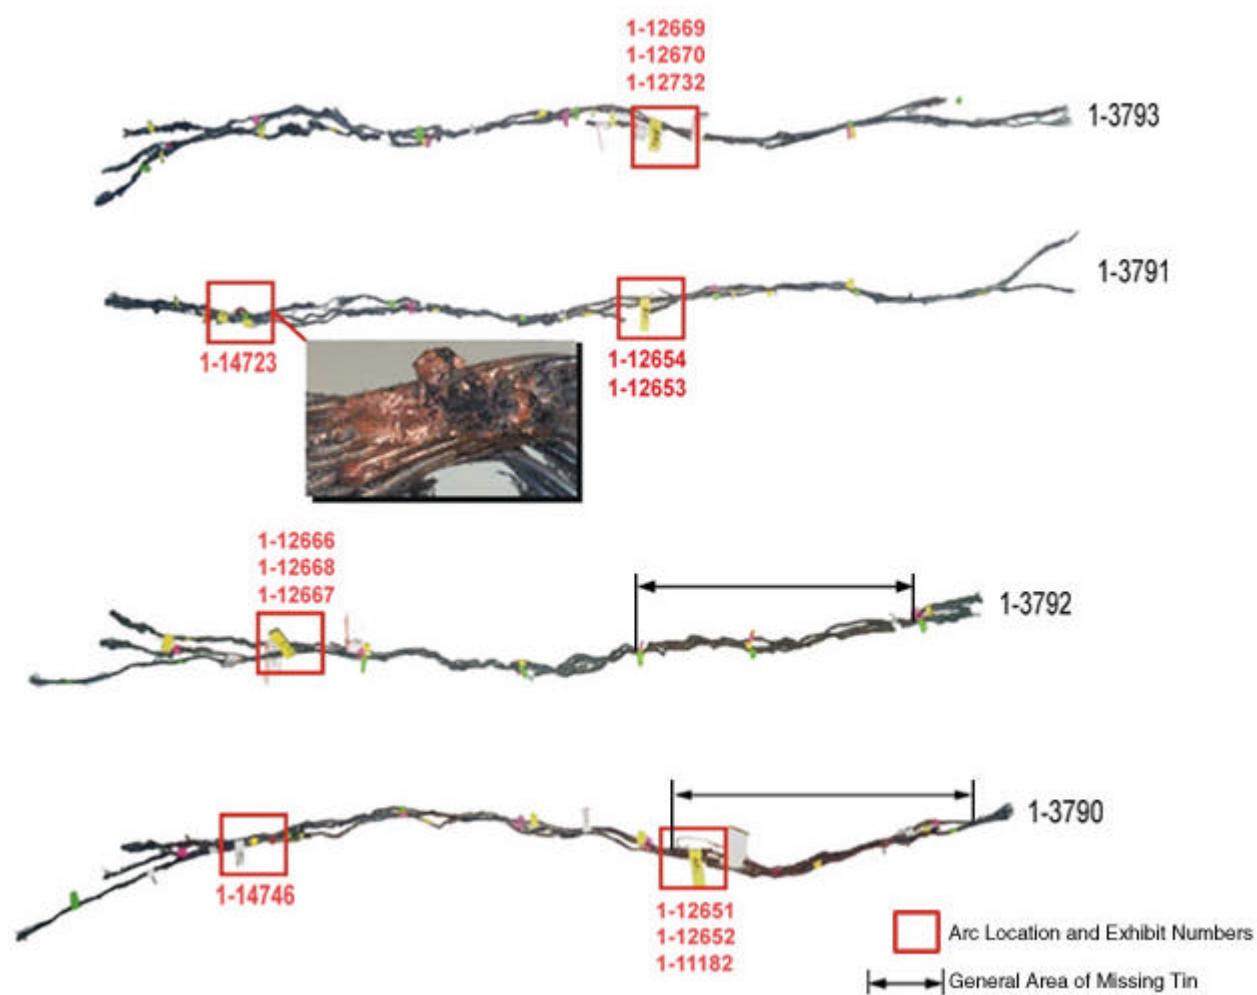
FIGURE 22 IFEN PSU cable segments

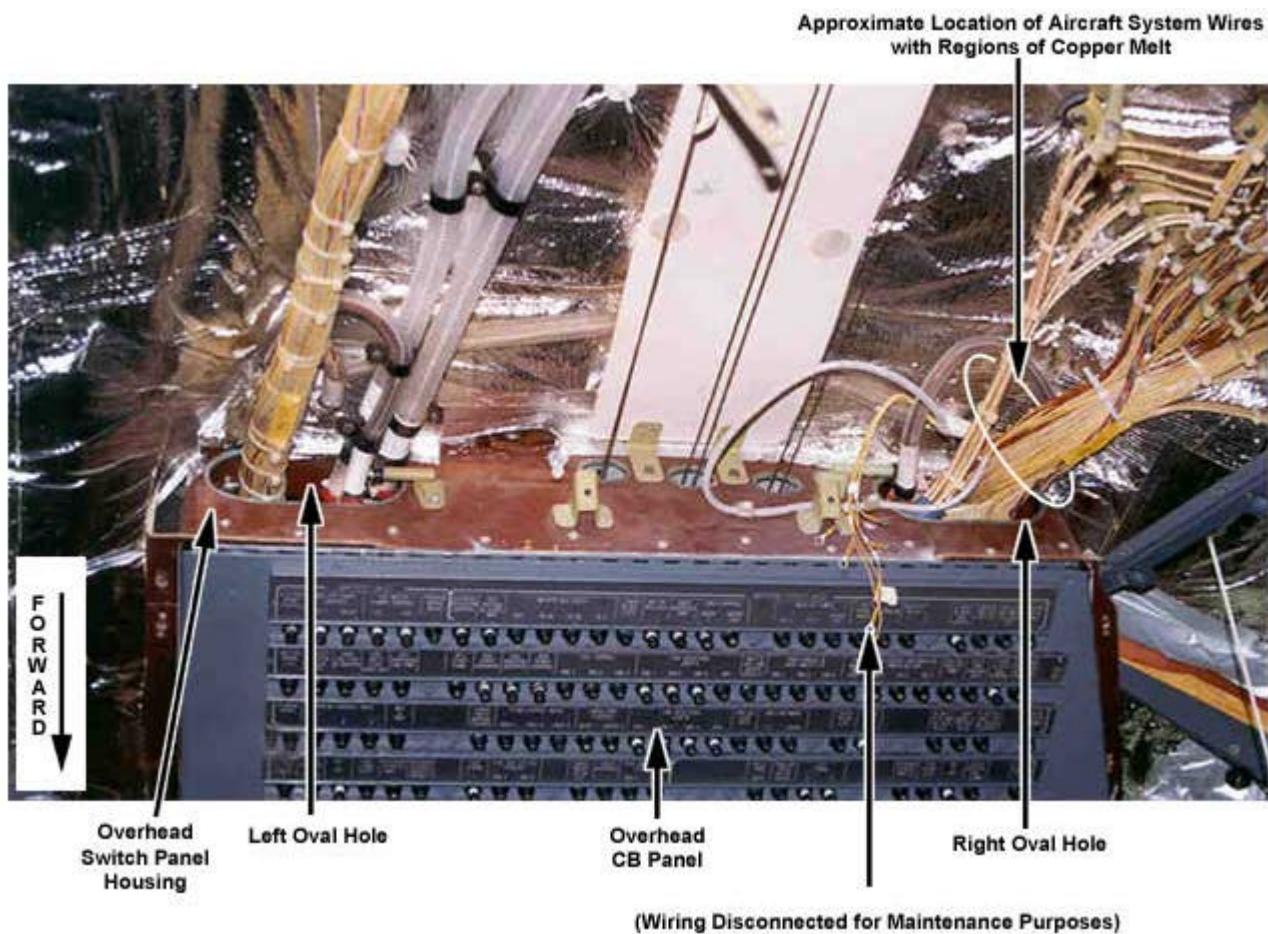
FIGURE 23 Location of identified aircraft wires with regions of copper melt

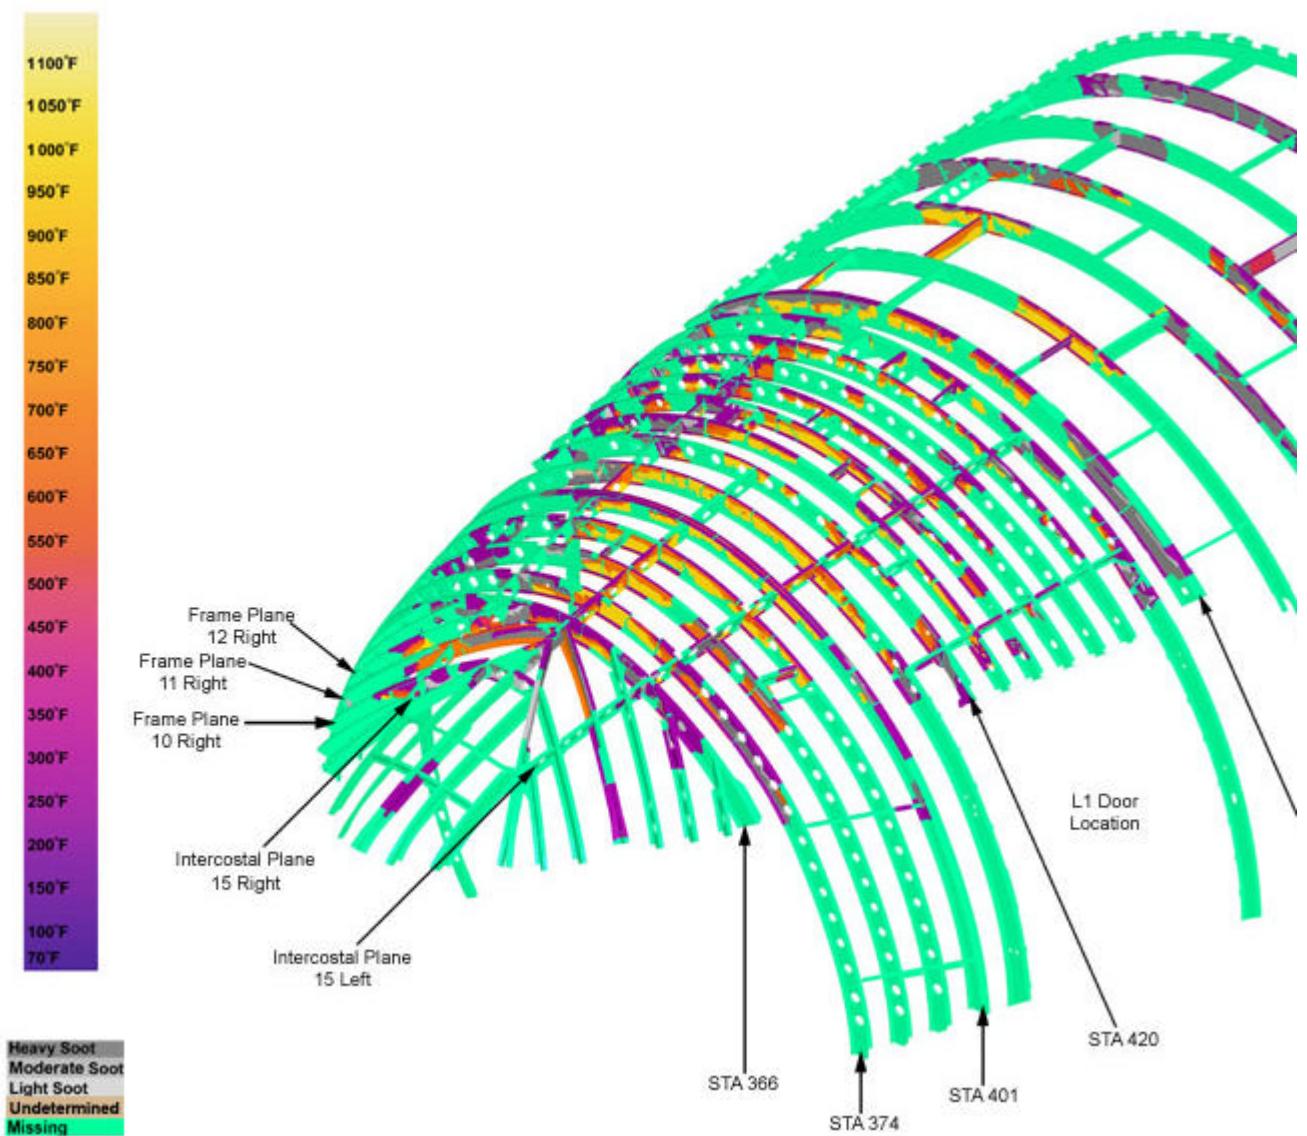
FIGURE 25 Heat damage – airframe structure

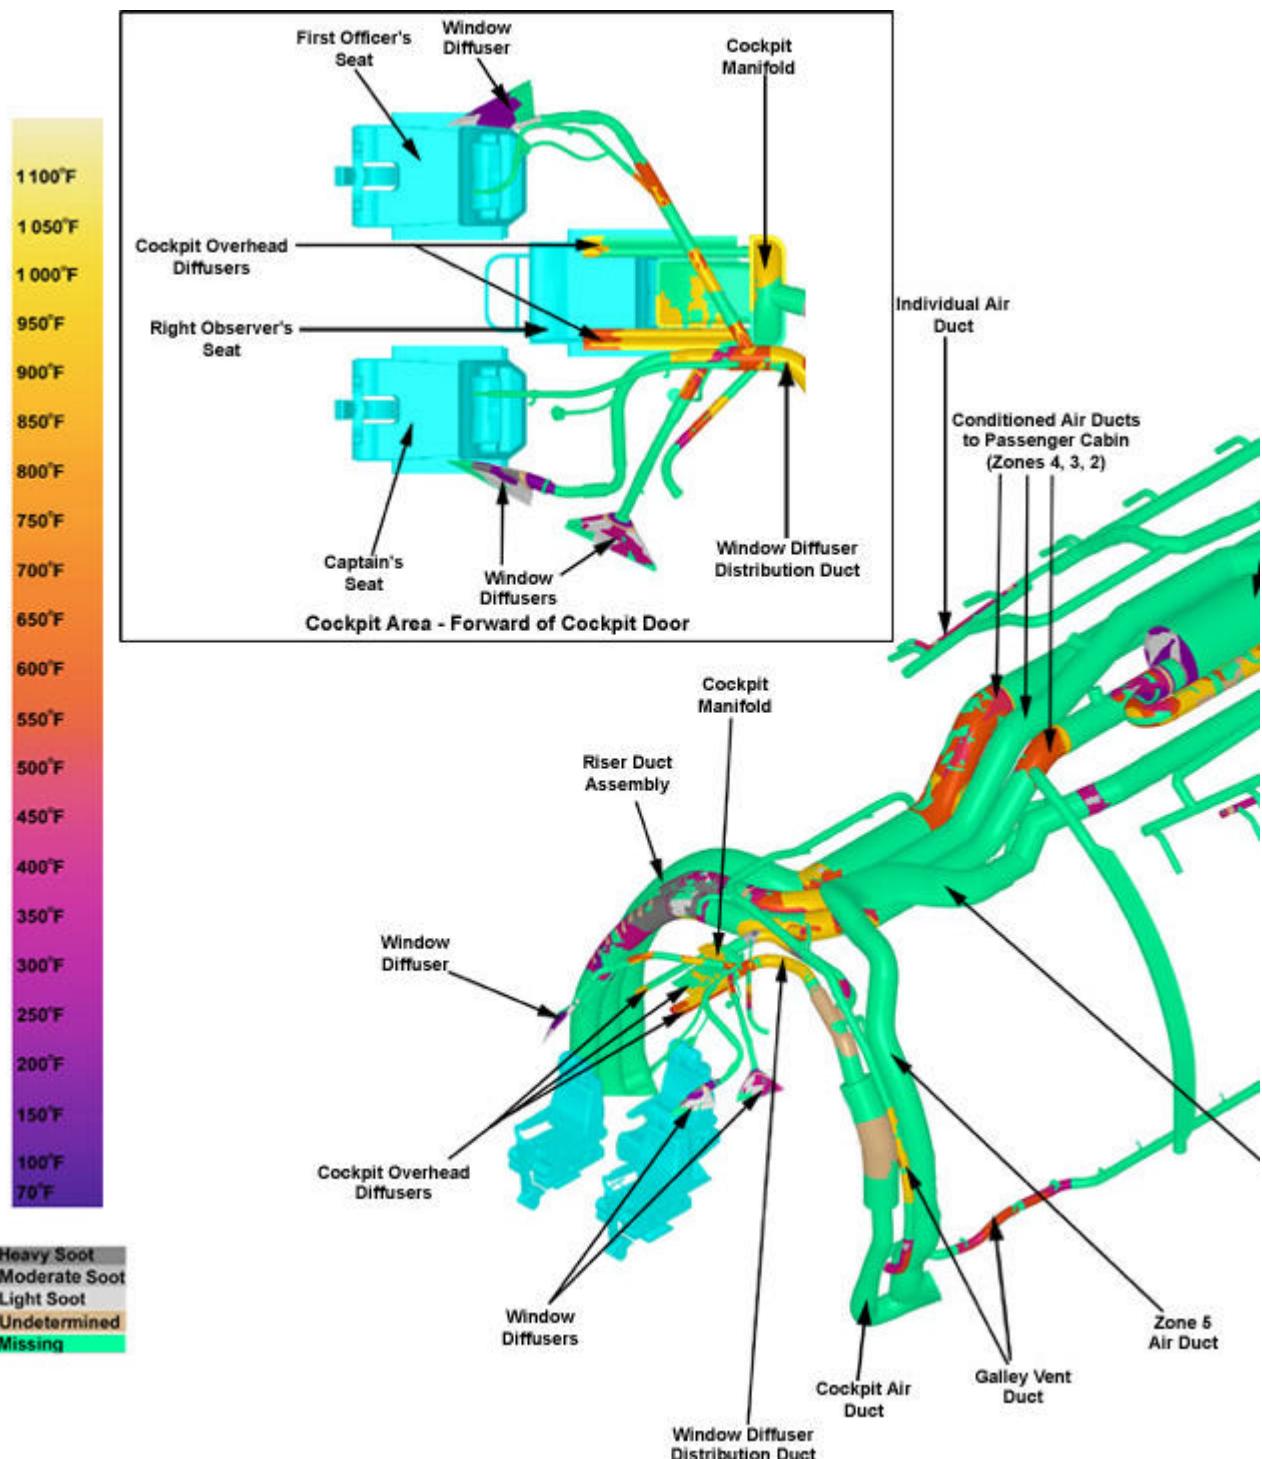
FIGURE 26 Heat damage – air distribution system

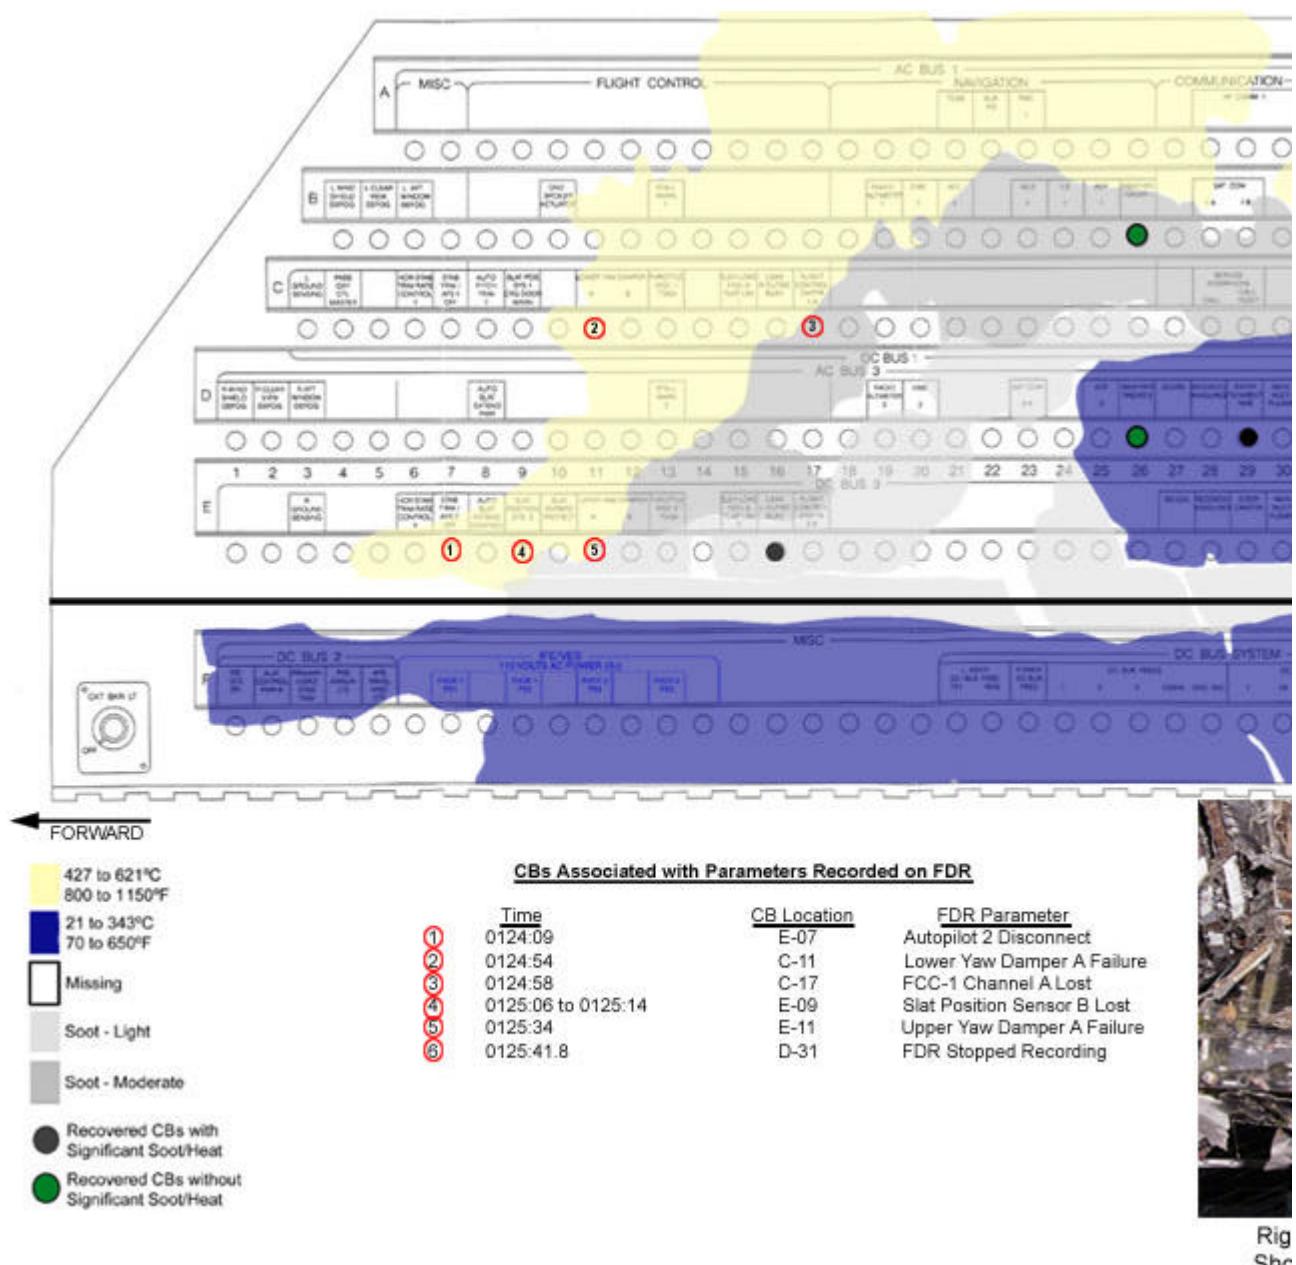
FIGURE 28 Heat damage – upper and lower avionics CB panels

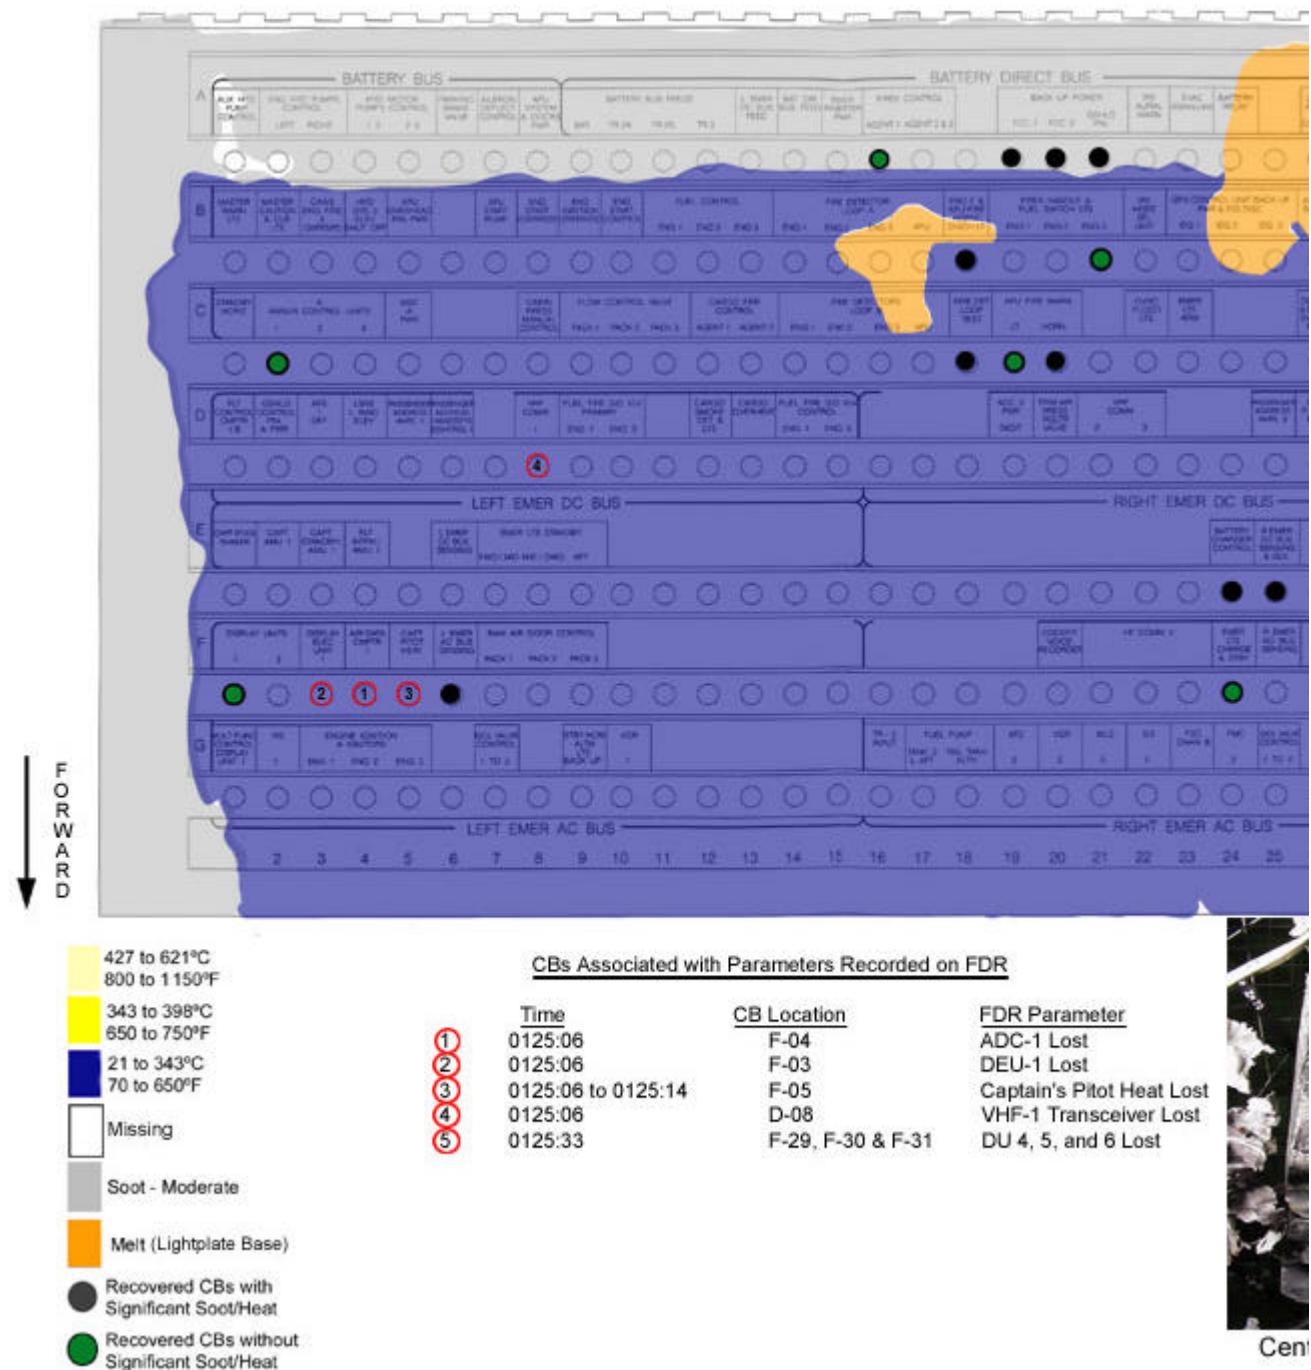
FIGURE 29 Heat damage – overhead CB panel

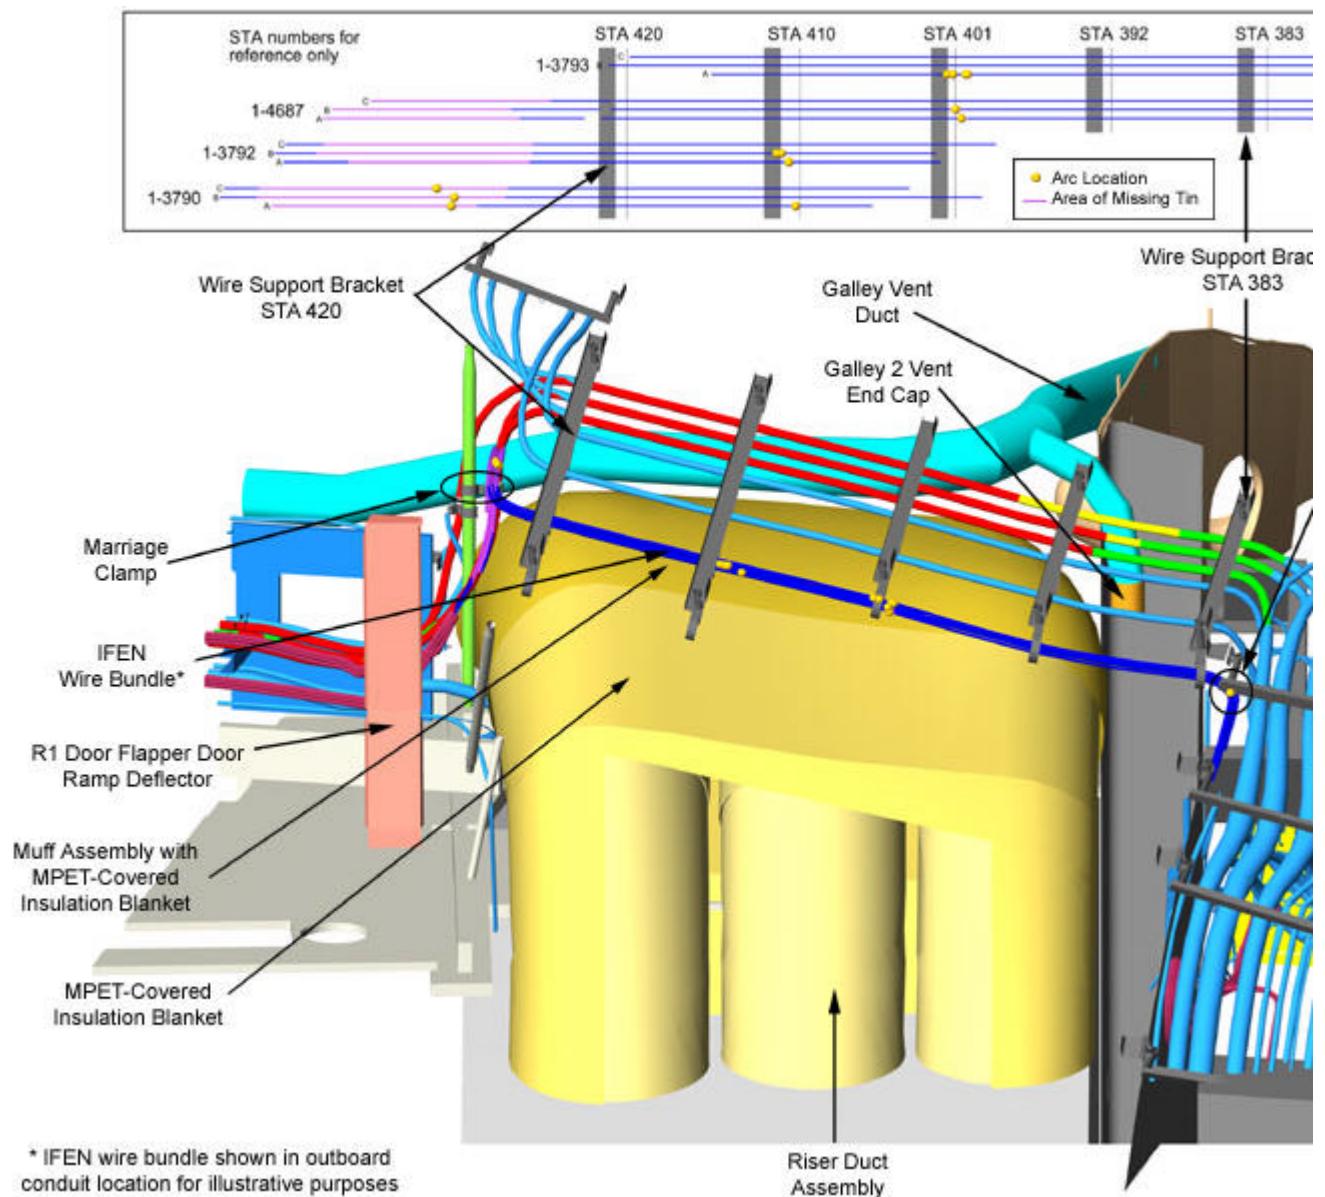
FIGURE 30 Position of recovered IFEN wires – outboard conduit

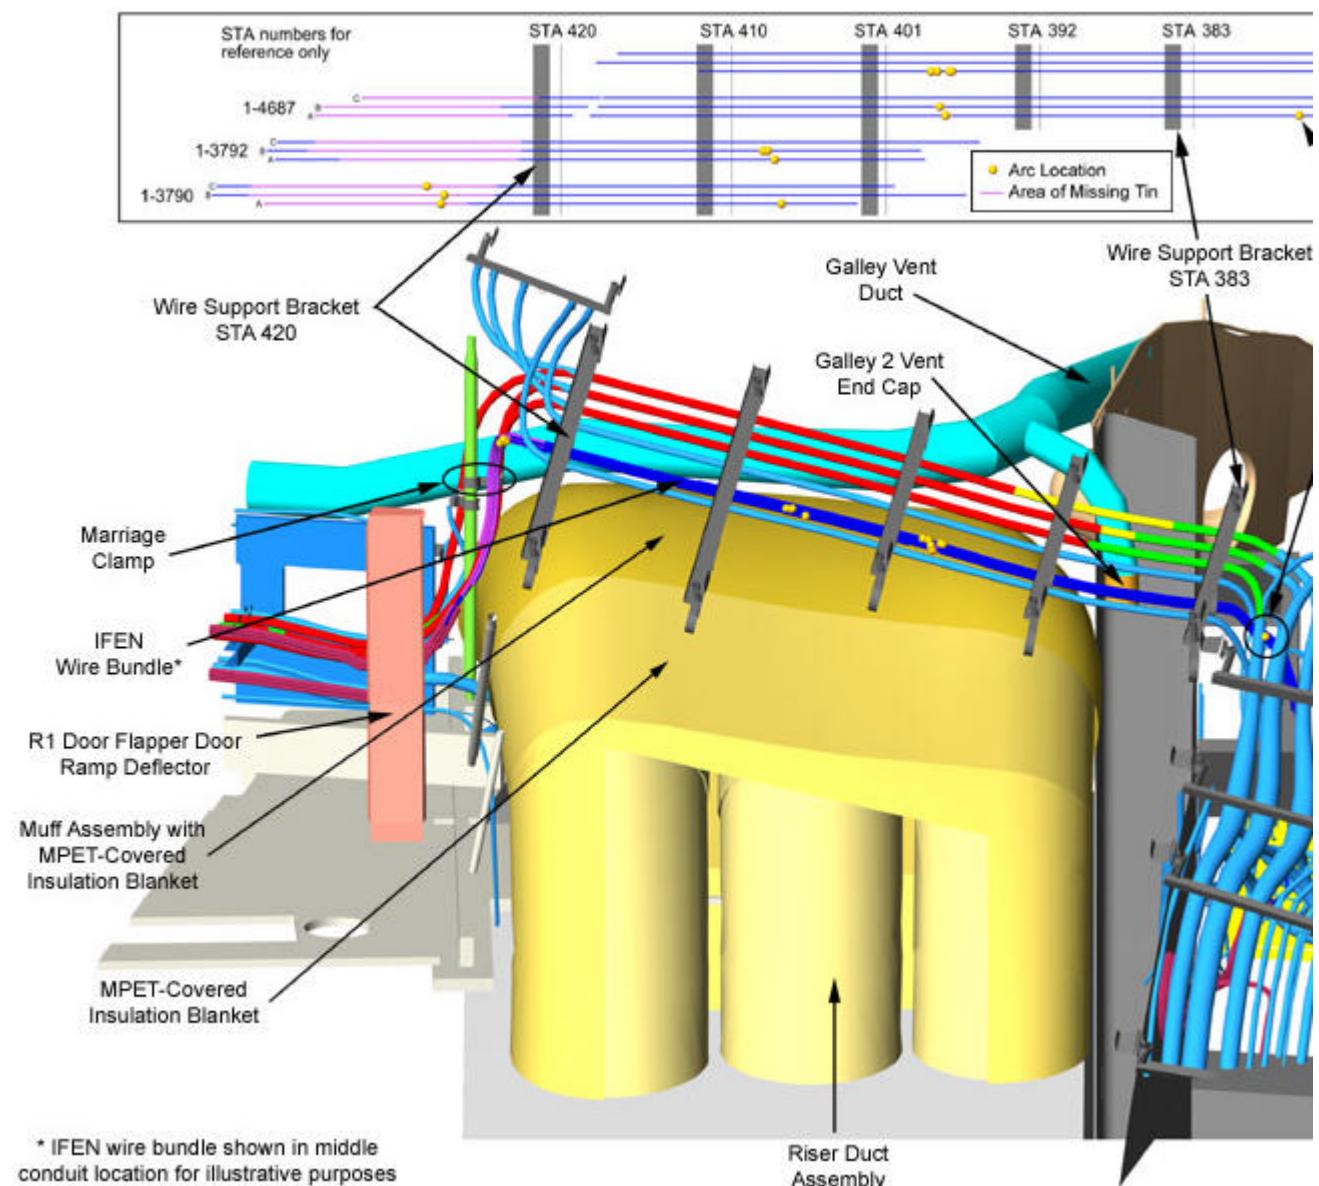
FIGURE 31 Position of recovered IFEN wires – middle conduit
