NLR-TP-2001-108

Development of a crashworthy composite fuselage concept for a commuter aircraft

Division:	Structures and Materials
Issued:	9 March 2001
Classification of title:	Unclassified

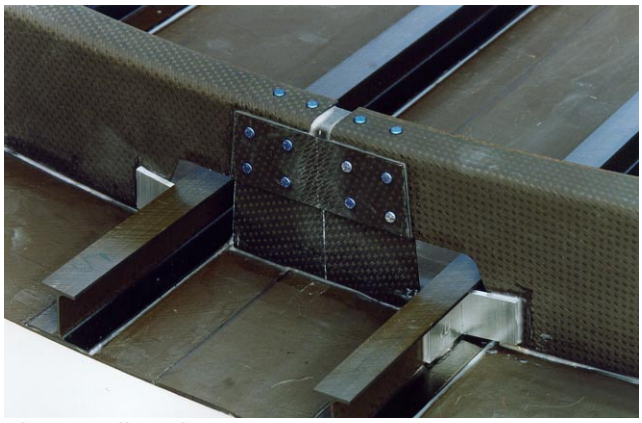
Fig. 3 Splice plate

The sub-floor frame sections were expected to break at the ground impact point, and were configured with a breakable splice plate, see Fig. 3, to control the failure. These frame sections were to be loaded by bending, due to the impact force, and the reactions of the hinges and the sine-wave beams, and possibly to buckle. However, with the crushing of the sine-wave beams by the dummy passenger mass placed above, and the ground reaction from below, the sine-wave force on the sub-floor frame sections would diminish, and the frames might rotate around the hinges. However, this would require the skin to break near the hinges, which was expected to occur without the need to trigger this failure.

In the first of the tests carried out by DLR, the function of the frame assembly with a collapsible splice plate could be proved. The splice plate between the two stiff frame sections broke very early after the impact and then the frames started to rotate around the hinges, exactly in the way they were designed. The only point of concern that could be found in this dynamic test was the bonded connection between the skin and the flange of the frame. This bonded joint failed totally by peeling stresses, and caused disintegration of the frame and the skin. As an improvement of the fuselage design, a number of rivets were used in the section which was eventually drop tested, in addition to the bonding connection, to avoid this type of failure.

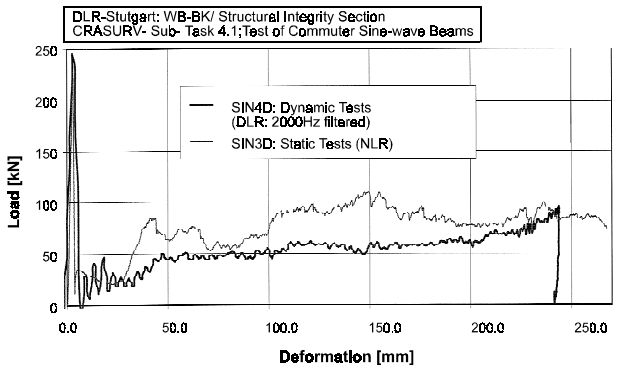
Fig. 7 Comparison of static and dynamic sine-wave beam tests (DLR)

The excellent crushing behaviour of composite sine-wave beams in combination with a ply drop-off trigger was demonstrated in the second dynamic test carried out at DLR (Fig. 5). The 350 mm high sine-wave beam (rather high compared to typical helicopter beams) failed along the trigger line and showed now damage far away from the trigger area. A continuous crushing process with a nearly constant load level of about 50 kN was observed, from the point where the web, broken at the trigger line and translated downwards, contacts the lower flange again. Compared to the quasi-static compression test carried out at NLR, the crushing load is about 25% lower (Fig. 7). Based on the results of the component tests, the design of the commuter section was finalized by Alenia.

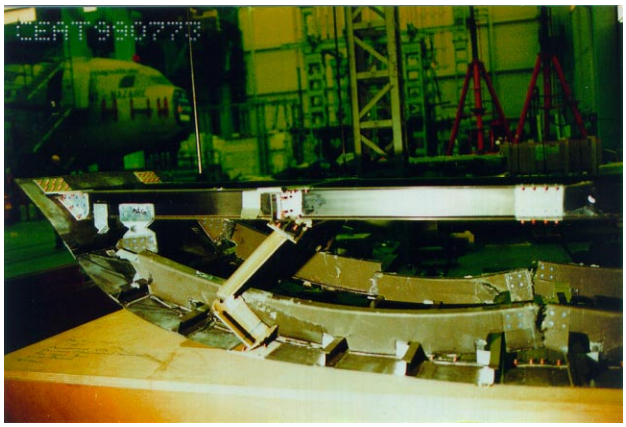
Fig. 11 Post-test configuration (CEAT)

The actual impact velocity was 7.09 m/s, the energy at impact 19866J. The commuter test resulted in an unexpected (and by the codes not fully predicted) failure mode, and failed without absorbing the required amount of energy. Upon impact, the splice-plates broke correctly, and the sine-waves triggered correctly too. However, the now destabilized sine-wave webs slid across the fuselage skin in the outward direction, rather than staying in plane to absorb energy by compression. The out-of-plane movement of the webs induced significant unexpected torsion moments on the (I-section) seat tracks, which failed unintendedly. As the skin did not fracture near the hinges, the frames were prevented to rotate, so that they bent, buckled and failed. The overall energy absorption was very low, and not by the mechanisms intended. However, the experimental data were useful to modify numerical models, and to validate the code developments. The failed structure, after being pulled up (it had been crushed flat), is shown in Fig. 11.

The major fault of the design was the fact that the sine-wave beams had no lateral support, for instance by lateral sine-wave beams such as in the boxes. An improved solution might have been found by connecting the frames to the sine-wave beams, as originally intended. However, these frames cannot support the sine-wave beams over the full height, because they are much lower. Another solution might have been to provide a "stopper" for the sliding sine-wave beam web, but that is probably a less efficient mechanism. The trigger of the sine-wave beam was still providing a rather high peak force. A trigger with reduced strength might have improved the failure mode. The skin did not break near the hinges. A trigger line, for instance provided by a rivet row, might have initiated failure of the skin, thereby improving the chance that the frame section would rotate as intended. The failure of the seat tracks was not important, because it was consequential to the undesirable failure mode.

The design concept was not successful, in that the energy absorption capability was significantly less than foreseen. This capability was to be provided by the controlled crushing of longitudinal sine-wave beams. However, due to the lack of lateral support, these beams slipped sideways, and escaped most of the compressive loading. In box type structures tested earlier, this phenomenon did not occur, which indicates the importance of the presence of rigidly connected lateral support structure to stabilize those components which are dedicated to absorb energy in a compressive mode. It is believed, that given such additional lateral support, the energy absorbing concept will work for commuter aircraft made of composite materials. However, alternative design concepts can be contemplated, possibly by developing entirely new and innovative energy absorbing frame concepts.

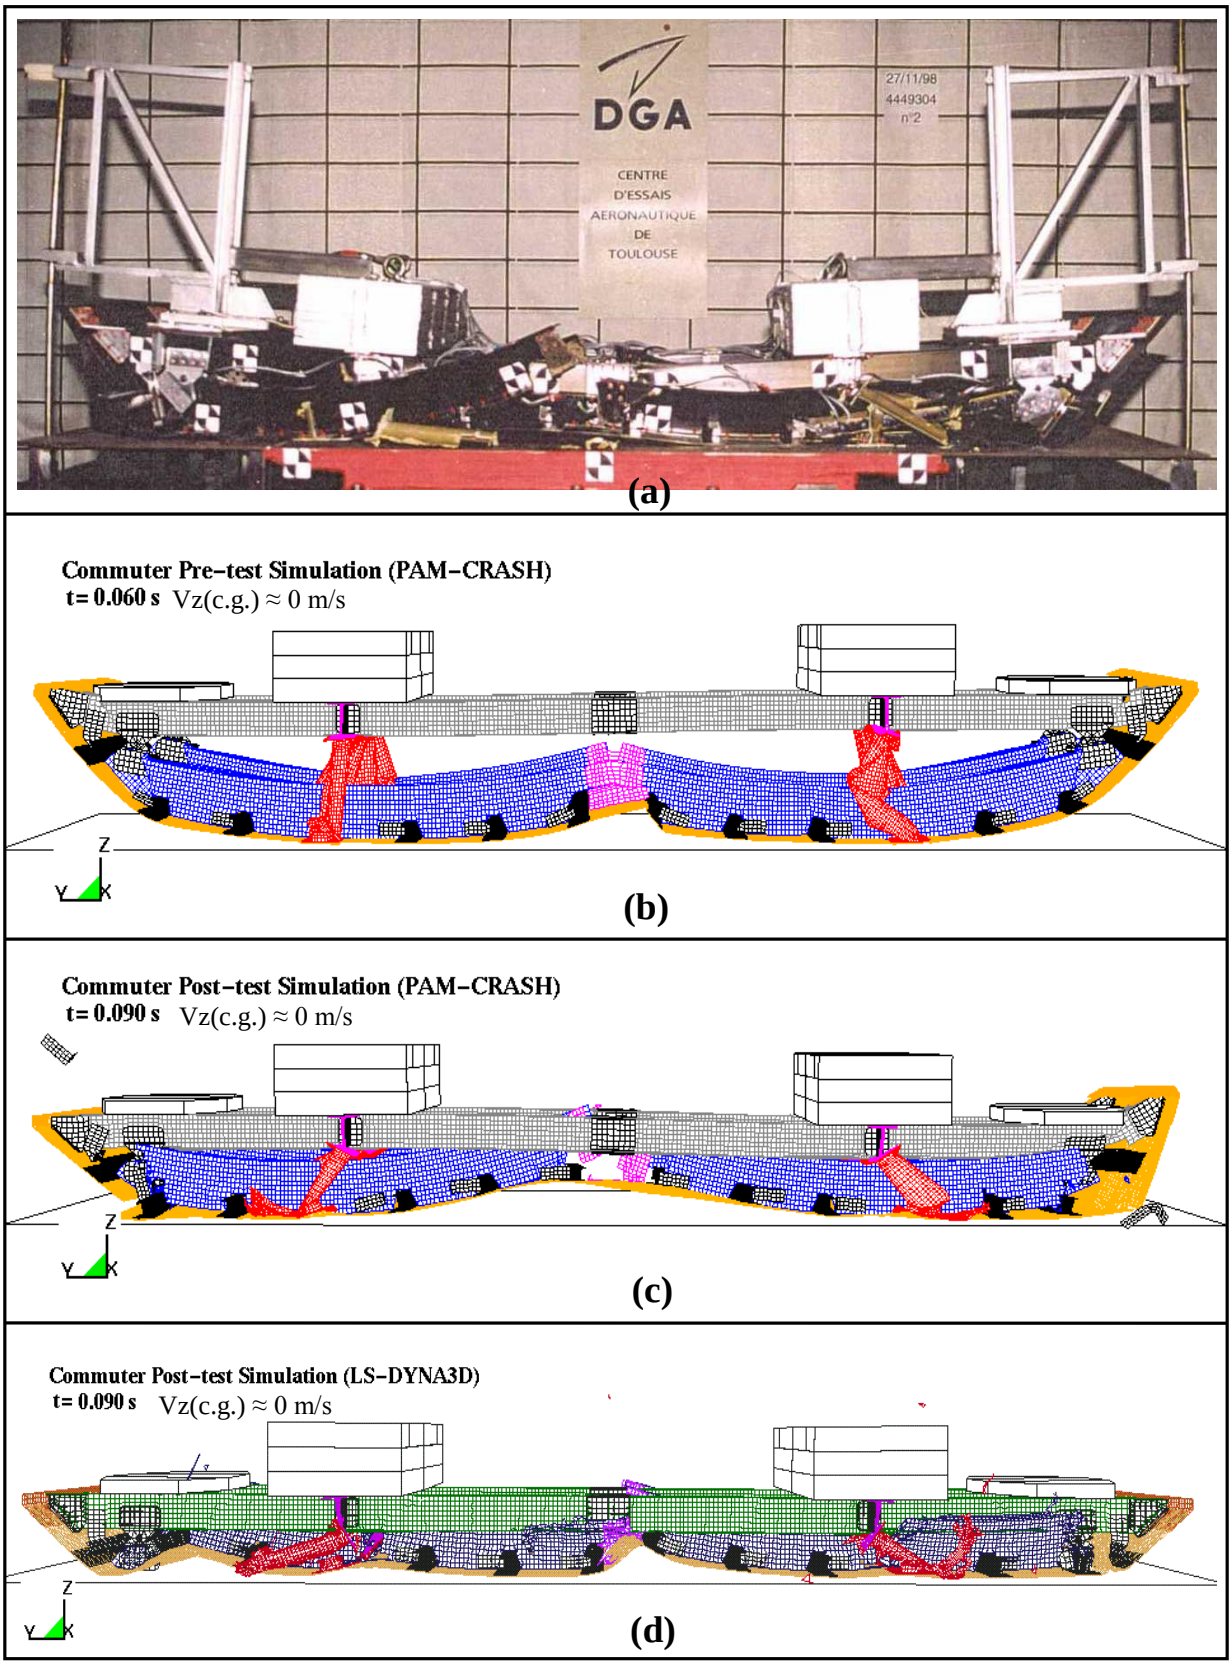
Fig. 13 Test/simulations comparisons of defomred shape at total vertical speed equal zero (CASA)

The sequence of events observed in the pre-test simulations was partially in agreement with the test results. The splice plate failure, the impact angle of the sinewave beams, and the functioning of the trigger mechanism occurred at about the same time as in the test. However, the friction coefficient between the sinewave beam and the skin was too high, which prevented the web of the sinewave beams to slide,

and the web of the seat track did not break as in the test. As a result, the pre-test simulations predicted a far too large amount of energy absorption by the sine-wave beams, compared to what was observed in the test.

For the post-test simulation with PAM-CRASH, the model was slightly modified. In order to get a more realistic failure (rupture), i.e., less ductile behaviour, the properties of the composite materials of the frames, the sine-wave beams and the seat tracks were embrittled. The ultimate failure loads of rivets and adhesive, friction coefficients and element elimination criteria (maximum strain) were decreased. In addition the actual test conditions were imposed: 7.09 m/s and a total mass of 719 kg. As a result of these modifications, the analysis predicted a collapse sequence which was well in agreement with the observed failure mode (see Figs. 13-14).
