# Air Accident Investigation Unit Ireland

## Reports 1/2007

AAIU Synoptic Report No: 2006-026

Aircraft Type and Registration:	Bell 206B, EI-BYJ
No. and Type of Engines:	1 x Allison 250
Aircraft Serial Number:	1897
Year of Manufacture:	1976
Date and Time (UTC):	13 June 2004 @ 18.15 hrs (19.15 hrs Local)
Location:	Inniskeen, Co. Monaghan
Type of Flight:	Public Transport
Persons on Board:	Crew - 1      Passengers - 4
Injuries:	Crew - None    Passengers - None
Nature of Damage:	Tail boom damage following autorotation.
Commander's Licence:	Airline Transport Pilot's Licence (Aeroplanes) & Commercial Pilot's Licence (Helicopters)
Commander's Details:	Male, aged 45 years
Commander's Flying Experience:	8,830 hours, of which 263 were on type
Information Source:	Station Manager, ATC Dublin. AAIU Field Investigation

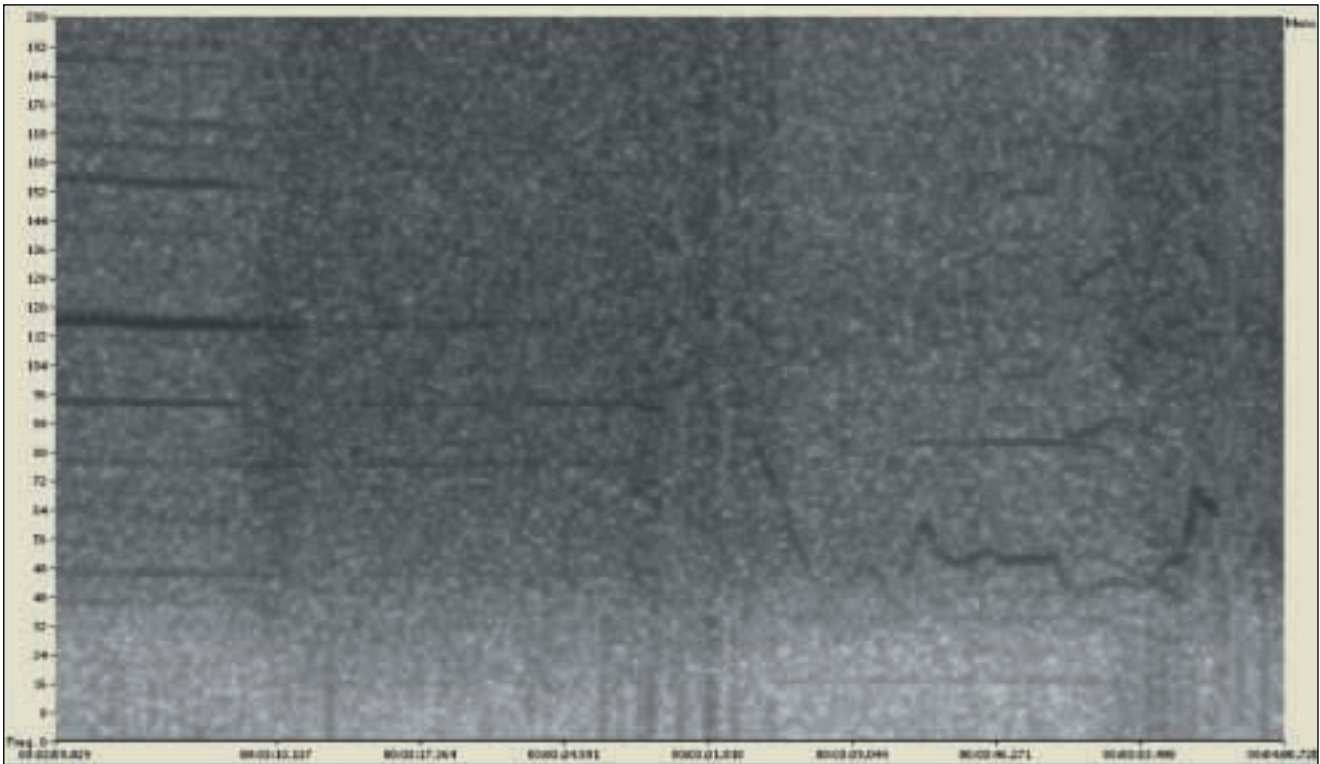
Frequency analysis of audio output from video camera onboard aircraft

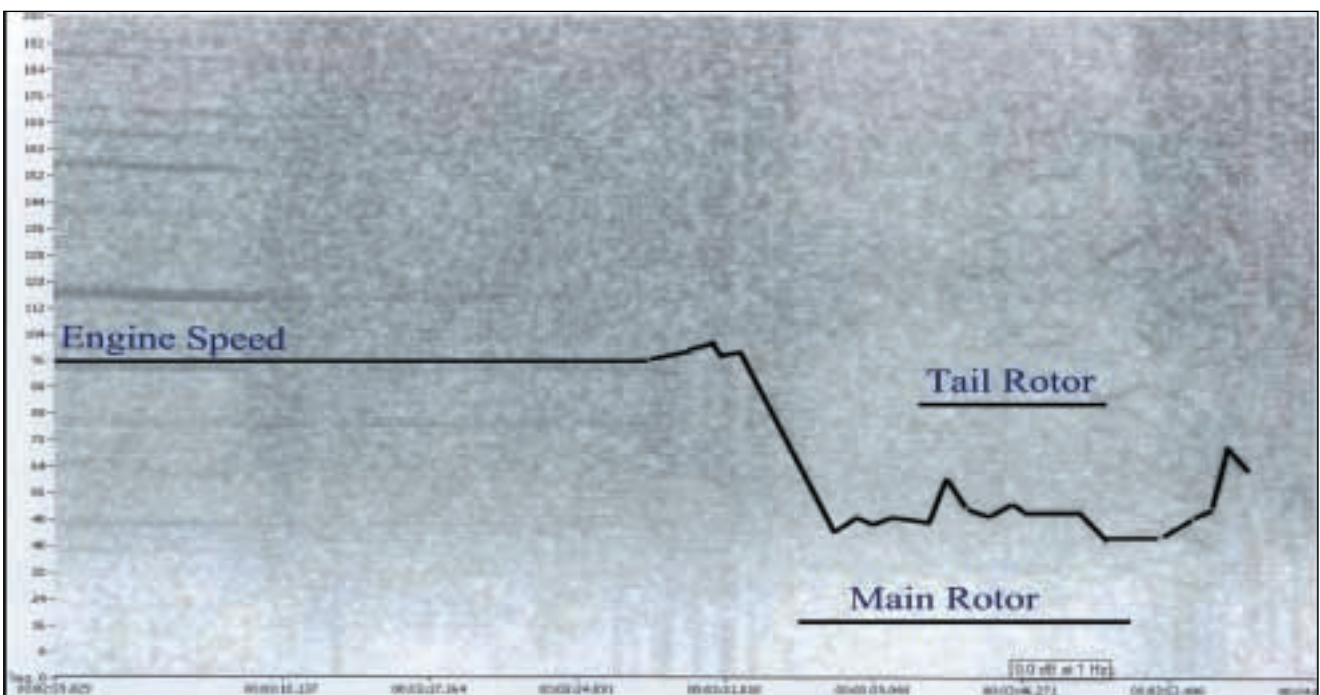
Sonogram of engine, main rotor and tail rotor speed

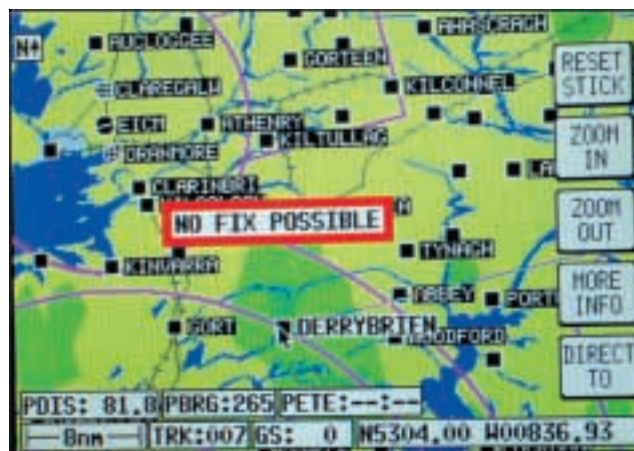
Image 1

This image was taken at an 8nm setting (ref lower left of display). This setting is probably the maximum range setting that the pilot would have used. The high ground in the general Derrybrien area is shown by the light green area surrounding Derrybrien. The summit area is shown by the darker green rectangle immediately north of Derrybrien. The accident site is approximately in the centre of this darker green rectangle. It may be noted that none of the local roads in the area are displayed. The two "rivers" shown (blue) starting near the summit area are, in fact, just mountain streams and are virtually invisible from the air in this area. The pink lines are the boundaries of Air Traffic Control areas.

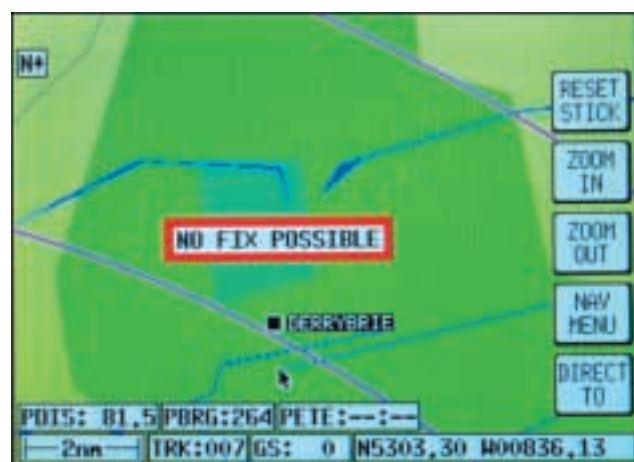
Image 2

This image again shows the Derrybrien area, but at a range setting of 2nm. This setting is probably the minimum range setting that the pilot would have used. The accident site is just above the centre of "NO FIX POSSIBLE" message. Again the lack of local terrain features in the display is noticeable.

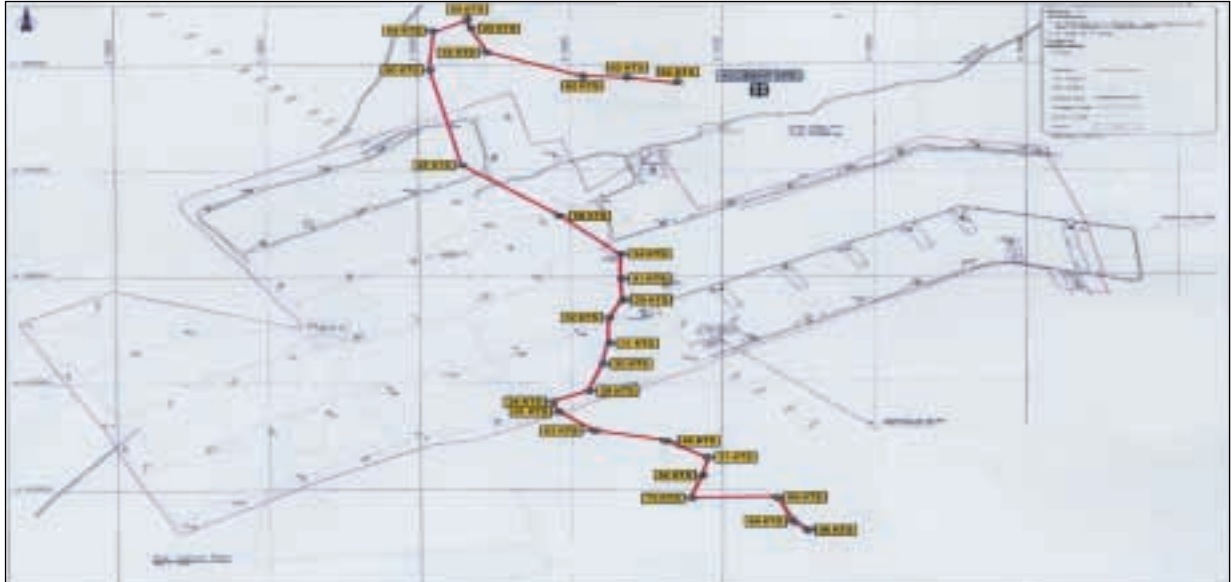
This map shows an overlay of the Shannon radar record onto a site-map of the Derrybrien Wind-Farm project, which includes the accident site. The speeds shown are the instantaneous speeds calculated by the radar at the points in question. While the shape of the plot is reasonably accurate, the plot can't be accurately geo-referenced onto the map, due to the (relatively) poor resolution of the radar. The placement of the plot was achieved by estimating the probable vertical flight path from the last recorder point (at 62 kts ground-speed) to the accident site. Between these two points the radar was unable to detect the helicopter, because it had descended below the crest of the high ground between itself and the radar transmitter. Because of the foregoing, no inference should be drawn as to the proximity of the flight path to any of the turbine towers of the Wind-Farm.

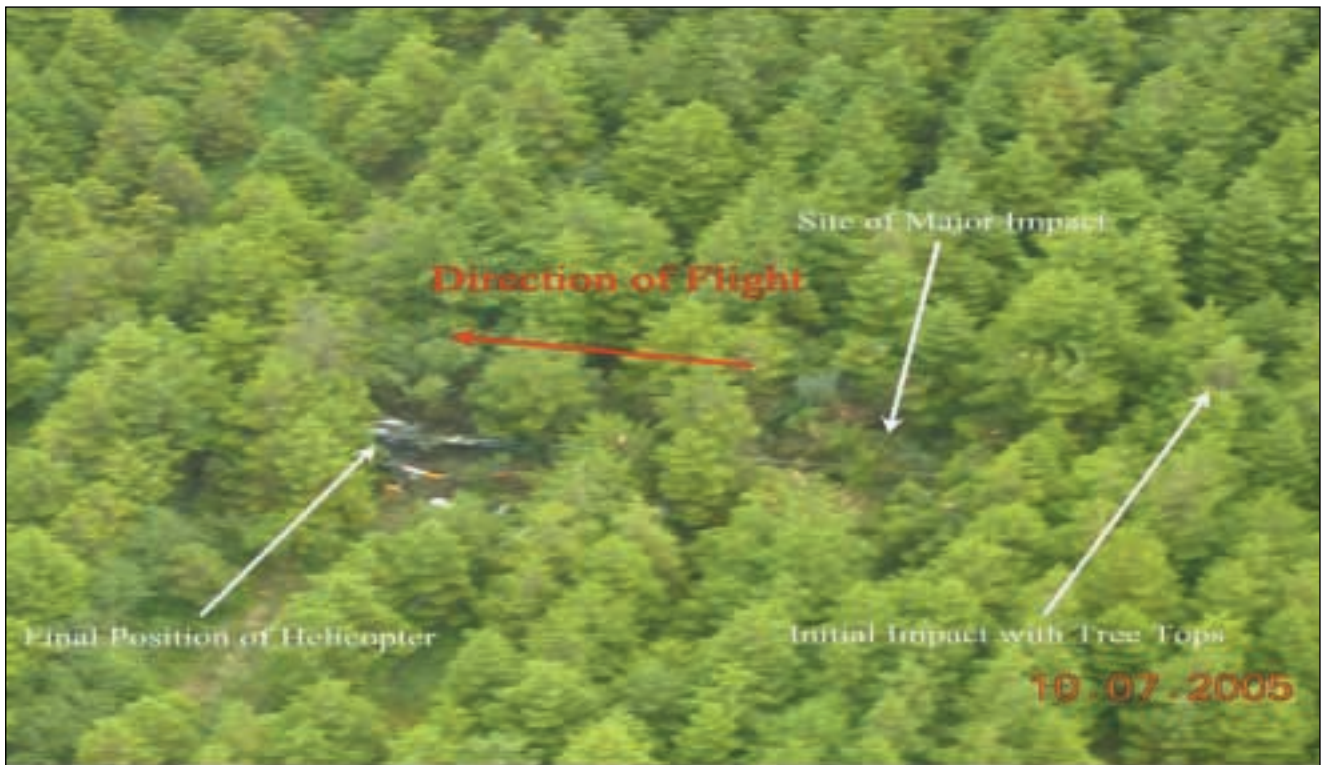
*Aerial Photo of Accident Site*

*Note: the white line streaming back from the helicopter is a survey tape being used by the Investigation.*

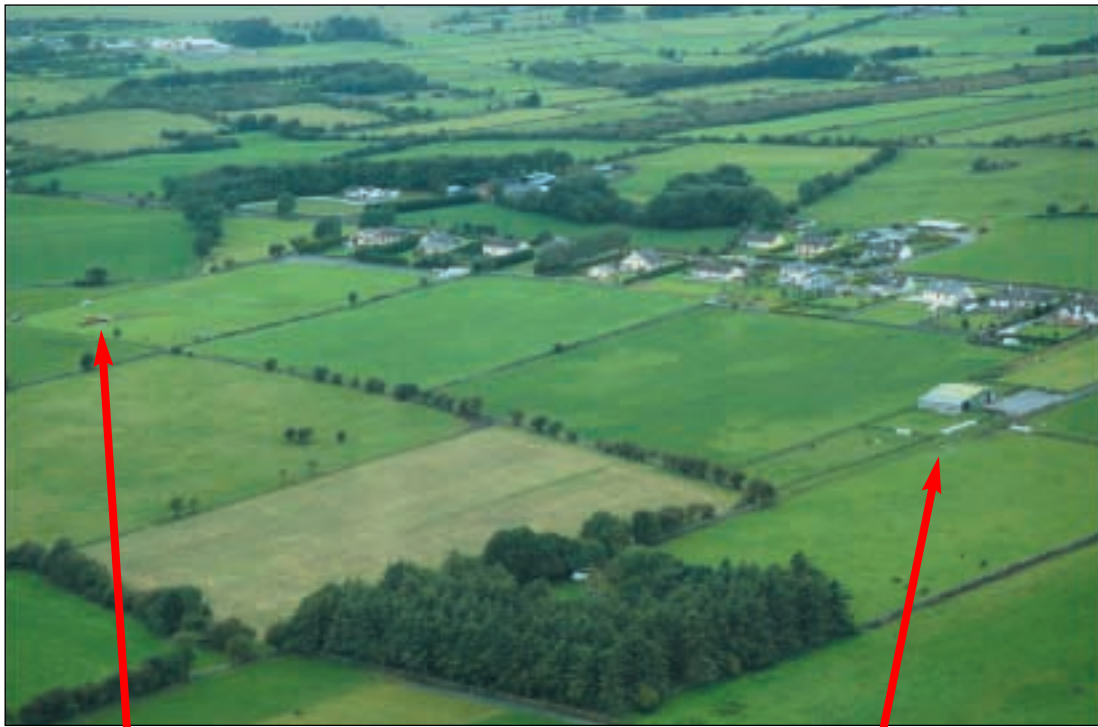
*General Aerial View Of Accident Site*

**Primary Impact Site**

**Secondary Site:  
Where wing section was  
located.**

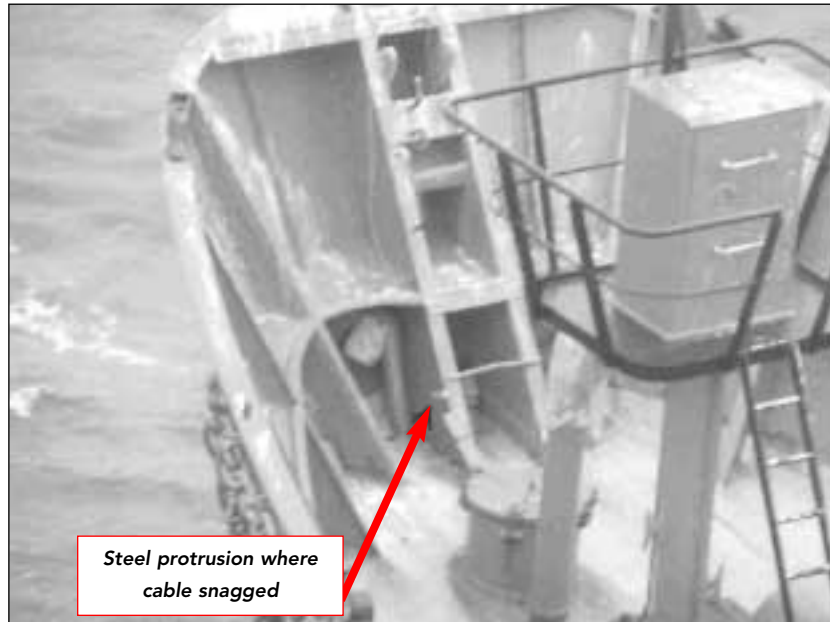
Photo No. 1

The Winchman was lowered to the deck and landed facing the foot of a steel ladder in the very bow of the ship where the sides are raised to provide a sheltered deck. The vessel was rising on a 2-metre swell and, as the Winchman attempted to release from the hoist hook, he was thrown off balance by the falling bow. To steady himself, the Winchman had to grasp the ladder with one hand, while at the same time trying to release from the hoist hook. During this process, a coil of cable looped around a small steel protrusion welded to the side of the ladder (**Photo No 1**).

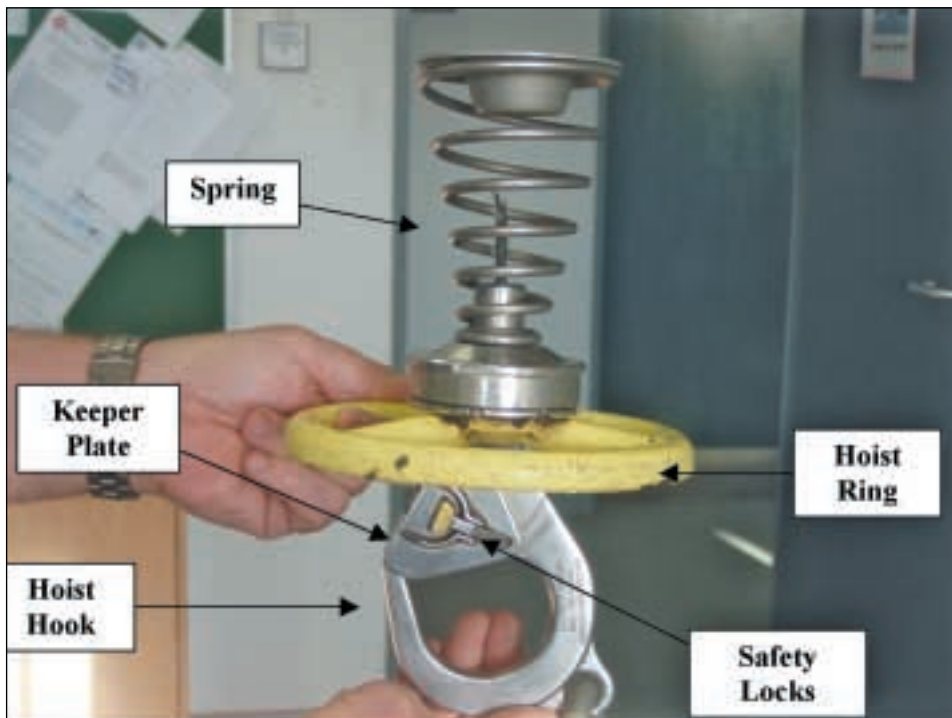
Photograph No 4 - Hoist Hook Assembly

The winch hook is made up of a stainless steel hook, a keeper plate with safety locks on either side, a hoist ring, and an end of travel hoist spring/weight (**Photo No. 4**).

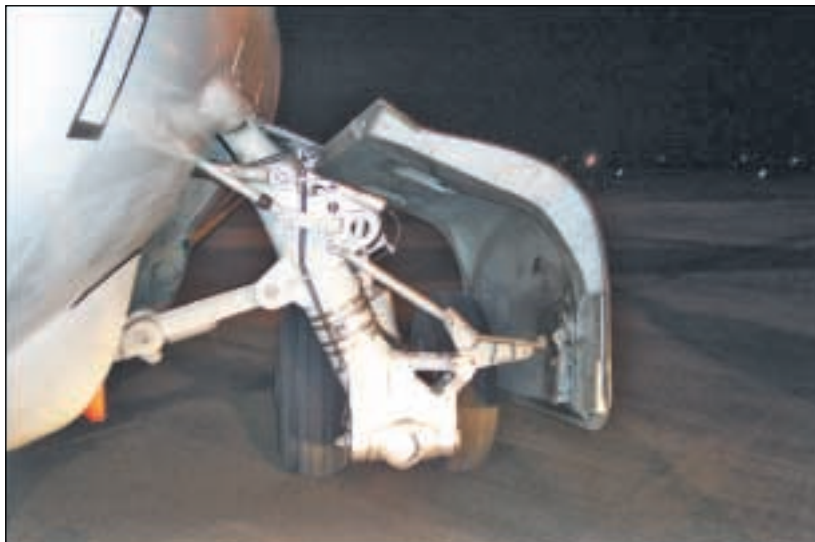
*Photo No. 3: General view of the LH undercarriage and door.*
