08/31/88 Delta

Official Accident Report Index Page

Report Number	NTSB/AAR-89/04
Access Number	PB89-910406
Report Title	Delta Air Lines, Inc. Boeing 727-232, N473DA, Dallas-Fort Worth International Airport, Texas August 31, 1988
Report Date	September 26, 1989
Organization Name	National Transportation Safety Board Bureau of Accident Investigation Washington, D.C. 20594
WUN	4965A
Sponsor Name	NATIONAL TRANSPORTATION SAFETY BOARD Washington, D.C. 20594
Report Type	Highway Accident Report August 17, 1988
Distribution Status	This document is available to the public through the National Technical Information Service, Springfield, Virginia 22161
Report Class	UNCLASSIFIED
Pg Class	UNCLASSIFIED
Pages	135
Abstract	This report examines the crash of Delta flight 1141 while taking off at the Dallas-Forth Worth, Texas on August 31, 1988. The safety issues discussed in the report include flightcrew procedures; wake vortices; engine performance; airplane flaps and slats; takeoff warning system; cockpit discipline; aircraft rescue and firefighting; emergency evacuation; and survival factors. Recommendations addressing these issues were made to the Federal Aviation Administration, the American Asso

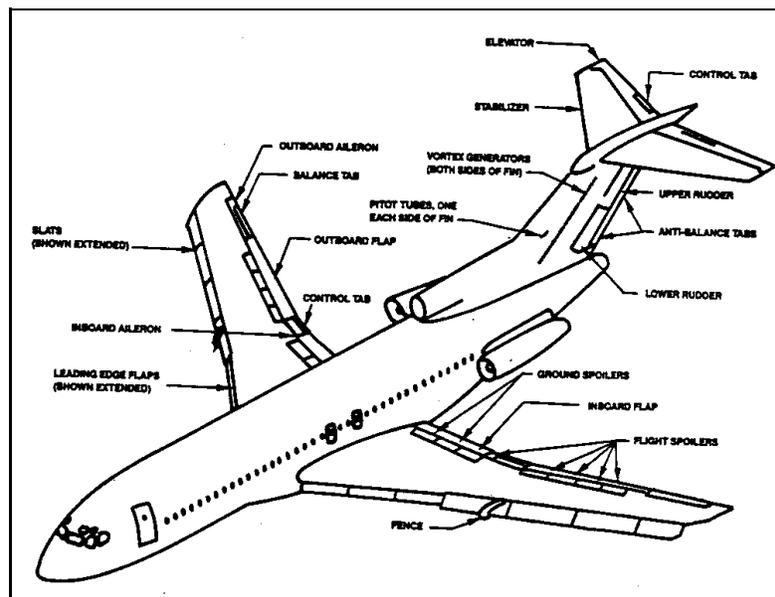
Figure 3.--Boeing 727 flight control surfaces.

Lift devices of the Boeing 727-232, consist of three leading edge flaps (Krueger flaps) located on the inboard lower surface of each wing, four leading edge slats on the outboard portion of the wing, and inboard and outboard trailing edge flaps (see figure 3). The trailing edge flaps are driven by two completely independent systems. Each drive system normally is hydraulically powered; electrical power is available for alternate operation. Each trailing edge flap is actuated by two flap transmission assemblies. The transmission assemblies on the outboard flaps are connected through torque tubes and gearboxes to a hydraulic motor which is the primary driving source. Another separate set of torque tubes and gearboxes interconnect the transmission assemblies on the two inboard flaps. This system is driven by a single hydraulic motor. Power to the motors is controlled by two differential control valves with feedback modulation from the power transmitting torque tubes.

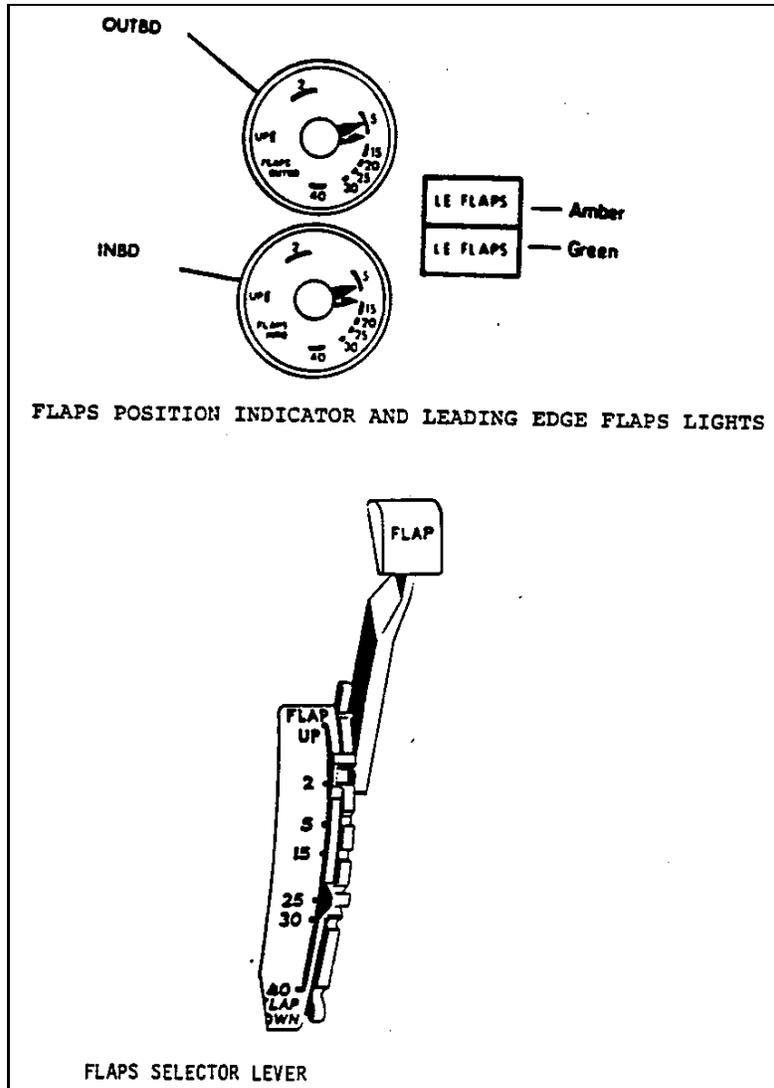
Figure 4.--Boeing 727 flap position indicator and flap selector lever.

past 2°. An amber light on the center instrument panel illuminates when the slats are in transit. A green light illuminates when the slats are extended. (See figure 4.)

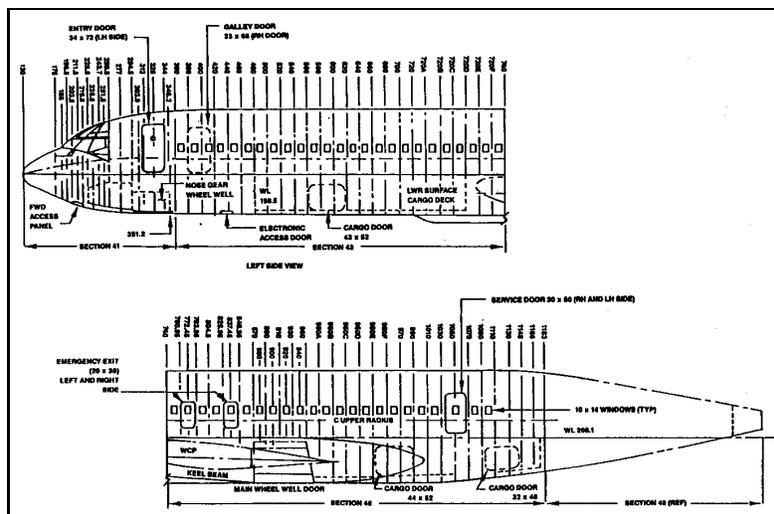
Figure 6.--Fuselage station diagram.

Fuselage and Empennage.--The fuselage had separated into three major sections: (1) the forward section consisted of the nose forward of fuselage station (FS)-420 (see figure 6); (2) the center fuselage section included the body structure between FS-420 and FS-950c; and (3) the aft fuselage section extended from FS-950c aft to the end of the No. 2 engine tailpipe.

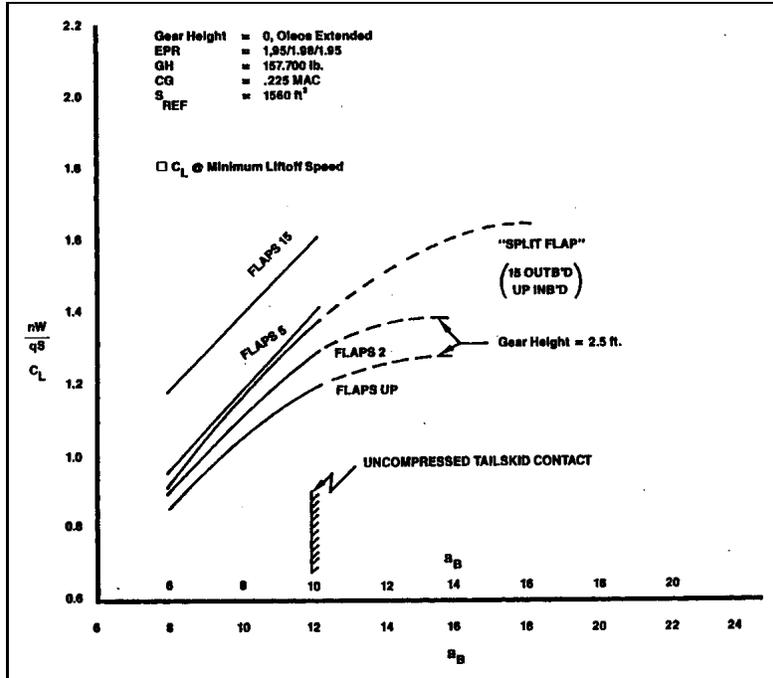
Figure 10.--Boeing 727 city curves, in ground effect zero altitude.

Boeing's calculations and wind tunnel testing of the lift available with the outboard flaps at 15° and the inboard flaps up, i.e. "split flaps," indicated that the stall warning is at 11° and stall AOA is 18.5°. For "split flaps," the available lift would be slightly less than with a normal flap setting of 5°. The stall AOA for "split flaps" is about 9° higher than the stall AOA for flaps at 15° or 5°. (See [figure 10](#) and [figure 11](#).) The "split flaps" scenario will be discussed later in this report.
