**Accident Investigation Board of Finland
Annual Report 2004**

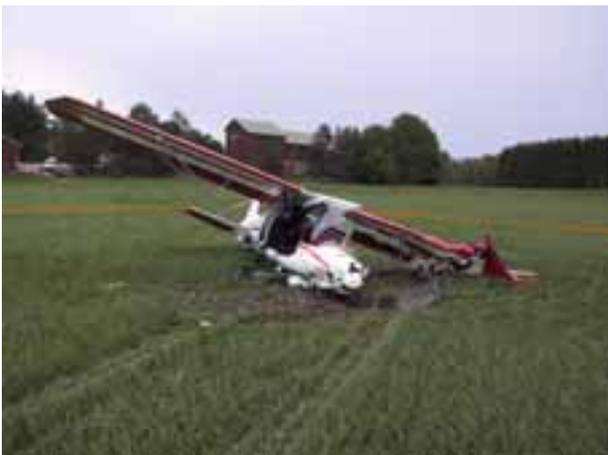
C 7/2003 L

**Ultra-light aircraft accident in Kirkkonummi
on 11 June, 2003**

The investigators found out that the conditions were against a successful take off. The take off direction was uphill and with tailwind, the aircraft was overweight, the field was uneven when compared to the aircraft wheel size, the pilot used full trailing edge flap setting and the engine was likely not producing maximum power due to an earlier impact damage. The cause of the accident was the decision of the pilot to begin the take off from the field under the unfavourable conditions.

The investigators recommended that the Flight Safety Authority would pay attention to the safety belt mounting of the aircraft. The investigators also recommended that the Flight Safety Authority would require all ultralight flight manuals to contain the measured air speed calibration tables.

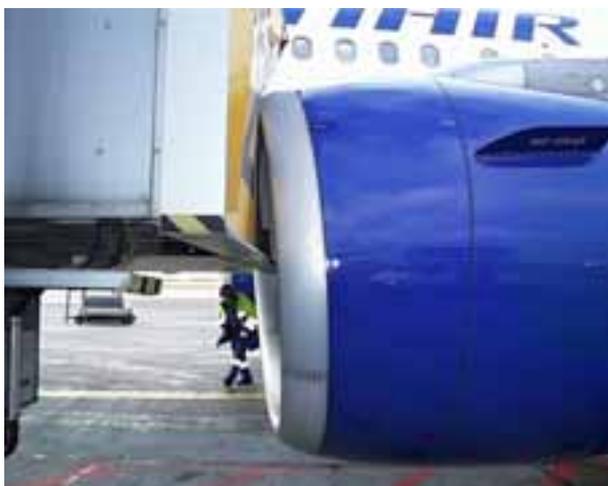
C 10/2003 L

**Taxiing incident at Helsinki-Vantaa airport
on 6 December, 2003**

The passenger bridge had extended to its maximum length, beyond the correct holding position, because of a malfunction in the automatic control system. Contributing factors to the incident were: 1) Double standards had developed in the passenger bridge operation, as well as for handling any faults and malfunctions with the passenger bridges. One procedure was in accordance with official training, and another was an established practice in daily operations. 2) There were shortcomings in the bridge operators' training, operating instructions, and in the monitoring of faults and malfunctions. 3) The marshallers, who carried out malfunction analyses and made decisions about taking a passenger bridge back into service after a malfunction, had insufficient training for handling these malfunctions and identifying any safety risks. 4) The responsible organisations had not audited the operating procedures, instructions and practices for bridge 24. 5) The persons in charge had differing views about the technical characteristics and driving practices of bridge 24.

The investigation commission gave the following safety recommendations: 1) CAA Finland should develop an indicator system for monitoring the position of passenger bridges, based on the APIS system. 2) CAA Finland should examine any prospects for improving technical reliability of the passenger bridge drive system, so that position detection would remain under control despite any fault or malfunction. 3) Helsinki-Vantaa airport should update the operating instructions for bridge 24 and make them constantly available to personnel. Moreover, bridge operators should be provided with a checklist for quick revision of the driving procedures, including safety instructions for the gate in question. 4) Helsinki-Vantaa airport should develop a procedure for collecting any technical failures and operational problems of passenger bridges into a follow-up file, and analysing them at regular intervals. Bridge operations should also be included in internal auditing. 5) Helsinki-Vantaa airport should provide sufficient training for technical support personnel on managing any malfunctions of passenger bridges. 6) Finnair Ltd. should ensure that gate officials are assigned to bridge 24 driving duty in good time.

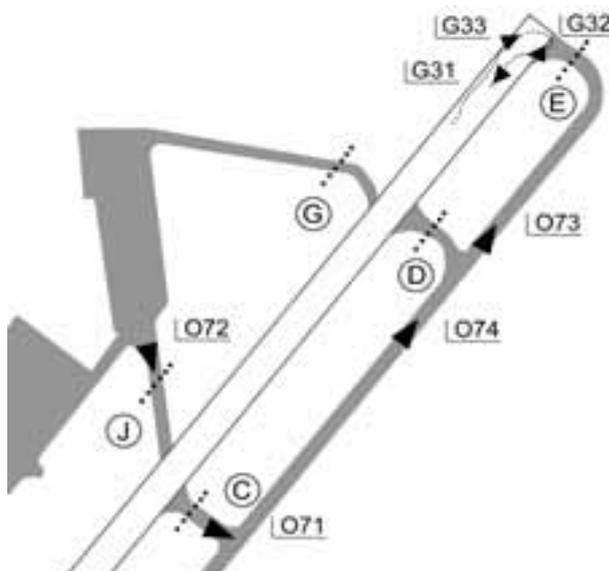
C 1/2004 L

Aircraft incident between a training fighter taking off and a taxiing over the runway at Rovaniemi airport on 14 January, 2004

It was slowly snowing at Rovaniemi airport at the time of incident. The sun had set at 14.26 o'clock and there was low cloud. It was dusk and instrument meteorological conditions prevailed. Military aircraft used the whole runway length for take off because the runway was slippery. The tower controller had cleared a Hawk formation G31 (three aircraft) to taxi from holding position Golf via runway 03 to line up runway 21. At the same time O71 (two F-18) were cleared to taxi to holding position Juliet and over runway 21 to holding position Echo. The controller assumed G31 would be ready for take off when the first F-18 had crossed the runway and he ordered the second F-18 to hold at Juliet. After this G31 was cleared for take off. They took off one by one. The controller followed that O72 stops at the holding position Juliet. At the same time he gave route clearances to the aircraft departing next and control zone traffic information to the radar controller. The controller did not count the number of Hawks taking off but instead followed them "from the corner of his eye". He looked at the runway to see if all the Hawks had taken off. The runway seemed to be empty and accordingly the controller gave O72 clearance to taxi across the runway. When O72 was taxiing across the runway, the third Hawk G33 was starting its take off roll. The pilot of G33 noticed the F-18 taxiing in front of him and aborted the take off. The controller simultaneously noticed the situation and ordered G33 to stop. Also the pilot of O72 noticed the approaching Hawk and accelerated taxiing to hurry over the runway. The filament of the taxi/approach light of last Hawk, G33, had been burned which impaired its visibility under the prevailing conditions.

The investigators found out that the controller knew there were three aircraft in the formation G31 taking off one by one at approximately 20 seconds intervals. As the formation took off the controller did not count the number of aircraft taking off and did not sufficiently secure that the runway was free before giving O72 clearance to taxi across the runway. The last Hawk G33 of the formation had problems to steer to the take off heading due to the slippery runway, and thus its take off

roll began approximately 25 later than normally. The pilot did not report to tower his delay for take off. Also, it did not have an operating taxi/approach light and it was thus nearly impossible to obtain visual contact to it from the control tower under the prevailing conditions.

The cause of the incident was the controller giving O72 the clearance to taxi across the runway without securing that all Hawks had already taken off. Contributing factors were, that the visual limitation to see with eyesight only a dark aircraft against a dark background, especially without an operating taxi/approach light and that the pilot did not inform tower that he will be late for take off.

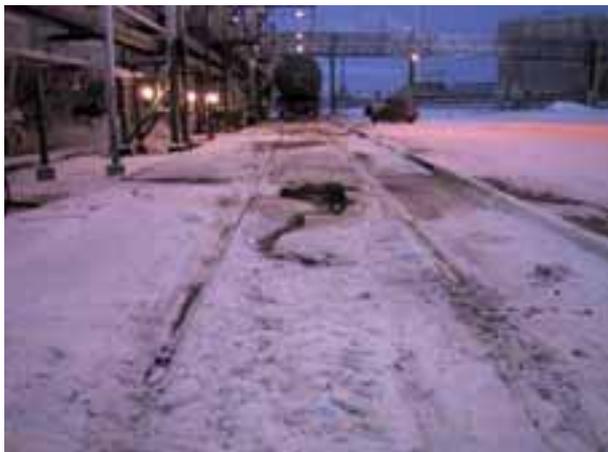
C 1/2003 R

Three tank wagons derailling at Hamina port on 3 January, 2003

On January 3, 2003 at 19.15 hours, three empty Russian tank wagons derailed at Hamina port, Finland, immediately upon leaving their unloading site. The wagons were designed for carrying of heavy fuel oil. The incident caused no damage to the track or the rolling stock.

In fact steaming had been operated on the unloading site, and the resulting condensation water had frozen on the channel rail construction so as to cover the rail channels and hence cause the wagon to derail.

In order to prevent corresponding incidents in the future, the Accident Investigation Board of Finland recommends that no channel rail structures be adopted in tracks on unloading sites where steaming is implemented in the unloading operations.

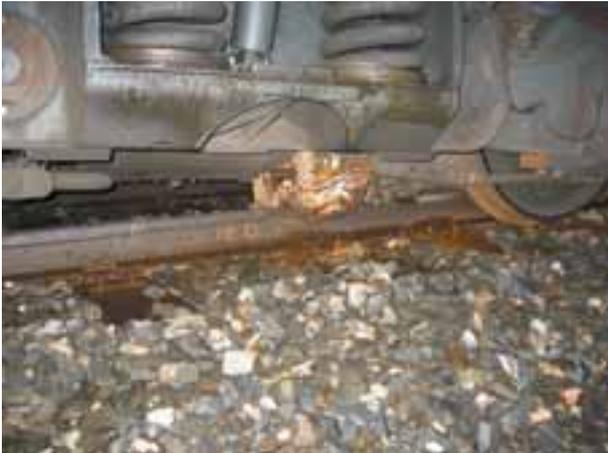
C 3/2003 R

Wheelset of freight train locomotive, derailling at Koskenkorva station on 30 March, 2003

On Sunday March 30, 2003, at 17.15 hrs, the rear wheelset of the locomotive of a freight train derailed at Koskenkorva station when the train ran into a log of birch wood lying lengthwise between the tracks. As a result of the incident, the Dv12 dieselhydraulic locomotive in question, two wooden decks of level-crossing, and track and safety installations and track equipment over about 170 meters were damaged. No personal injury was generated by the incident. The resulting total costs amounted to about € 7,900.

The direct cause of the incident was the locomotive bumping into the birch-wood log lying between the tracks. As a factor contributing to the generation of the incident, the engine driver failed to brake though he perceived the log well before the bumping into it. He did not even brake when the log hit the locomotive.

In order to prevent corresponding incidents in the future, the Accident Investigation Board of Finland recommends that the person responsible for the checking of the travel condition of the train, pay more attention to an appropriate loading of the train and whenever necessary, tie the load, before giving the train a departure permission.

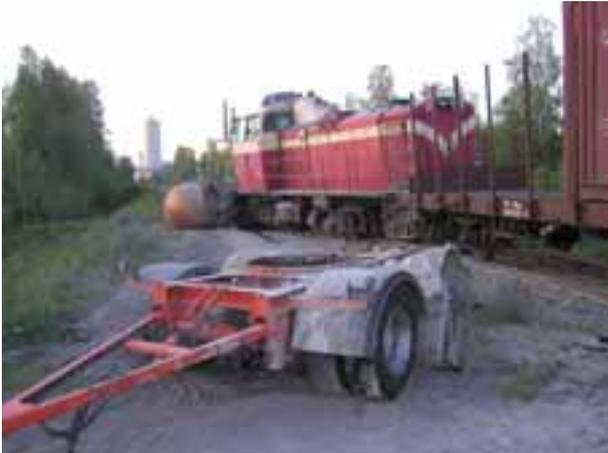
C 6/2003 R

Shunting unit and vehicle combination carrying a cement load colliding in Lappeenranta on 1 July, 2003

On Tuesday July 1st, 2003, an accident took place in Lappeenranta, Finland, when a shunting unit collided with a vehicle combination travelling on a level crossing. In the accident four persons were slightly injured. The locomotive of the shunting unit derailed. As a result of the accident, the trailer of the vehicle combination, a Dv12 dieselhydraulic locomotive and safety installations in the track were damaged. Moreover, the rubber deck of the level crossing suffered some damage. The resulting total cost amounted to about € 150 300.

The accident was caused by the vehicle combination having insufficient time at its disposal for passing the level crossing before the arrival of the shunting unit at the crossing. The visual clearance at the level crossing does not always ensure its safe crossing. As a contributory factor to the accident, within the level crossing area the attention of the driver of the vehicle combination was partly focussed on his mobile phone.

With consideration of the accident, the Accident Investigation Board of Finland recommends that the level crossing referred to be equipped with warning devices. The Accident Investigation Board moreover recommends that such level crossings without safety installations, featuring a poor visual clearance that cannot ensure vehicle combinations a safe crossing, be equipped with a driving prohibition sign applicable to regular vehicle combination traffic.

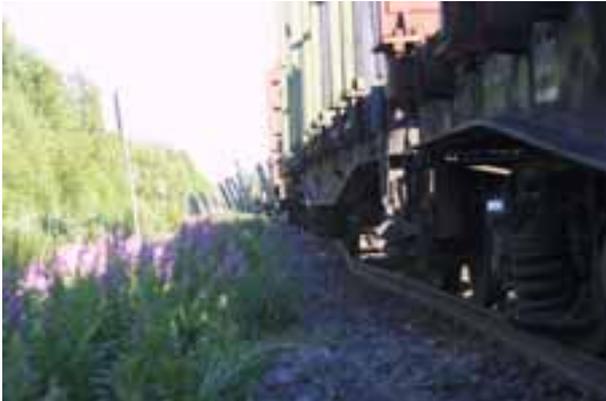
C 7/2003 R

Fourteen Russian freight cars derailling on the section between Hammaslahti and Tikkala on 16 July, 2003

On Wednesday July 16, 2003 at 15.48 hours, a train accident took place on the section between Hammaslahti and Tikkala in Finland: 14 freight cars of a train travelling from Uimaharju toward Niirala derailed. The derailed cars were in the middle of the train, the first one being the 24th car from the locomotive. At the time of the incident the train was running at a speed of 73km/h. No personal injury was generated in the incident, but thirteen Russian timber-carrying cars were damaged as well as ten electric-railway poles and about 400 meters of track. Moreover at the site of the incident, the wooden planking of a level crossing with a farm road was entirely destroyed.

The immediate cause of the incident included the important stress generated in the track as a result of hot weather conditions, and the subsequent heat curve. The relevant incident investigation conducted was unable to specify a particular technical cause for the incapacity of the track structures to endure the generated stress. Actually the relatively advanced age of the track between Hammaslahti and Tikkala and its partly poor condition undoubtedly contributed to the discharging of the stress so as to form a heat curve. The track runs on soft marshland, and its maintenance has therefore proven to be particularly difficult. In this specific case, some railway officials detected the transition that had preceded the heat curve. Unfortunately in spite of the efforts of the engine drivers and the remote control operators, no adequate measures were engaged so as to prevent the incident.

Consequently the Accident Investigation Board of Finland recommends that in view of a prevention of such incidents, the condition of the section between Hammaslahti and Tikkala be improved by implementation of its overall reconstruction or by an adoption and realization of a new track lay-out. In addition, certain improvements in the drawing up of notices of railway technical defects are also recommended to be adopted.

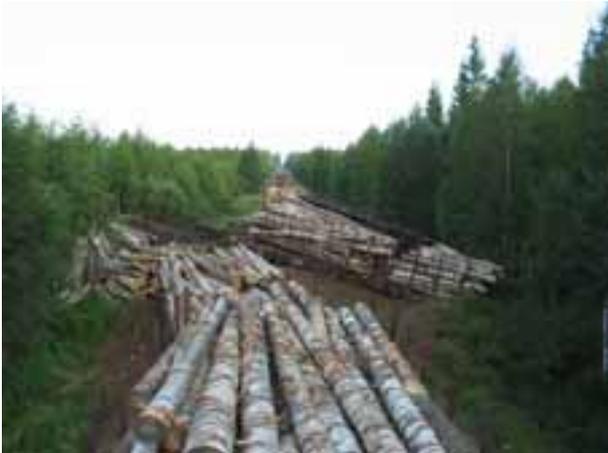
C 9/2003 R

Nine loaded timber-carrying wagons derailed at Rantasalmi on 31 July, 2003

On Thursday July 31, 2003, an incident took place at Rantasalmi where nine wagons of a freight train derailed. In the incident, the nine derailed wagons were damaged as well as about 200 m of track.

The direct cause of the wagon derailment incident was a heat curve having been generated in the track. The heat curve again was a result of the high temperature of the track combined with the poor condition of the rail fastenings and the sleeper bed, as well as the dislocation of rail joints. In addition, the sleeper replacement work in the track and the on-going tamping operations contributed to the vulnerability of the track.

In order to prevent corresponding incidents in the future, the Accident Investigation Board of Finland reiterates its recommendation S181 issued as a result of an accident having taken place at Huutokoski, Finland, on May 31, 2002. The track should immediately be repaired and the defective old sleepers be replaced by new ones. Replacement of spike fastening by screw fastening, replacement of the rails by heavier ones, and replacement of the gravel in the railway bed by ballast should be discussed and considered.

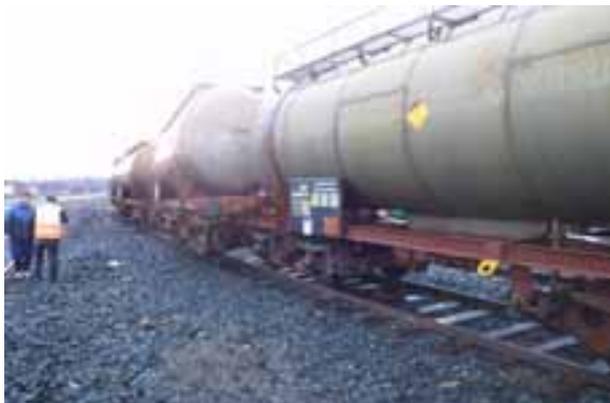
C 10/2003 R

Shunting unit colliding with wagons designed for the transport of dangerous goods on Kemi railway yard on 14 November, 2003

On Friday November 14, 2003 on Kemi railway yard, an incident took place where three empty sodium chlorate wagons and seven loaded cellulose carrying wagons pushed by a shunting locomotive, bumped into loaded sodium chlorate wagons that were at stand-still on the track. As a result of the incident, three wagons derailed. The damage generated by the collision corresponded to about €17,000.

The incident was caused by the shunting foreman having by error mixed up the tracks. In fact he had requested the shunting operator to move the wagons to track 17 while he himself nevertheless was standing between track 14 and track 15, waiting for the wagons to arrive on track 16.

To prevent corresponding incidents in the future, the Accident Investigation Board of Finland recommends that shunting staffs be ensured relevant training whenever changes or modifications have been realized in the railway yard and that the railway yard tracks be equipped with number plates.

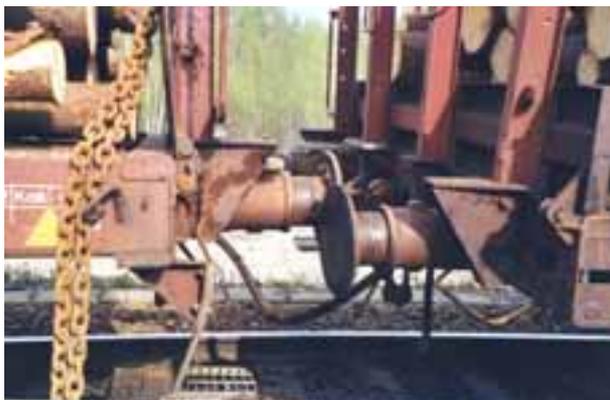
C 3/2004 R

Freight train car derailling at Joensuu on 8 May, 2004

In the section of the track where the heat curve had generated, there was sleeper replacement work going on. In fact the track had been temporarily opened for traffic the previous day, with the intention of packing the track by using a tamping machine on Monday. At the date of the incident the outdoor temperature rose to +26°C.

To prevent corresponding incidents in the future, the Accident Investigation Board of Finland recommends that in all work site plans, condition limits be specified for unfinished track work sites that are temporarily opened for traffic. The condition limits would unambiguously define the circumstances where the condition of the track no longer permits its utilization as due to a risk of generation of a heat curve or as due to other changes in the track condition.

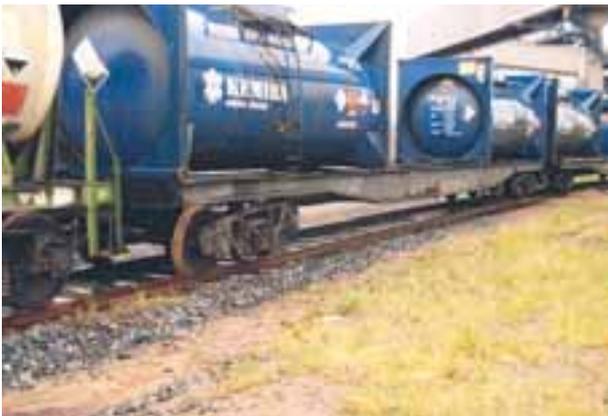
C 6/2004 R

Two Russian container wagons loaded with sulphur dioxide carrying containers derailed at Harjavalta on 7 June, 2004

The derailment was caused by the poor condition of the track. Important lateral pegs, that is, rail joint wear had been generated in the steep curve. Moreover, the insufficient tamping of the track and the probably non-bent rails used in the curve contributed to its poor condition.

In order to prevent corresponding incidents in the future, the Accident Investigation Board of Finland recommends that the company responsible for the maintenance of the track in question draw up a maintenance plan for the railway lay-out specifying the regular maintenance operations to be implemented for the railway lay-out.

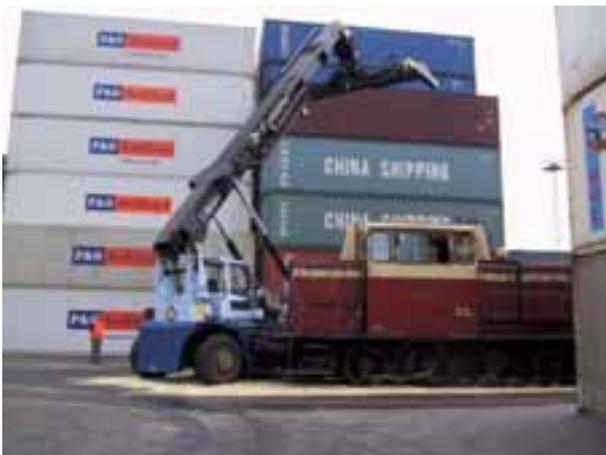
C 8/2004 R

Shunting unit and reach truck colliding in Helsinki West Port on 29 June, 2004

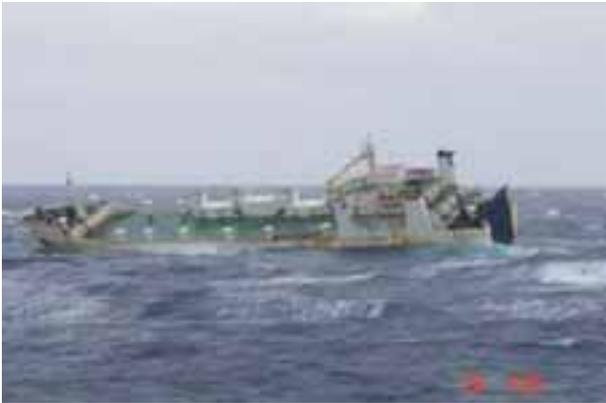
B 1/2003 M

ms CAMILLA, serious incident in North Atlantic on 23 January, 2003

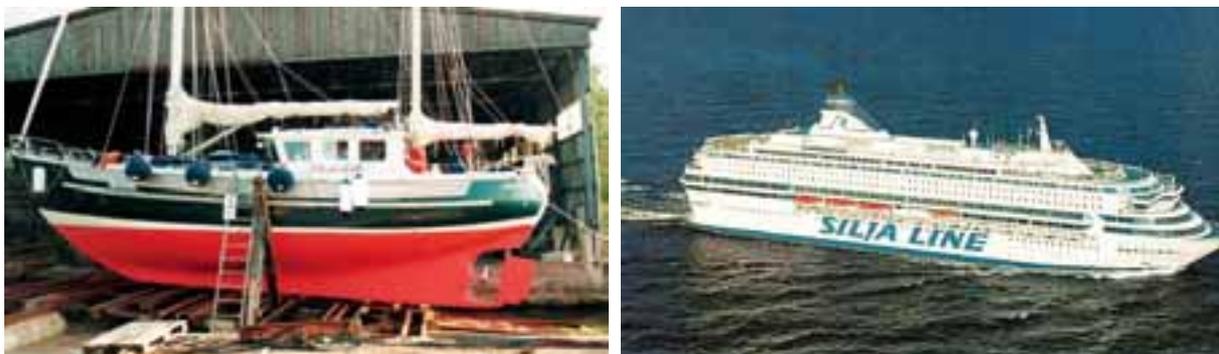
C 7/1997 M

ms SILJA EUROPA—sailing yacht FLANÖR, collision in Åland archipelago on 20 August, 1997

Finnish passenger-car ferry ms SILJA EUROPA and German sailing yacht FLANÖR collided on 20.8.1997 at about 14.15 close to the fairway edge mark Rågrund in Åland archipelago. There was dense fog at the time of collision, visibility being about 200 meters.

The starboard side of the FLANÖR was damaged and she started to leak. The crew of the FLANÖR sent MAYDAY message, shot emergency rockets, launched the liferaft, and started to pump out the water. SILJA EUROPA stopped immediately and launched her MOB boat. This MOB boat was the first to arrive alongside FLANÖR in six minutes. The Frontier Guards's helicopter and its boat were alerted and several other ships reported themselves to the rescue operation. Alerted rescue units arrived to the scene within 13 minutes.

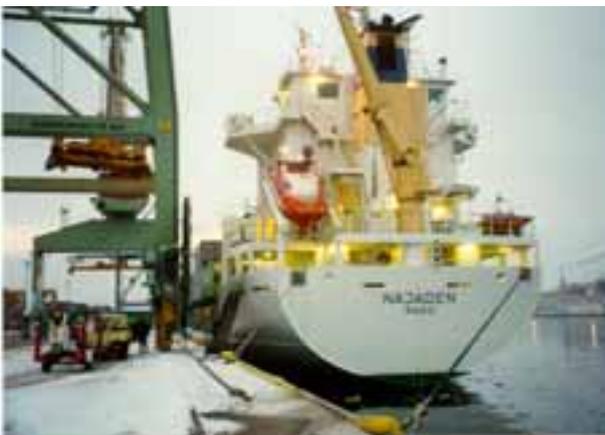
C 8/1997 M

ms NAJADEN, grounding off Estonian coast on 12 July, 1997

In summer 1997, bound from Kotka, Finland for Hamburg, Germany a Finnish Feeder-class cargo vessel grounded on 12.7.1997 off Estonian coast. The officer on watch had fallen asleep soon after he took the watch. He had not altered the course to follow the traffic separation but the vessel carried on across the Gulf of Finland over three hours until she grounded. The bottom of the vessel was damaged. Those onboard were not hurt and no environmental harm was caused.

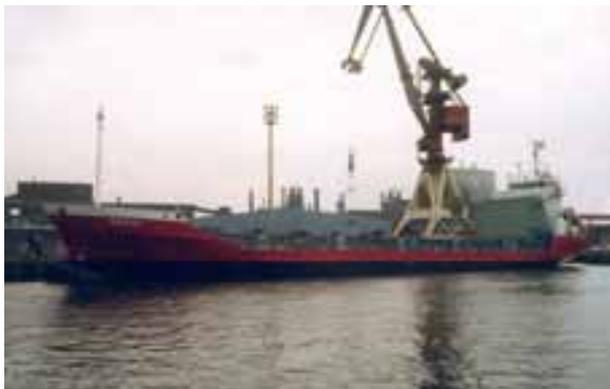
C 8a/1997 M

The Finnish feeder-class cargo ship SOFIA deviated off her planned track to low water area some 3 miles NW off Hälsingborg. The mate acting as the officer on watch was alone on the bridge and he had fallen asleep just before the narrow sound between Hälsingborg and Elsinore. The ship got stuck to the bottom but no damage occurred to her bottom plating. After unloading the cargo the ship was taken off to deeper water and loaded her cargo again and then sailed according the original plan to England. No environmental damage was caused.

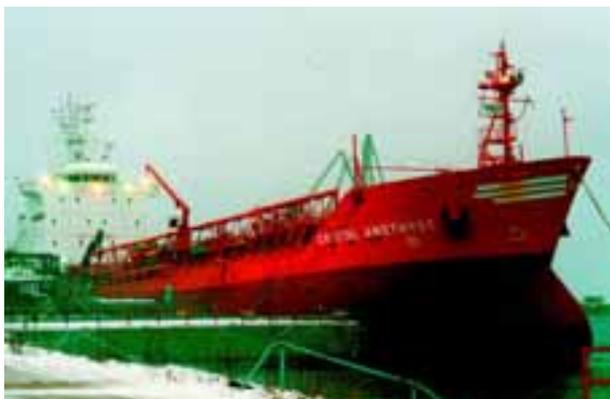
C 16/1997 M

mt CRYSTAL AMETHYST, grounding off Mussalo Harbour in Kotka on 1 December, 1997

Master concentrated on steering and adjusting the propeller pitch. The pilot gave steering commands using rudder angles. Pilot's reference of position was a green buoy, which he assumed to be the northerly one of two buoys. The chief mate came on the bridge at 18:09 and took the helm. At 18:10 CRYSTAL AMETHYST ran aground at Matinmatala. The pilot's reference of position had been the buoy in north westerly direction instead of the assumed one in northerly direction.

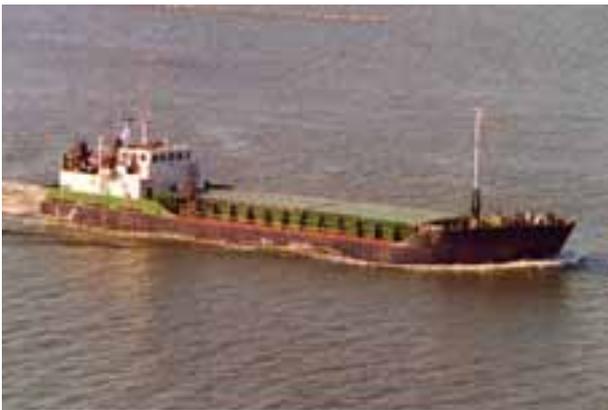
C 7/1998 M

Motor vessel PAMELA, grounding in the Finnish archipelago on 3 August, 1998

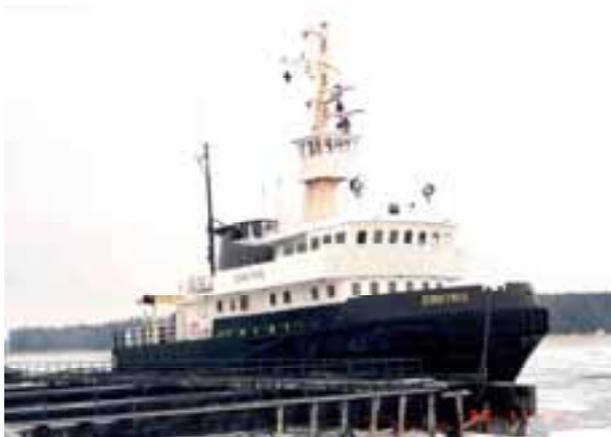
Finnish motor vessel PAMELA ran aground in Stångskär en route from Korppoo to Olkiluoto on 3.8.1998. The master was acting as the officer on watch as he fell asleep. The vessel got damages to her bottom plating. No environmental harm occurred.

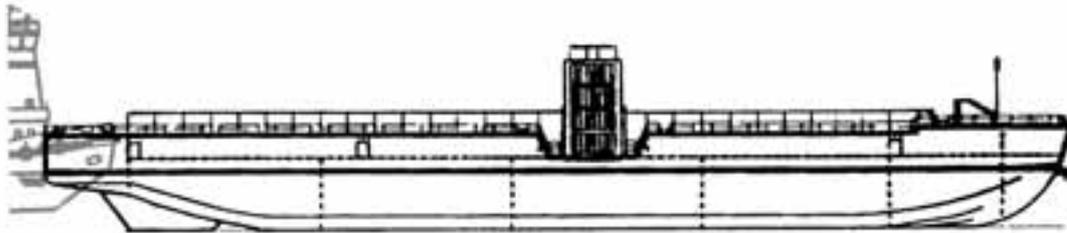
C 4/2001 M

The pusher barge combination ALFA / PARA-UNO collided with the freighter SORMOVSKIY 118 in the separation zone on the northern Baltic. The damages were minor. ALFA, owned by Paratug Ltd in Turku, Finland, had left Gotland for Inkoo in Finland. ALFA. The owner of SORMOVSKIY 118 is Onego Shipping from Petrozavodsk, Russia. She was bound for St. Petersburg.

The conditions were good and there were no technical problems. It was found that the Rule of the Road was not followed. Just before the accident the look-out was in ALFA's bridge but he did not know how to manoeuvre the vessel in the critical situation. Shortly before the OOW had to leave the bridge though the situation needed intensive observing and possible action. The investigators do not give any recommendations.

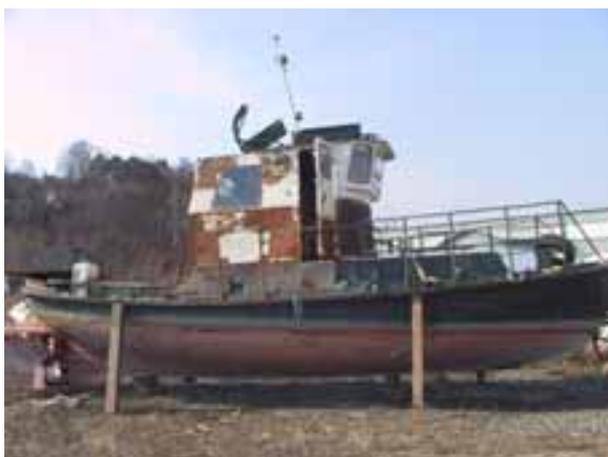
The damage control took place preliminary in nearby area and later in the port of Naantali with the attendance of classification society's representative. The damages were minor and the vessel got a permission to carry on trading.

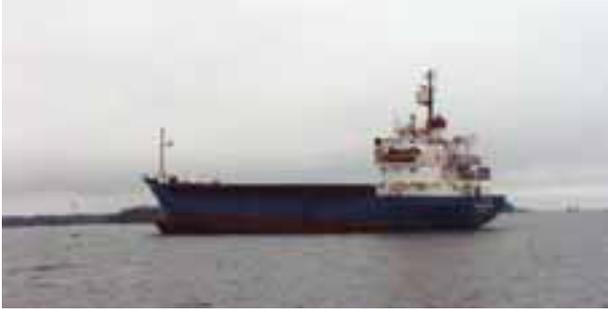
C 10/2002 M

Passenger ferry ms SUOMENLINNA-SVEABORG had departed from Suomenlinna according to the schedule on Saturday August 31st 2002. Onboard were 131 passengers and a crew of four. When the master had turned the vessel towards the quay at the end of the journey he observed, that the propeller pitch control was not responding. He switched the control to emergency mode, which did not work. At about 18:15 the vessel collided at a speed of 6 knots with the fender of the quay and she bounced back about its own length.

Altogether 12 persons needed first-aid or hospital treatment. The two most severely injured passengers had descended the stairs and fallen down due to the force of the collision. The vessel received minor damage.

The immediate cause of the collision was established to have been a shortcut in the leads of the lighting of the pitch control display. The shortcut for its part caused a relay in the control system not to function. The chafing and temporary contact had been a consequence of the vibrations of the vessel.

As contributing factors were observed problems related to the pitch control retrofit carried out in 1995 on the vessel, which originally had been built in 1952. The ship owner actions on the recurring faults was found to be inadequate.

As safety recommendations it has been released that both the ship owner and the Finnish Maritime Administration should improve their roles so that the safety management system would better remedy the observed technical faults and deficiencies in operational practises.

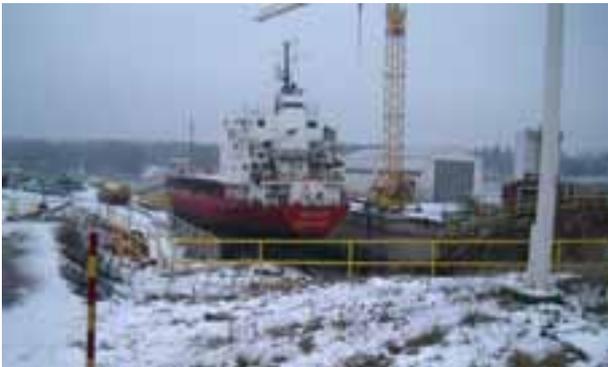
C 1/2003 M

On 5.2.2003, a steel trawler BRIAN KENT from Pori, Finland, crashed into an ice floe at a distance of about 35 nautical miles northwest of Reposaari. As a result of the incident, the bow of the trawler was damaged and the collision bulkhead behind the fore peak retracted and partly came loose from the coaming. The fore peak and the fore hold behind the collision bulkhead were entirely covered by water.

The corresponding investigation conducted disclosed that the frames in the fore peak of BRIAN KENT failed to be appropriately fixed in the keel. In fact some frames ended at a distance of several hundreds of millimetres before the keel. As a result, the bow construction was weak.

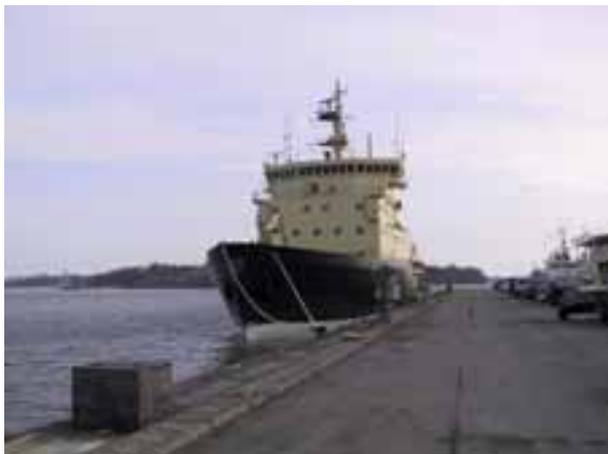
**C 3/2003 M**

The general cargo vessel BIANCA run aground on March 31, 2003 at 0504 hours. The grounding took place in the Swedish territorial waters north of the Gävle fairway in the Sjalstenarna shallows. BIANCA hit the ground in to the eastern end of the shallow with heading 287 degrees. She got damages to her hull, leakages to bottom tanks as well a serious one in to the engine room.

The fatigue of the OOW and his falling asleep follows the same scheme as numerous other groundings of Finnish cargo vessels during the last years. In all these as well as in the BIANCA case the contributing factor has been the lack of rest and lack of management of the bridge teamwork, i.e. the look out is not used effectively. The breaking of ones circadian rhythm makes it difficult to stay awake during the late night and early morning hours. This was the case also with BIANCA's grounding.

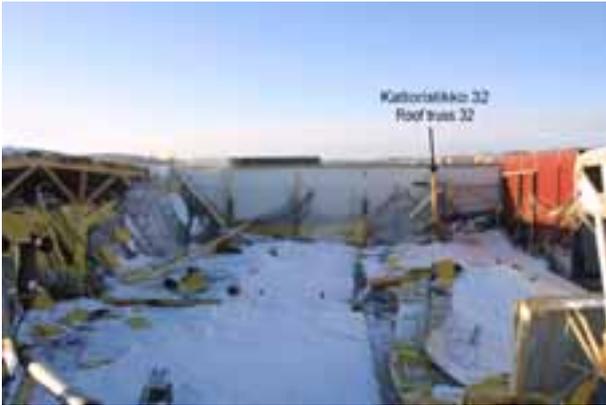
The direct cause of the collapsing of the roof was that the fastening brackets of the beam lattices mounted between the hall girders detached from their weldings. The fastening brackets used in the collapsed hall differed from the brackets in the earlier hall; in fact they had been designed insufficiently without due consideration of the loads they would have to endure. Actually the strength of the brackets had not been ensured by design calculations in the planning and design phase, and the plans had been checked only by the planner himself. Therefore this design error in the planning of the component detail could freely move on through the entire construction process and finally cause the roof to collapse.

Furthermore, the relevant investigation disclosed shortcomings in the calculations of the loads to be endured by the beam lattices mounted between the girders, in the dimensioning of the structural components connected in the damaged joint, and in the overall bracing of the hall. These secondary shortcomings nevertheless had no direct impact on the collapsing of the roof.

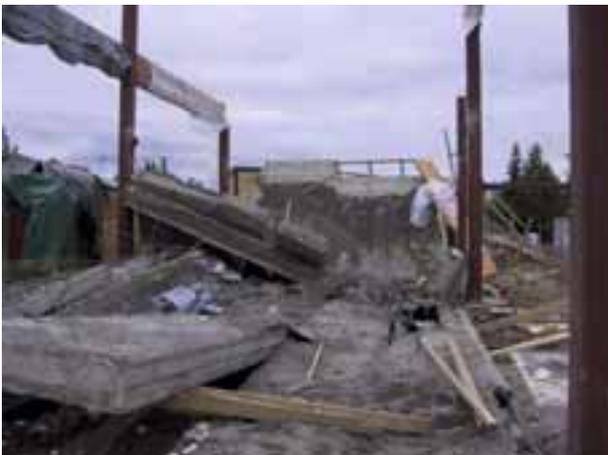
B 3/2003 Y

Fall of an intermediate floor structure intended as permanent at a service station site in Orivesi on 25 August, 2003

The steelwork had been manufactured in a small machine shop, transported to the site, and assembled and installed there. The hollow-core slab section with its horizontal steel beams fell when three of the six consoles supporting the horizontal beams and hollow-core slabs came off the pillars. The consoles had been fixed to the pillars with fillet welds, but these failed completely. The welds hardly penetrated the pillar, and the load borne by each joint was only a fraction of its design capacity. Apparently, the technical reason was that the welding voltage used had been slightly too high and the welding torch had been held in a slightly incorrect position.

To avoid similar accidents, the investigation commission recommends that the organisations in the of steel construction branch establish procedures for determining and proving the compliance of welded steel structures in order to aid in the supervision of construction and assist the construction organisation and the manufacturers of structures.

Furthermore, the investigation commission recommends that the construction supervision authority remind the developer during the early stages of a project of his duty of solicitude and of methods of establishing the compliance of products supplied by contractors and subcontractors. In this way, developers would be better prepared to monitor the capability of the construction organisation formed by them to produce structures in compliance with the standards.

In the welding tests performed during the inquiry, it was noted that one proof of a good welded joint is a bright streak left on the edge of the weld. This observation should be studied in more depth, and - as applicable - the subject should be added to the instructions for visual inspection of welded joints.

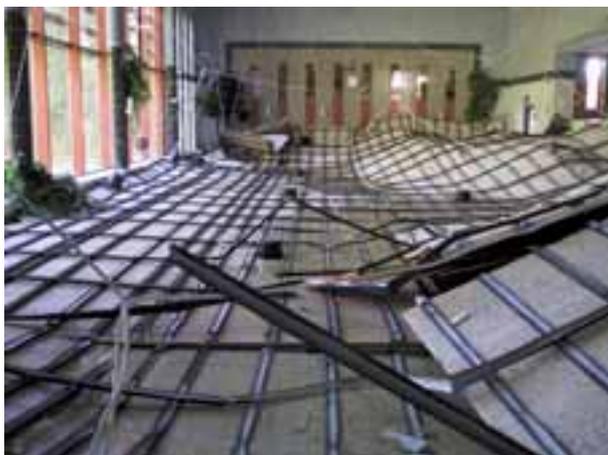
B 4/2003 Y

Dropped ceiling of indoor spa resort collapsing in Kuopio on 4 September, 2003

The collapse of the dropped ceiling was caused by a breaking of the suspension wires made of stainless steel, as a result of stress corrosion. Some wires close to one another having broken, the stress in the adjacent wires grew to the extent that other wires that had weakened by the stress corrosion, broke and spring suspensions came loose from the supporting long beams. As wire material, AISI 304 stainless steel had been selected, as at the time of the realization of the project, the designers, planners, constructors and building supervision authorities had no knowledge of the SFS-ENV 1993-1-4 Eurocode preliminary standard with its national implementation instructions, and they were hence unable to use it in the selection of an appropriate steel quality for indoor swimming-pool and spa conditions. According to an investigation conducted by the Technical Research Centre of Finland (VTT), the AISI 316 acid resistant steel specified in the original plans would not have been a significantly better solution as regards stress corrosion. Stress corrosion is not only conditioned by stresses caused by load, but a more important conditioning factor is to be seen in the residual stresses generated by wire treatment. In practice residual stresses can hardly be avoided as they are generated even in the installation phase.

The ceiling having been built, the condition of its suspension and supporting structures had not been inspected, as the dropped ceiling featured no inspection hatches and its height from the upper level of the pool was over five meters.

To prevent corresponding collapses of dropped ceilings, the Accident Investigation Board of Finland recommends that the regulations and instructions pertaining to planning and design should include detailed specifications for such important load support construction materials that are appropriate for indoor swimming-pool and spa conditions, in terms of safety. Moreover, the instructions concerning dropped ceiling structures of indoor spa resorts and swimming pools ought to be updated so as to consider dropped ceilings as support constructions and to realize the air-conditioning of the space above the dropped ceiling in a way rendering impossible any chlorine penetration or accumulation on the surfaces of non-corrosion-resistant structures.

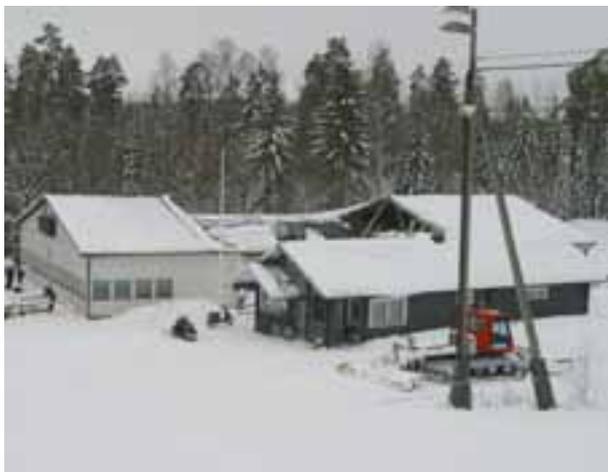
B 1/2004 Y

Collapse of the roof of a maintenance building built by voluntary workers at a slalom centre in the municipality of Pohja on 1 February, 2004

The technical cause of the accident was a flexural moment, significantly higher than the capacity of the rafters and which was exerted on the rafters near the ridge. This could have been avoided by designing the truss diagonals to extend all the way up to the ridge, whereas in the actual truss, the diagonals extended along the rafters, but stopped 1.5 metres short of the ridge. The trusses were therefore poorly dimensioned, and the flexural moment and other force values for the rafters incorrectly calculated.

The slalom centre is owned by a local sports club, and the maintenance building was designed and built by voluntary workers in 1993 and 1994. In the opinion of the Board of Inquiry, the structural deficiencies were caused by the construction organisation's lack of experience.

For existing buildings of this type, the Board of Inquiry recommends that municipalities, local building officials and building owners establish whether buildings exist within their areas whose structural safety should be examined. If their structural safety cannot be established based on the designs and other material, additional studies and reinforcement of the structures may be necessary.
