Accident
on 24 December 2000
at Tahiti Faaa Airport
to the DC10-10
registered N132AA
operated by Hawaiian Airlines

REPORT
n-aa001224a

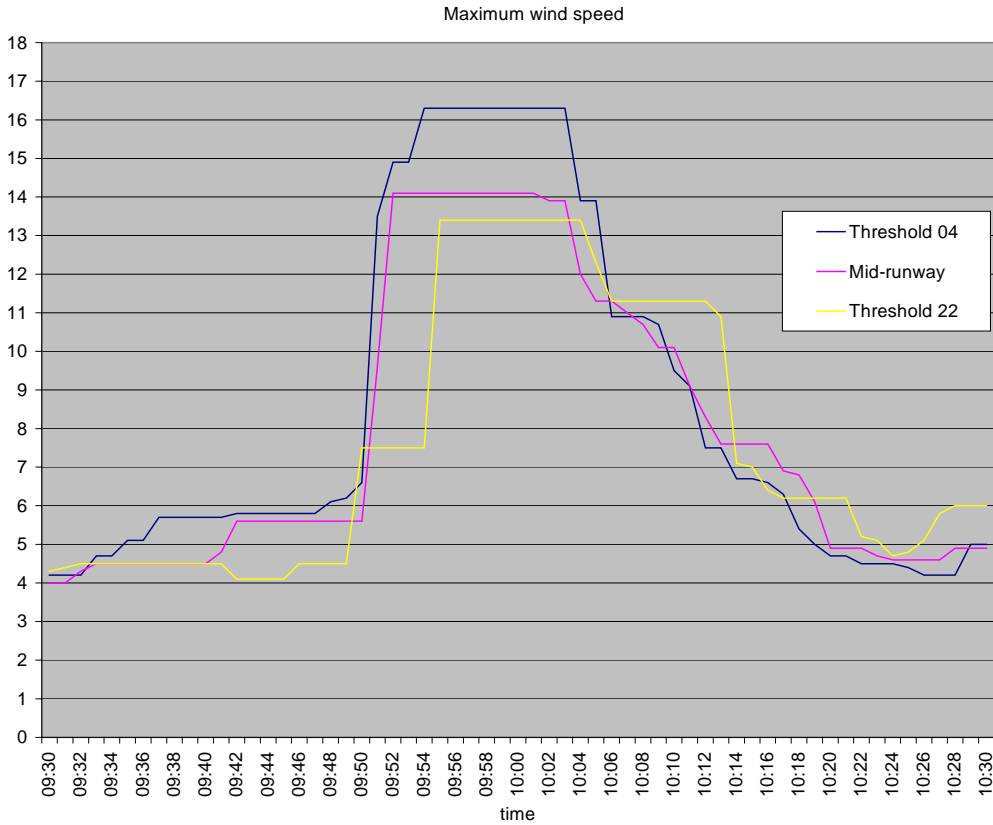
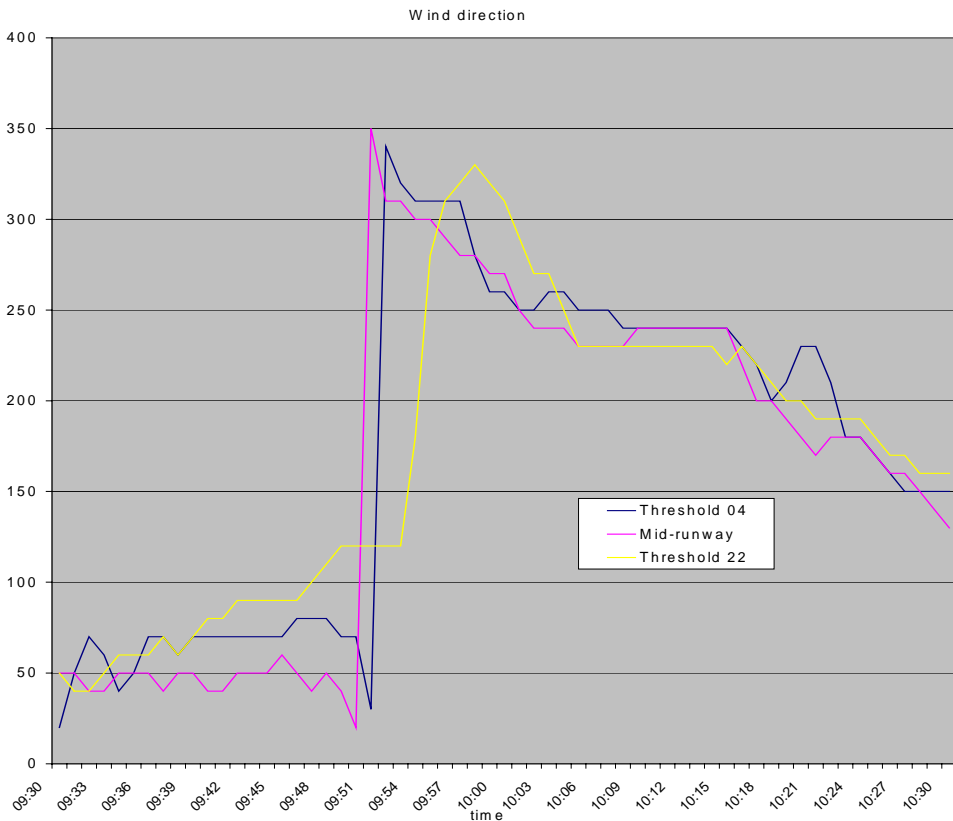
Between 9 h 47 min and 9 h 56 min, the wind speed increased rapidly, reaching 5.8, 6.1, 6.2, 6.6, 13.5, 14.9, 14.9, 16.3, 16.3 and 16.3 m/s at threshold 04, with a significant variation in direction. Between 9 h 52 and 9 h 53 min, the wind direction was 330° at threshold 04 while it was 310° at the meteorological station and 120° at threshold 22.

The variations in wind speed and direction indicate the presence of turbulent wind and windshear characteristic of a storm. The recordings also indicate that the stormy period lasted about fifteen minutes.

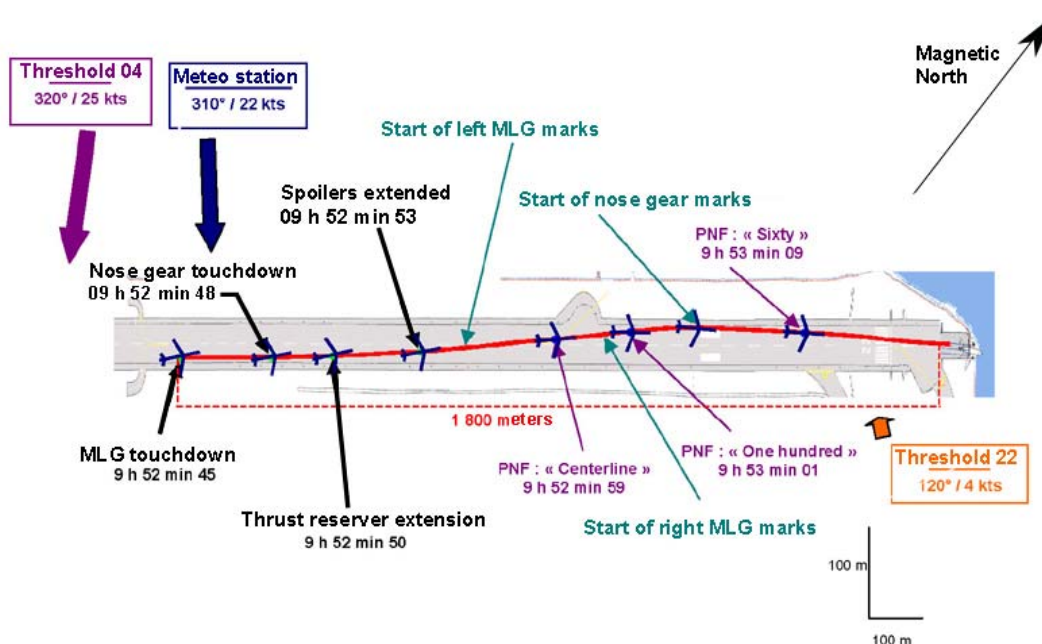
Ground track determined from recorded FDR data

The landing roll, compared with the airplane's magnetic heading, indicates that the airplane started sliding to the right for eleven seconds from touchdown of the main gear, then slid to the left, between 9 h 53 min and 9 h 53 min 13 s.

Note: The winds indicated above correspond to those at 9 h 53 min averaged over the last two minutes at thresholds 04 and 22 and the meteorological station. Threshold 04 is not included due to the scale chosen.

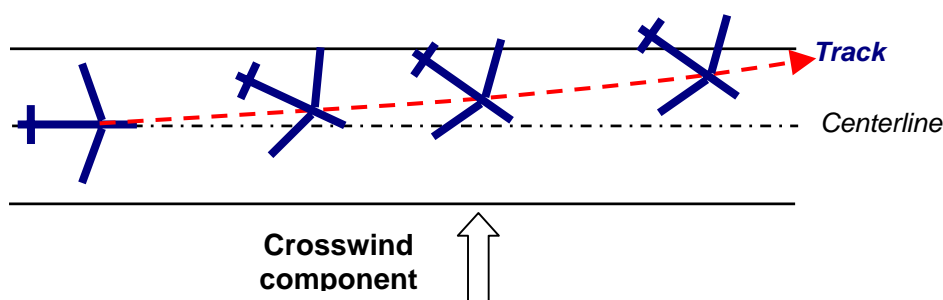
On a wet runway and with a crosswind, the wind's effect on the fuselage and the tail tend to align the airplane into the face of the wind and to move across with the runway wind. This tendency of the airplane to align itself into the face of the wind and to be pushed off the centerline is increased by the application of reverse thrust.

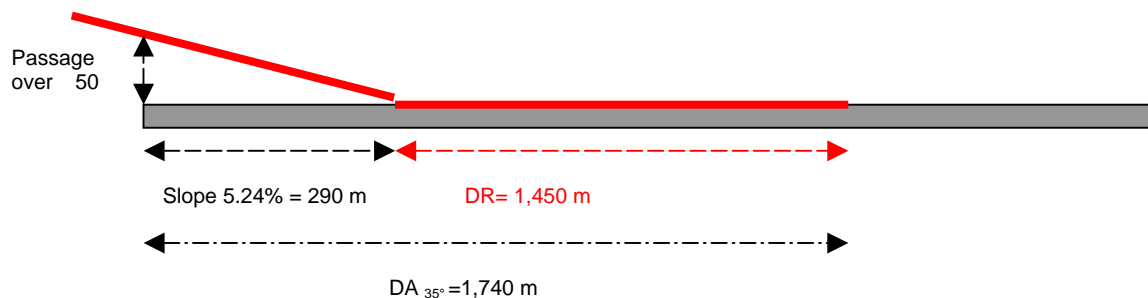
Taking into account a flaps configuration of 35°, the graph relative to a landing at 335,000 lbs on a wet runway at sea level, with water level between three and six millimeters with full reverse thrust on all three engines, gives a required landing distance⁽⁵⁾ of 5,800 feet, so $LD_{35^\circ} = 1,740$ meters. The approach slope at Faa for QFU 04 is 5.24%. From a strictly performance perspective, by passing above the runway threshold by fifty feet, the corresponding computed distance between theoretical wheel touchdown and complete airplane stop is 1,450 meters⁽⁶⁾. The data drawn from the FDR showed that the distance between the touchdown and the runway excursion was about 1,800 meters.

It should be noted that the direction and strength of the wind, the runway slope, the temperature and the runway surface adhesion are also factors that influence the landing distance and that are not taken into account for this calculation.
