Runway overrun Onur Air

Runway overrun after rejected take-off of the Onur Air MD-88, registration TC-ONP, at Groningen Airport Eelde on 17 June 2003

The Hague, 6 April 2006 (investigation number 2003071)

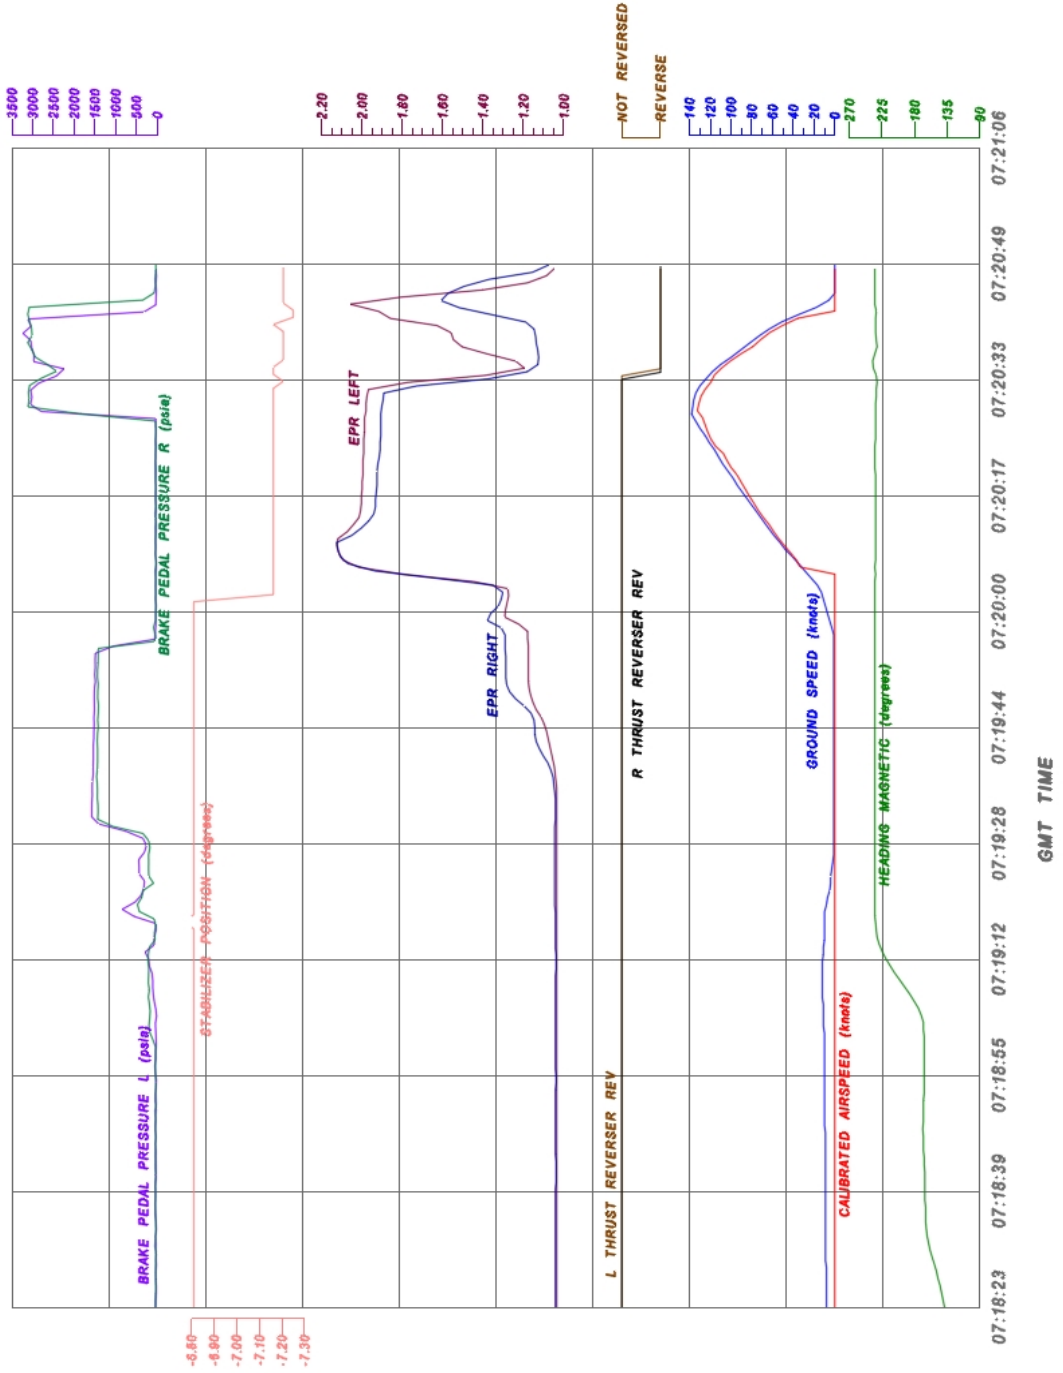
FDR data plot

On the runway checks were performed. FDR data indicated a stabilizer position change from 6.8 to 7.2 degrees aircraft nose up (ANU). Thereafter the crew initiated a static engine spin-up. Again the stabilizer warning sounded. The crew released the brakes and started the take-off roll. From the CVR it is derived that during the entire take-off roll the warning sounded continuously.

When attempting to rotate the captain experienced a heavy elevator control force. The captain stated that he needed much more than normal back pressure on his control column to lift the nose. He felt "it was impossible to make the take-off", and as the nose did not rise he decided to reject the take-off. Post accident analysis revealed that the rejection was initiated at 128 knots.
