Transportation
Safety Board
of Canada

SR 111

Investigation

Report

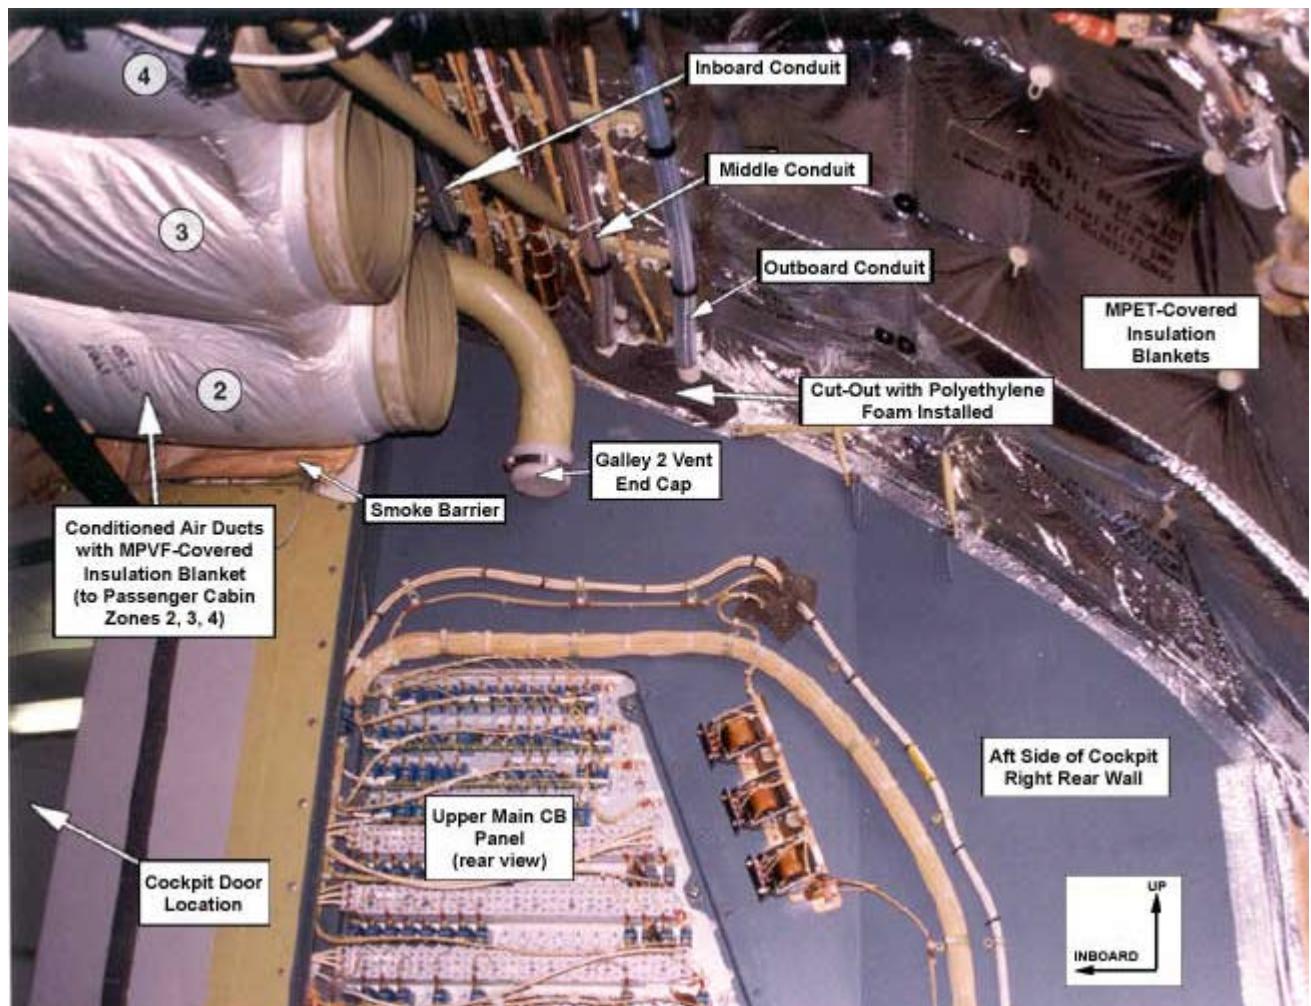
FIGURE 4 Area behind cockpit rear wall (Galley 2 and riser duct assembly removed)

In the occurrence aircraft, which was built in 1991, MPET-covered insulation blankets were used to insulate the fuselage. They were also used to insulate some of the air conditioning ducts. Most of the air conditioning ducts were insulated with metallized polyvinyl fluoride (MPVF)-covered insulation blankets (see [Figure 4](#)).

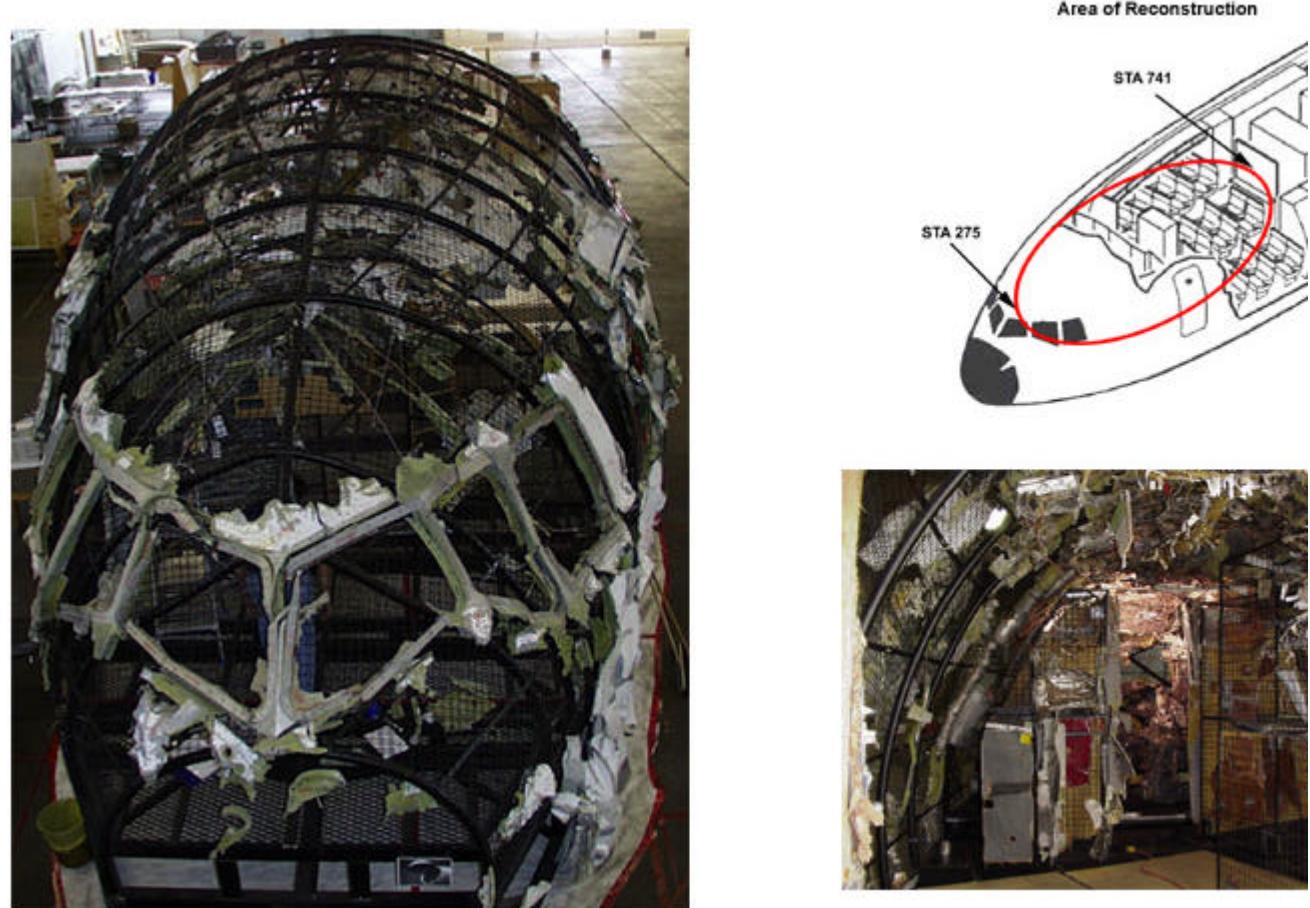
FIGURE 19 Reconstruction mock-up

A full-scale metal framework of the front 10 m (33 feet) of the aircraft fuselage was fabricated by the Nova Scotia Department of Transportation and Public Works Mechanical Branch. Identified portions of primary structure, skin panels, and air conditioning ducts were straightened, fracture matched, sewn together with wire, and installed on the reconstruction mock-up. (See [Figure 19](#).) Galleys 1, 2, and 3 were partially reconstructed over separate wire mesh frames and positioned within the reconstructed framework. Pieces of the cockpit seats,

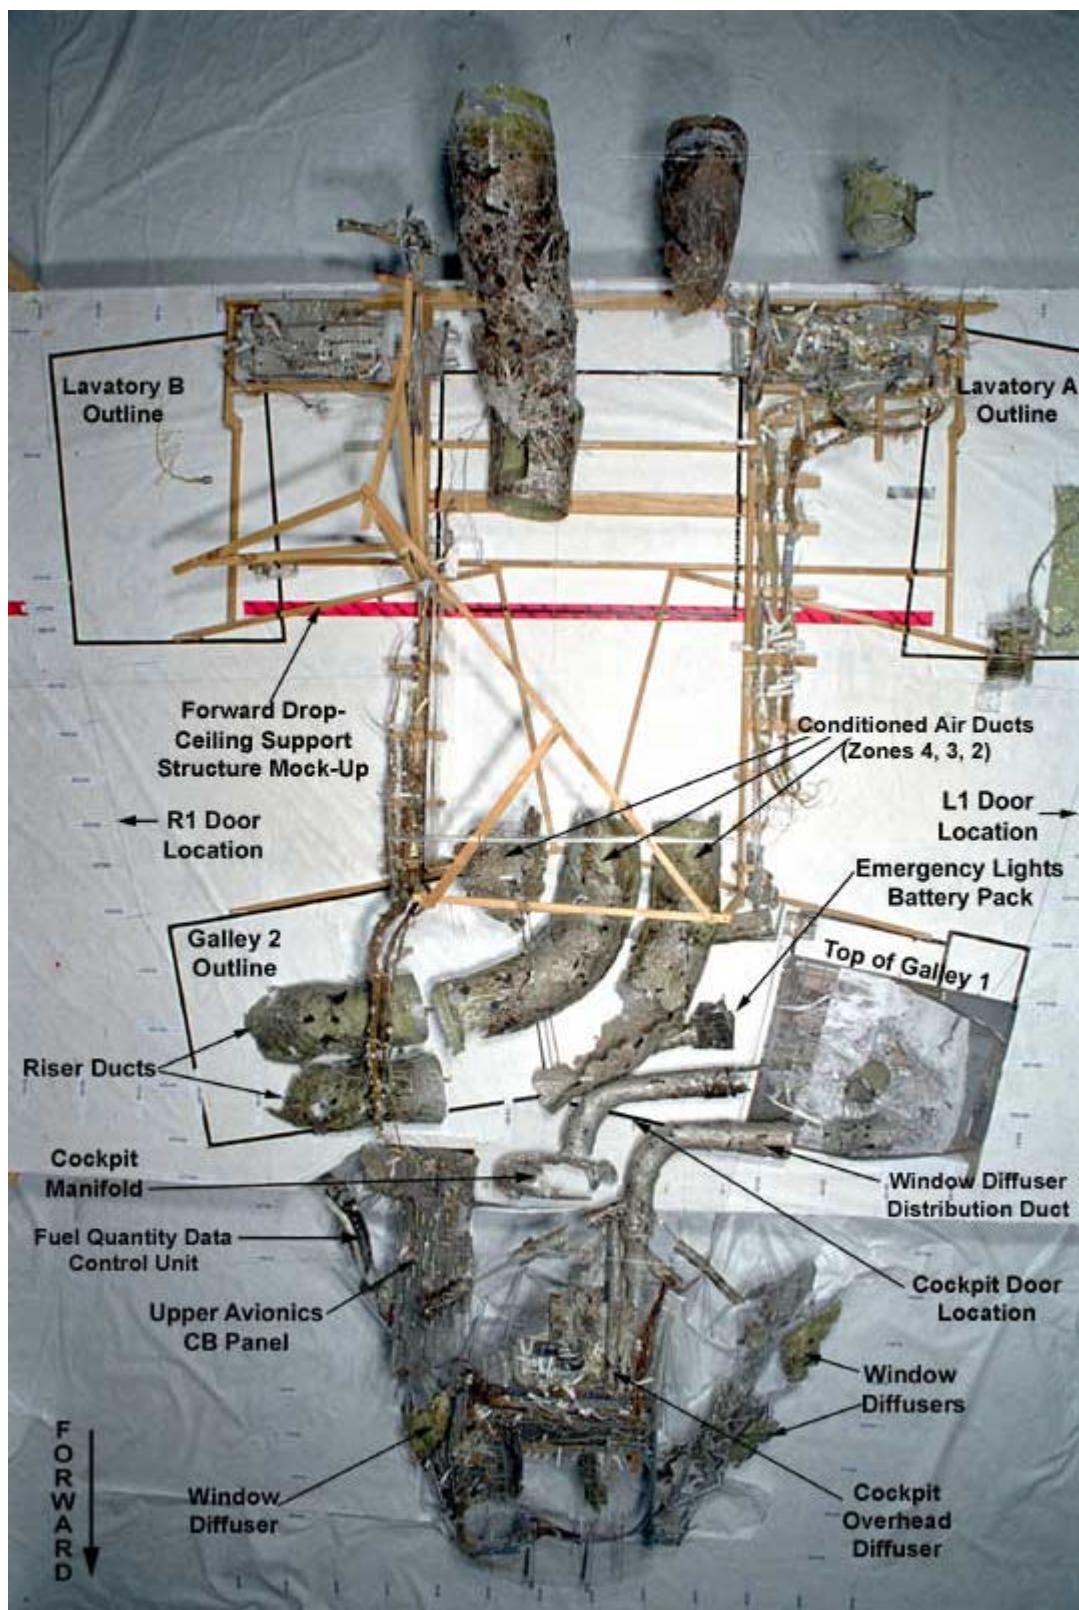
FIGURE 27 Cockpit attic and forward cabin drop-ceiling areas mock-up

About 75 per cent of the upper and lower CB panels were identified, reconstructed, and placed in the reconstruction mock-up (see [Figure 27](#) and [Figure 28](#)). The most forward sections of the upper and lower CB panels were not recovered. The upper avionics CB panel had been exposed to heat coming from both the front and back sides. The lower CB panel did

Examination of the battery pack showed that, although it was extensively heat damaged, the heat occurred from the outside in (see [Figure 27](#)). This indicates that the fire did not start from a heat condition, such as thermal heating, within the battery pack.
